Christchurch City Council
PRK_0348_BLDG_010 EQ2
Toilets Block No 2 Ground
The Groynes, 182 Johns Road

QUALITATIVE ASSESSMENT REPORT
FINAL

- Rev C
- 21 November 2012

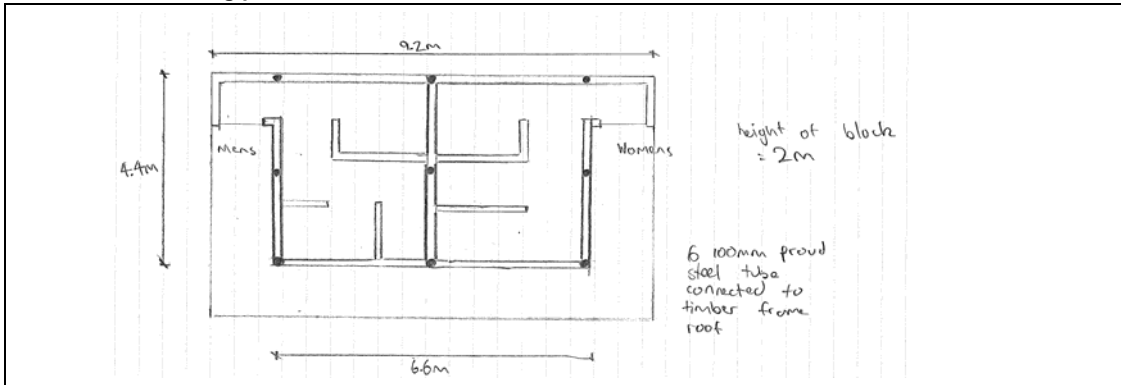
1.2 Sketch of building plan

This building is a single storey toilet block. It is constructed from reinforced filled masonry walls with a timber framed corrugated iron roof, which is connected with steel tubes and brackets cantilevering vertically from the walls. Drawings were available for this structure and it has indicated the building was designed in August 1985.

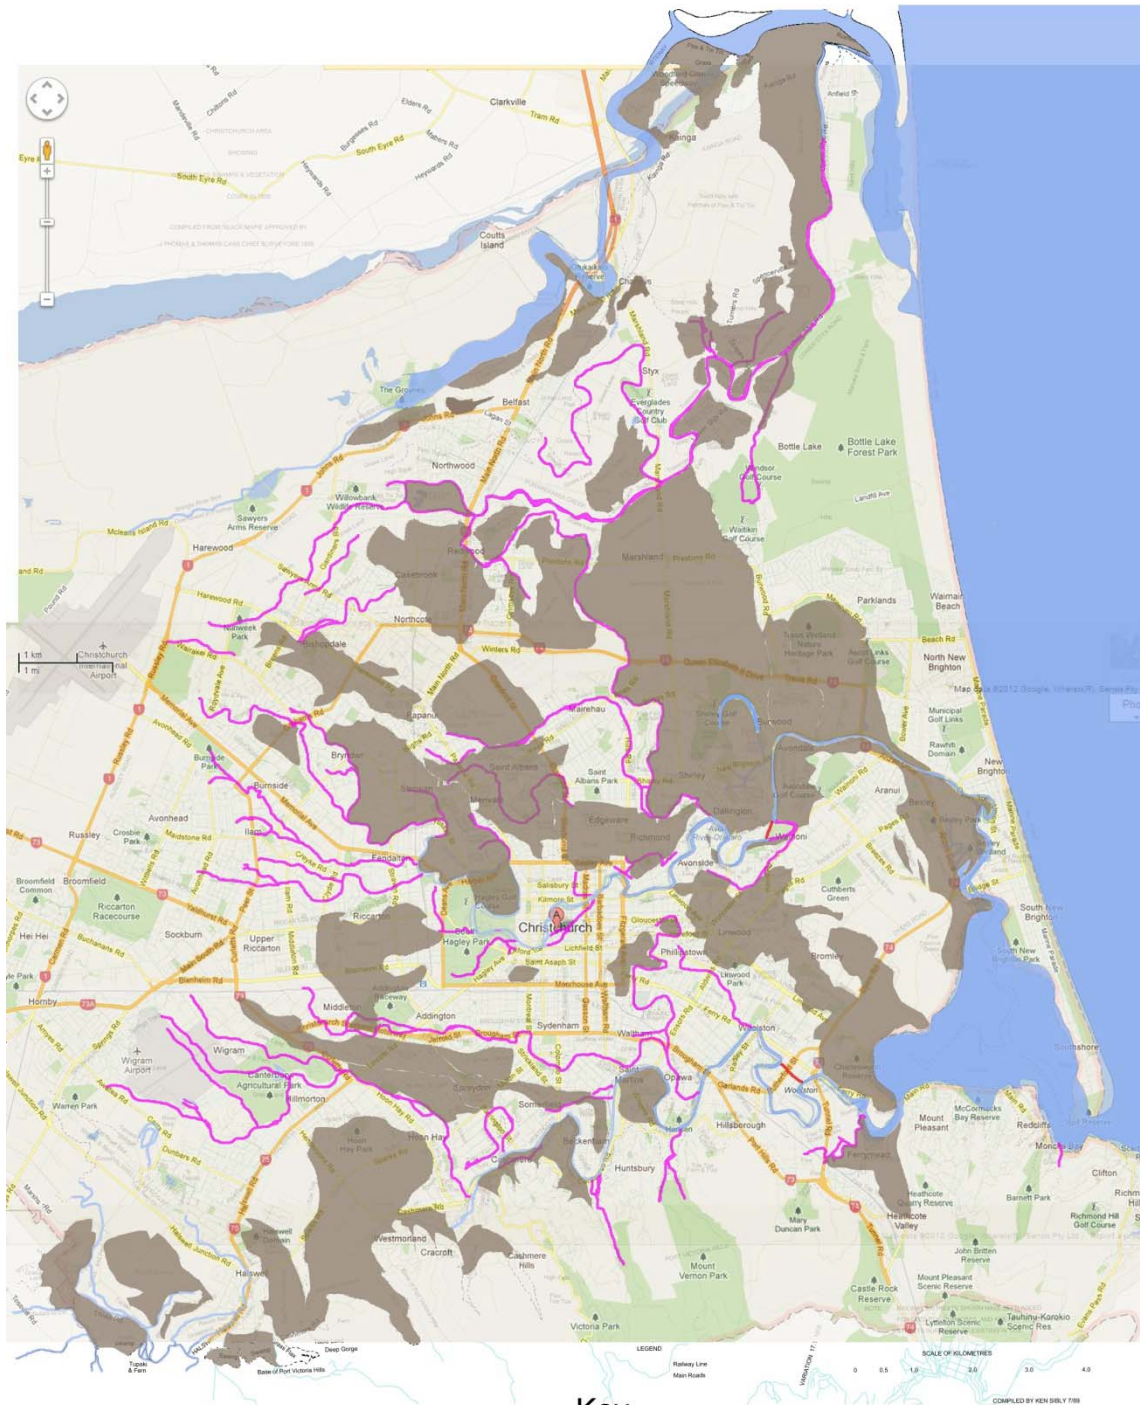
Appendix A – Christchurch 1856 land use

Reference to historical documents (eg Appendix A) shows that parts of the site were classified as swamp or marshland. The area classified appears to be larger than lakes currently present on site. This could indicate that adjacent land on site could be underlain by soft or liquefiable deposits. With a number of creeks running through the site, it is possibly that much of the area would be underlain by soft river deposits.

The swamps and previous creeks/riders from 1856 have been overlaid onto a map of Christchurch in 2012

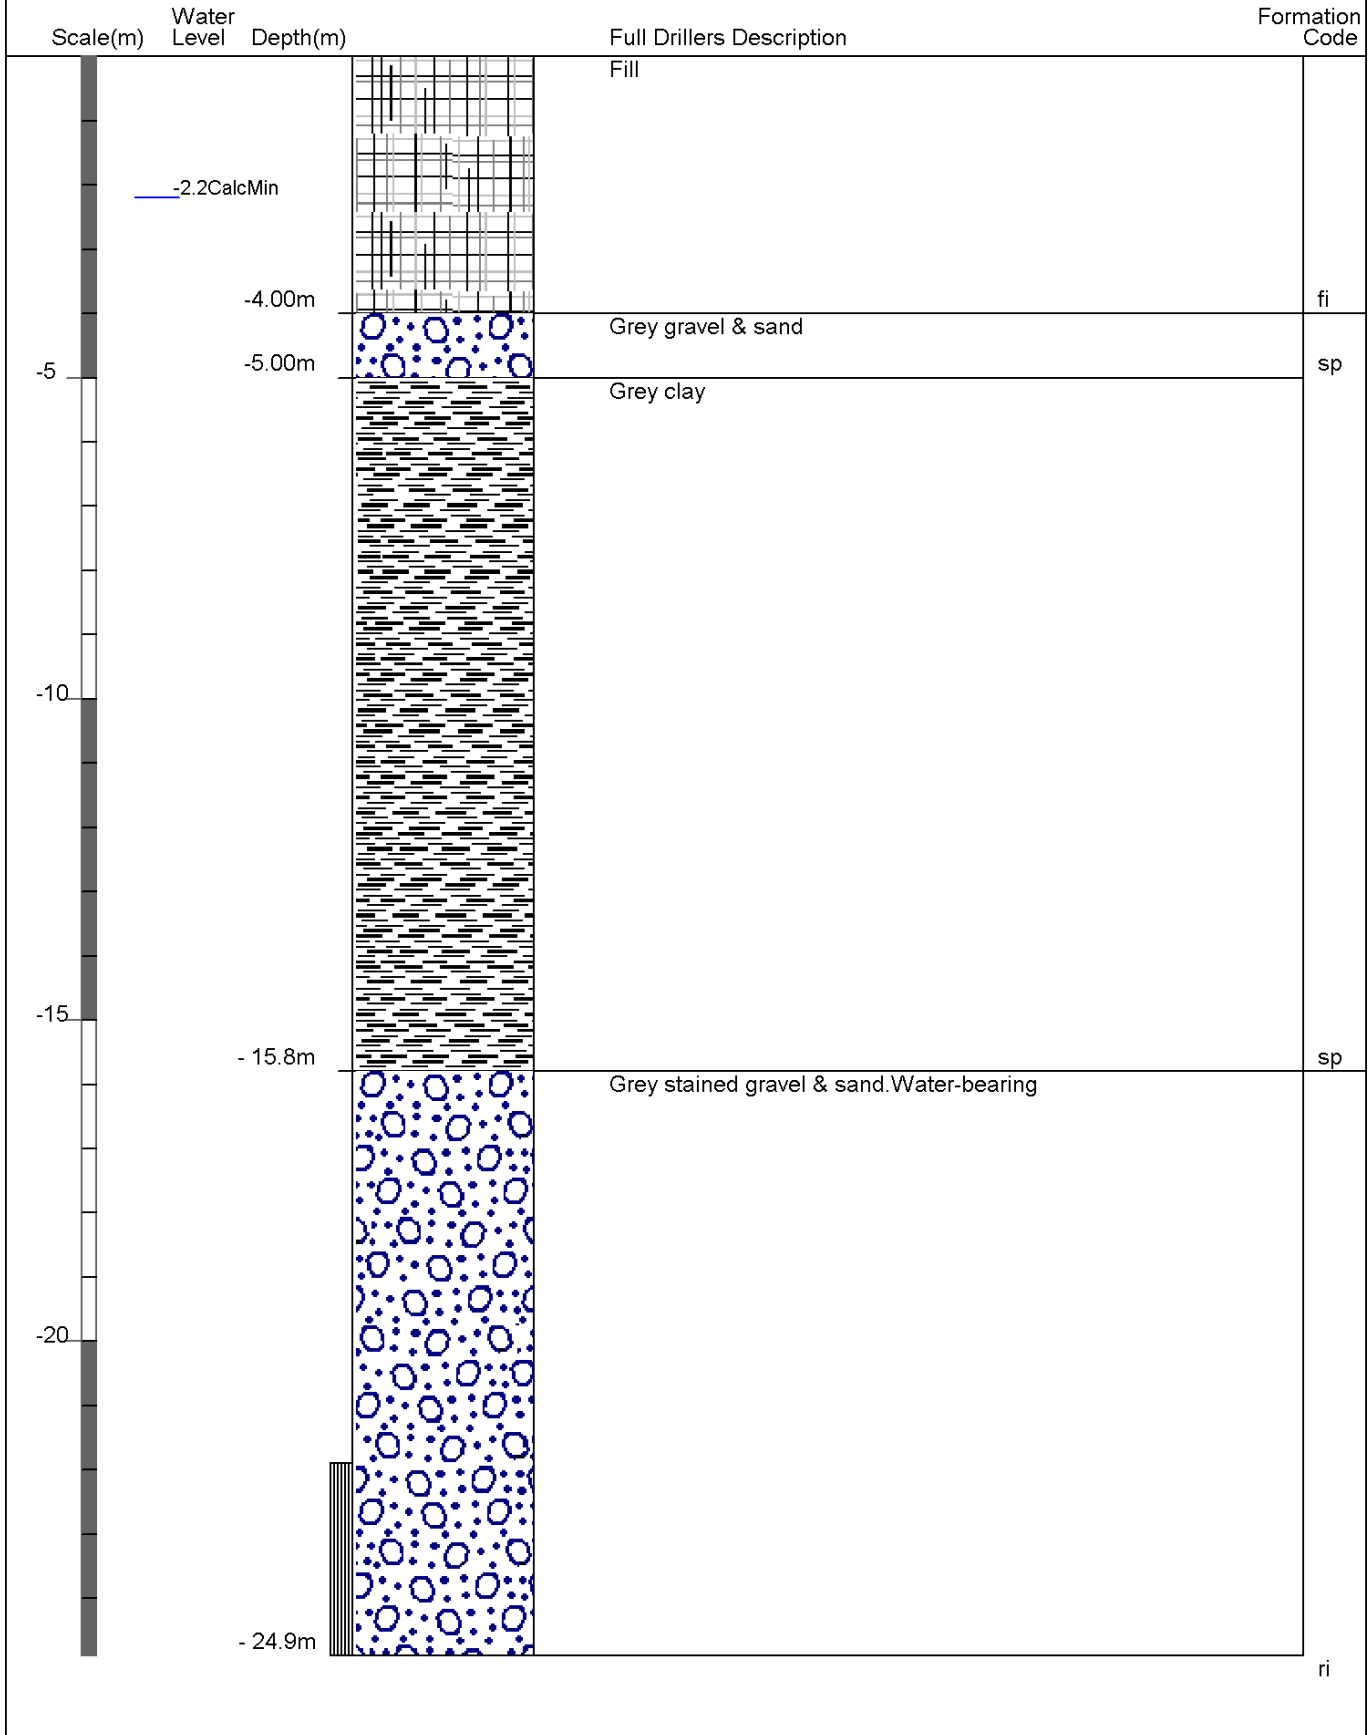
Borelog for well M35/5250

Gridref: M35:7810-5045 Accuracy : 4 (1=best, 4=worst)
 Ground Level Altitude : 11.2 +MSD
 Driller : A M Bisley & Co
 Drill Method : Cable Tool
 Drill Depth : -24.9m Drill Date : 25/06/1985

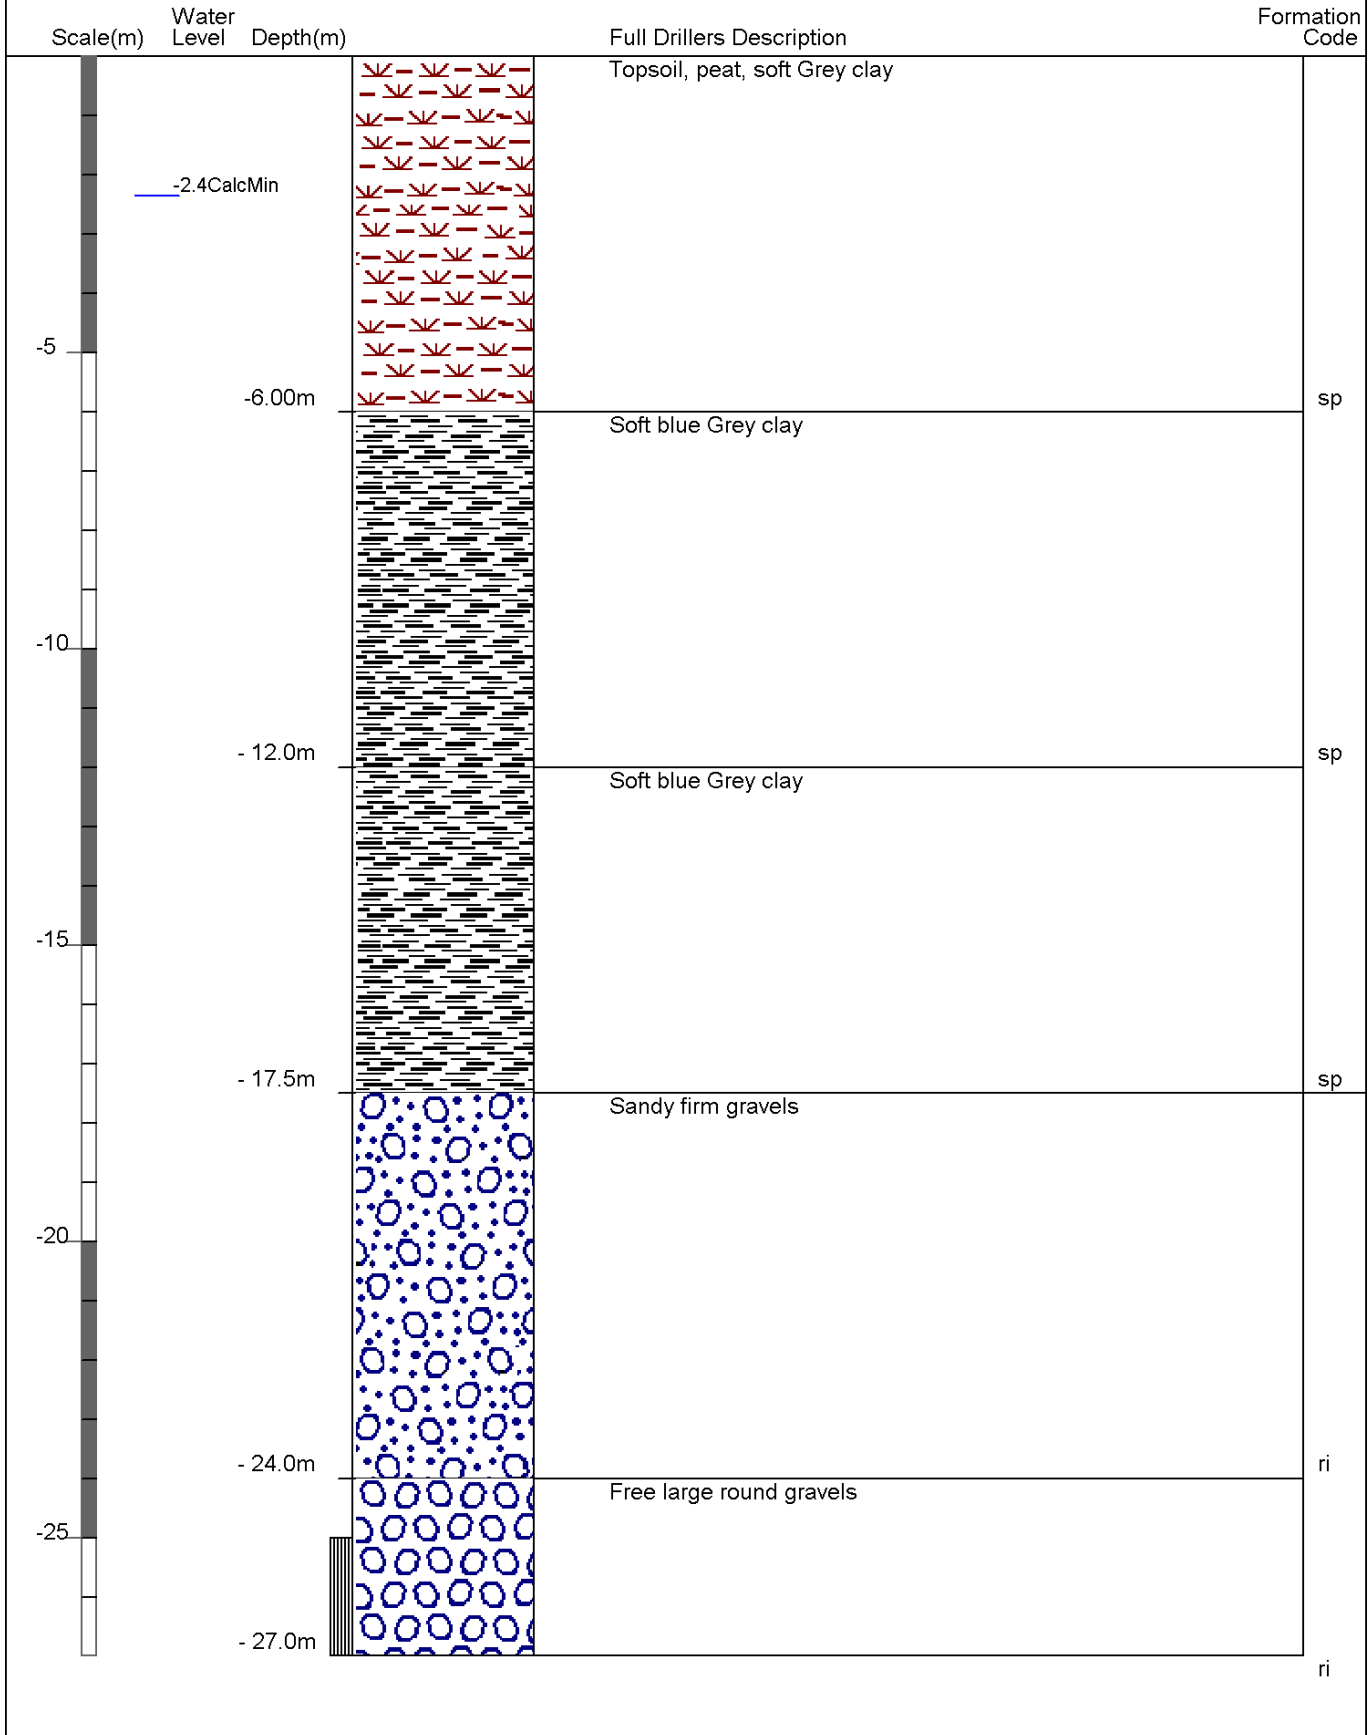
Borelog for well M35/7885

Gridref: M35:7844-5053 Accuracy : 4 (1=best, 4=worst)
 Ground Level Altitude : 13 +MSD
 Driller : East Coast Drilling
 Drill Method : Rotary Rig
 Drill Depth : -27m Drill Date : 6/01/1998

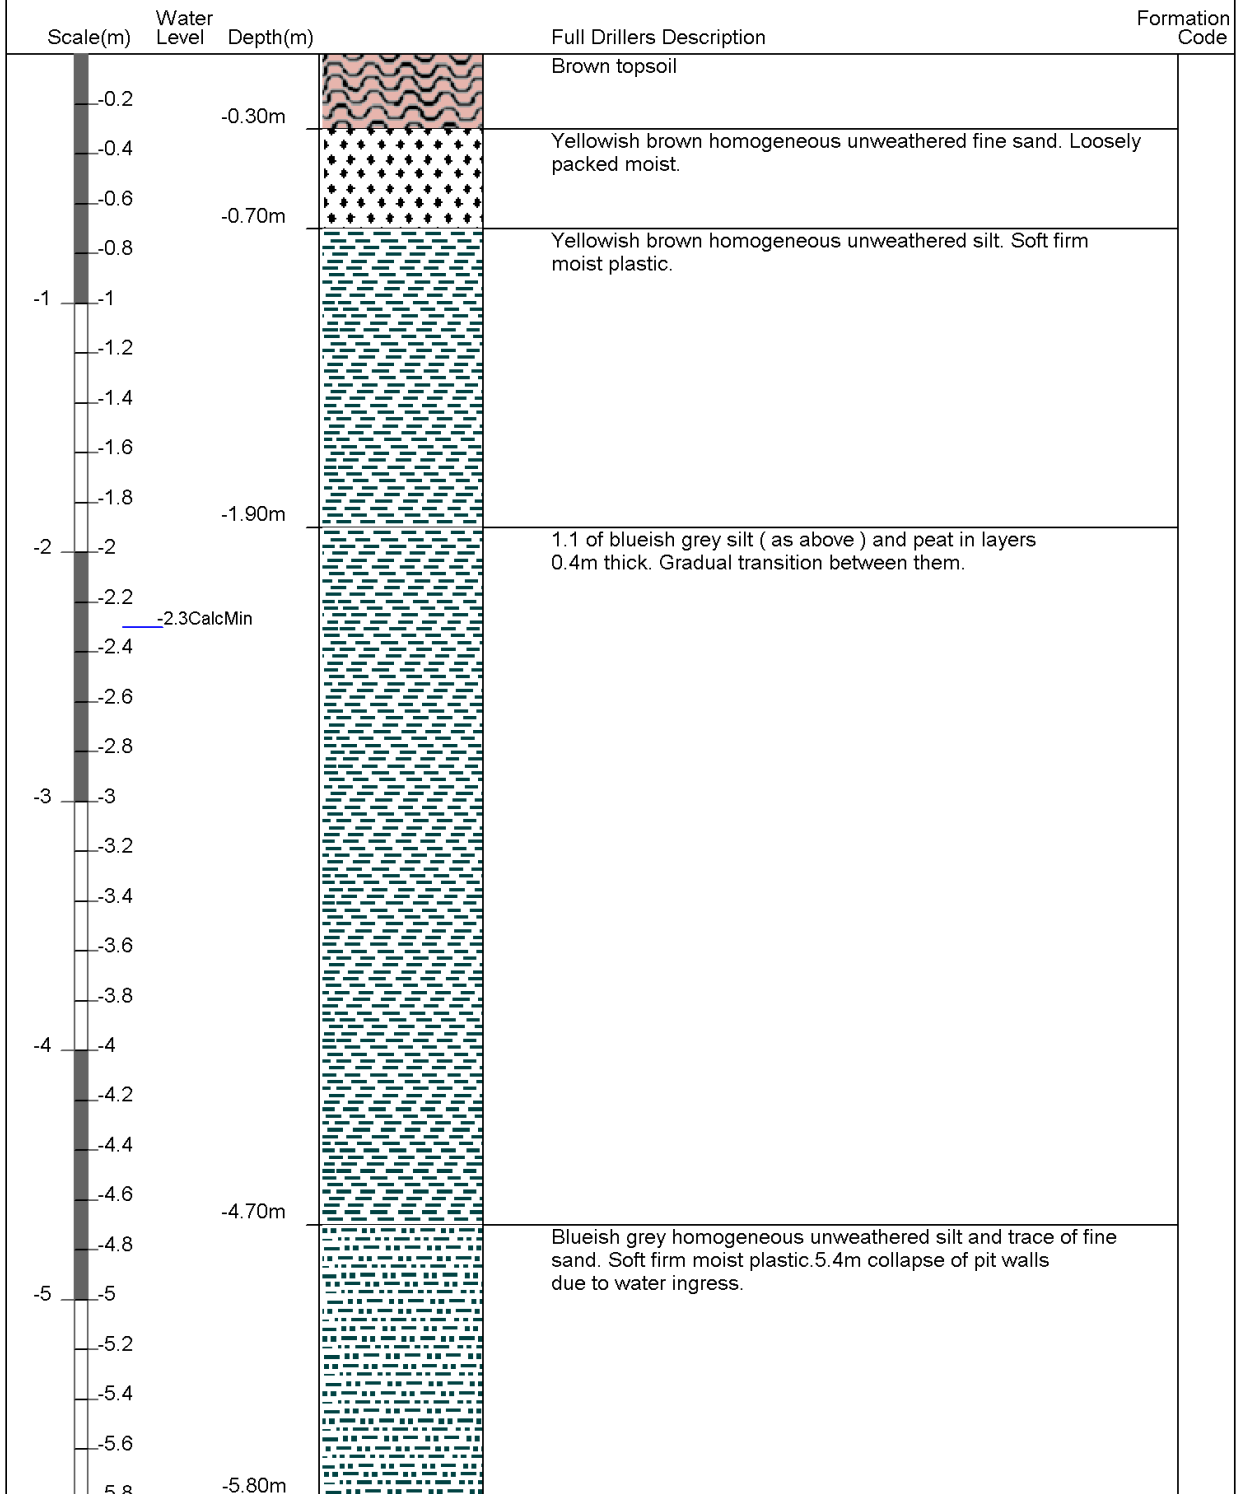
Borelog for well M35/10305

Gridref: M35:78627-50764 Accuracy : 2 (1=high, 5=low)
 Ground Level Altitude : 12.74 +MSD
 Driller : Texco Drilling Ltd
 Drill Method : Unknown
 Drill Depth : -5.8m Drill Date : 6/07/2004

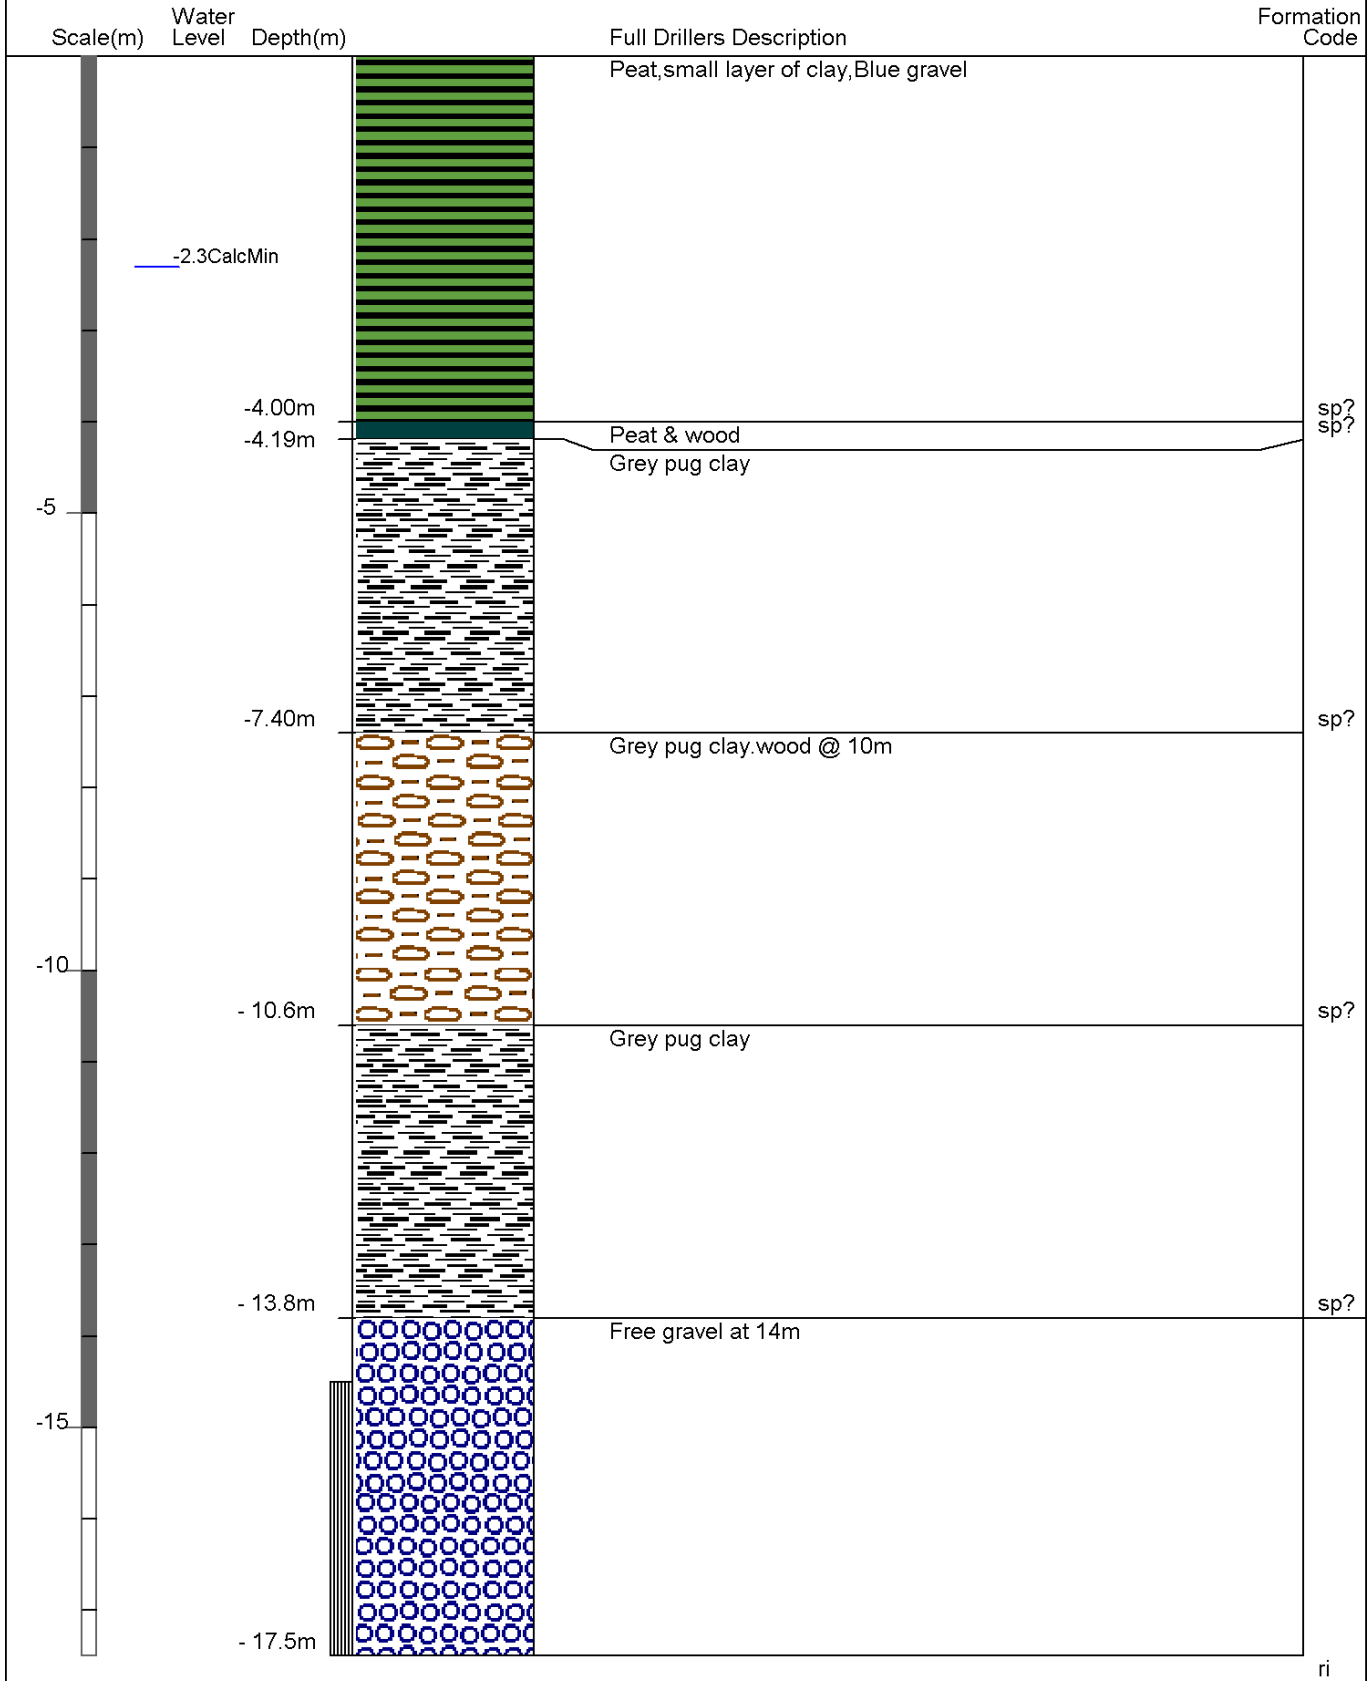
Borelog for well M35/3475

Gridref: M35:785-505 Accuracy : 4 (1=best, 4=worst)
 Ground Level Altitude : 13.1 +MSD
 Driller : Smith, J R & I G
 Drill Method : Cable Tool
 Drill Depth : -17.5m Drill Date : 29/11/1983

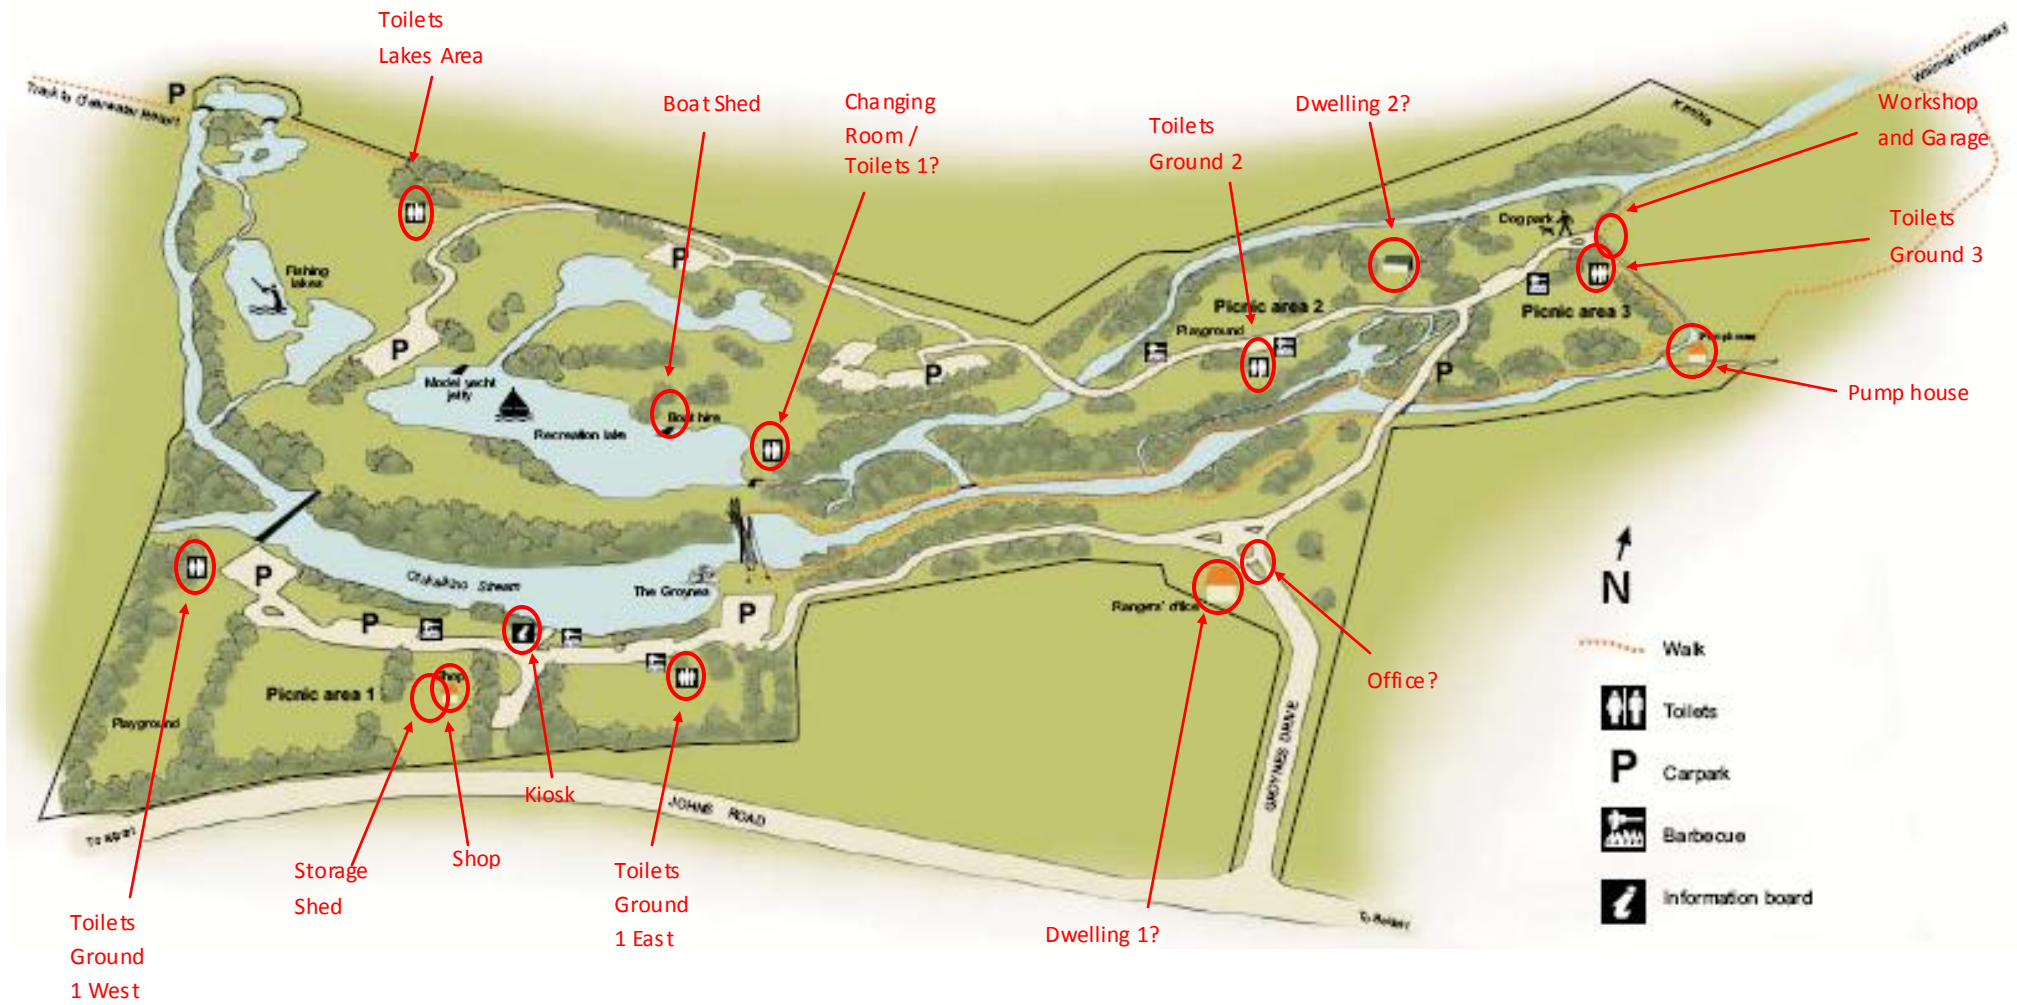
Appendix D – Site Plan outlining the location of the building as named in the external site walkover

Could not find – Toilets Kimihia? Or Toilets – CLOSED (behind toilet block?)
