Christchurch City Council
PRK_0348_BLDG_012 EQ2
The Groynes - Pump House
182 Johns Road

QUANTITATIVE ASSESSMENT REPORT
FINAL

- Rev B
- 27 February 2013

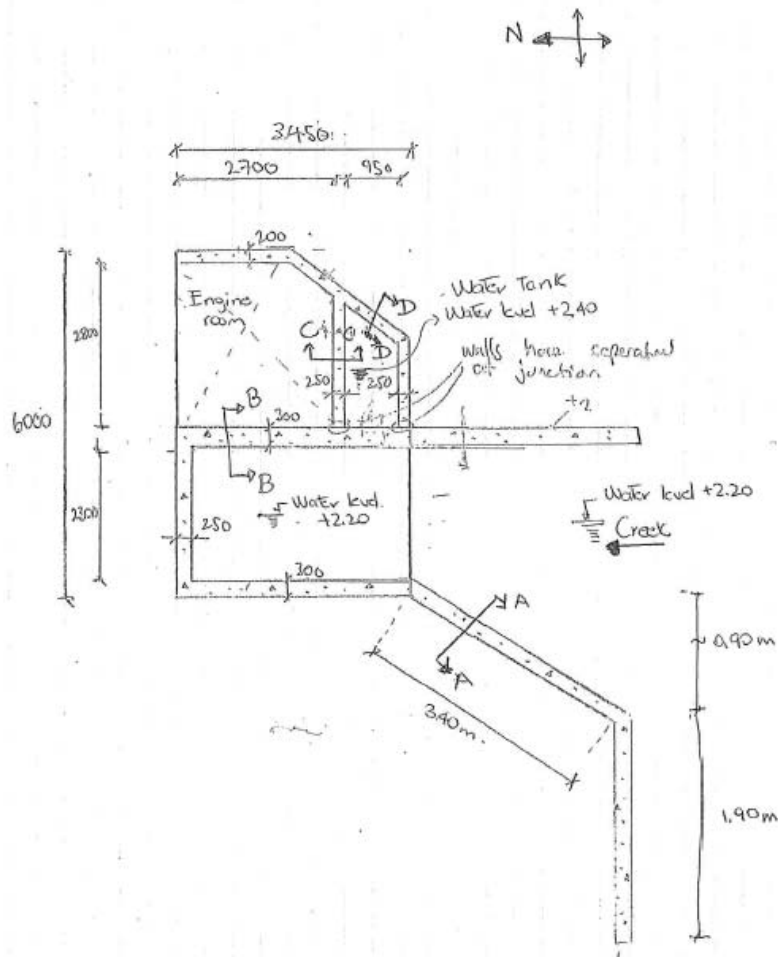
Figure 3: Sketch of the pumphouse

The pumphouse structure located at the Groyne is formed from reinforced concrete walls at the ground level with a timber structure above. The pumphouse is constructed above a creek and in a position where the sides of the creek slope. Some of the walls are therefore retaining. The thickness of these retaining walls is 300mm while the other walls forming the structure are either 200 or 250mm thick. The height of the concrete walls is approximately 2.60m. An sketch of the pumphouse is attached below.

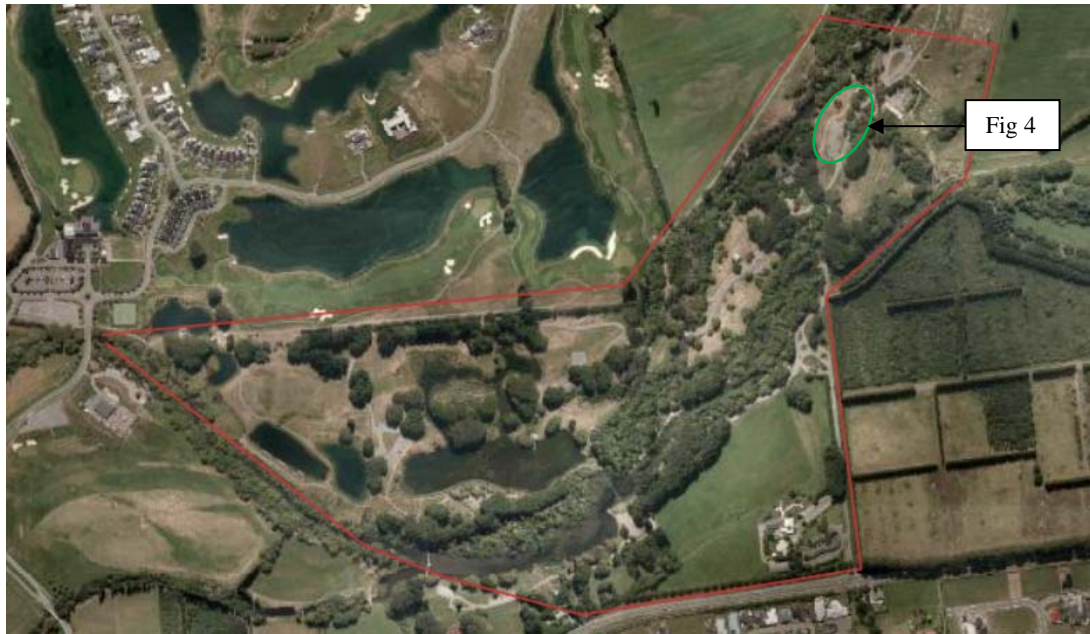
- Figure 3 – Aerial photography from 24 Feb 2011 (<http://viewers.geospatial.govt.nz/>)

The aerial photographs appears to show some evidence of liquefaction occurring on site due to the 22 February earthquake, with localised sand boils and liquefied material ejected near the road way visible in figure 4.

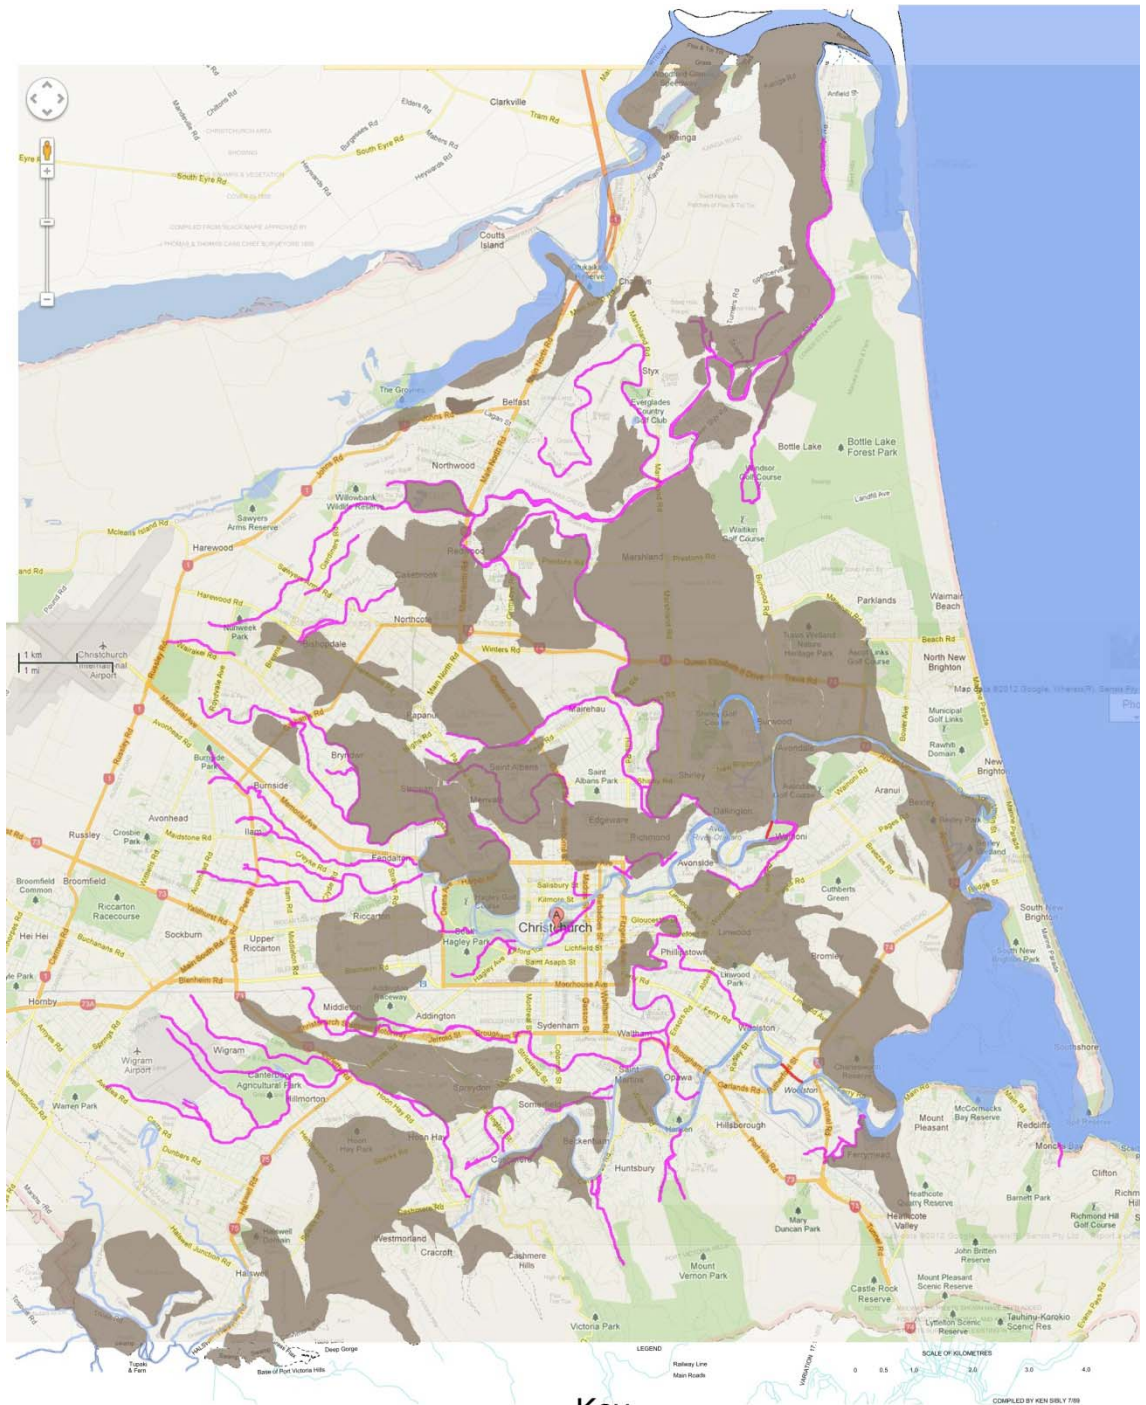
Reference to historical documents (eg Appendix A) shows that parts of the site were classified as swamp or marshland. The area classified appears to be larger than lakes currently present on site. This could indicate that adjacent land on site could be underlain by soft or liquefiable deposits. With a number of creeks running through the site, it is possibly that much of the area would be underlain by soft river deposits.

The swamps and previous creeks/riders from 1856 have been overlaid onto a map of Christchurch in 2012
