CHRISTCHURCH CITY COUNCIL
PRK_1190_BLDG_001 EQ2
North Hagley Pumphouse
10 Riccarton Ave, Christchurch Central

QUALITATIVE ASSESSMENT REPORT
FINAL

- Rev B
- 25 March 2013

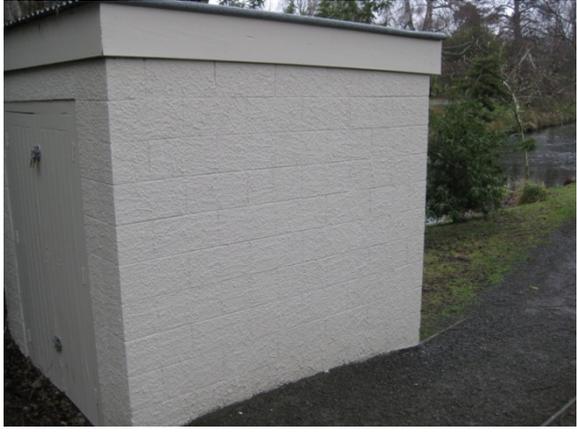
<p>Photo 1: North elevation</p>	<p>Photo 2: West elevation</p>

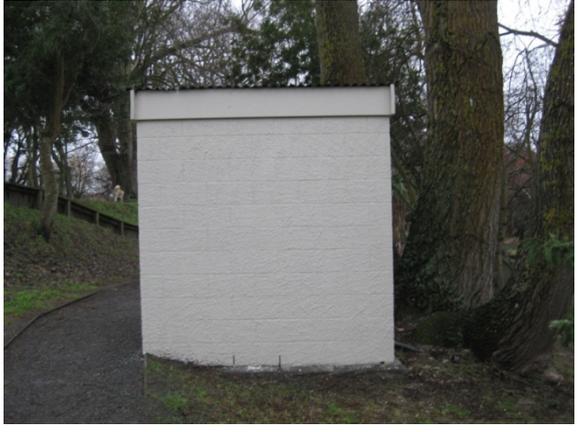
<p>Photo 3: South elevation</p>	<p>Photo 4: East elevation</p>

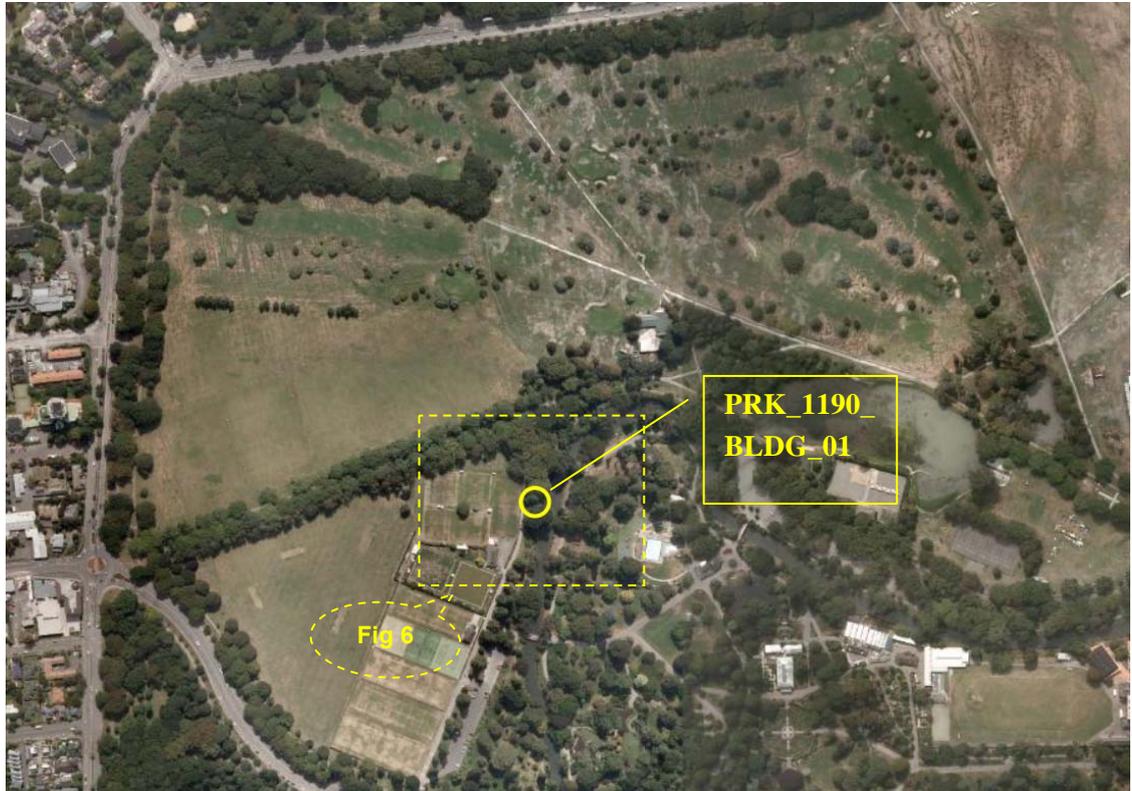
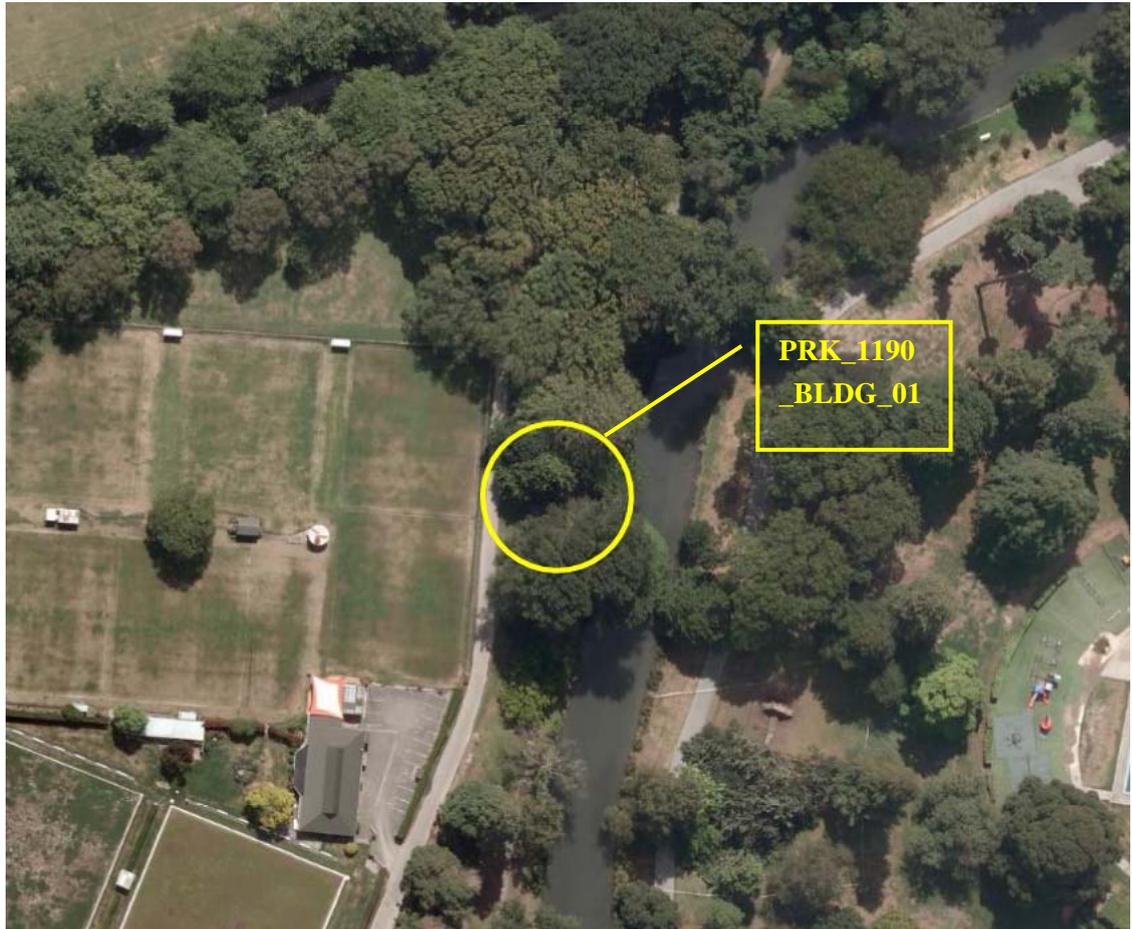
- **Figure 5- Aerial photography from 24 Feb 2011 (<http://viewers.geospatial.govt.nz/>)**

■ **Figure 6- Aerial photography from 24 Feb 2011 (<http://viewers.geospatial.govt.nz/>)**

An aerial view of the structure itself was not possible as the pump house is obstructed by the branches of surrounding trees. However, there appears to be no evidence of any liquefied ejecta in the immediate surrounding area. Additionally, there appears to be no lateral land movement towards the river running immediately east of the site. However, the dark murky colour of the river may indicate liquefaction of the loose river bed sediments with suspended silt material still present in the water at the time the aerial photograph was taken.

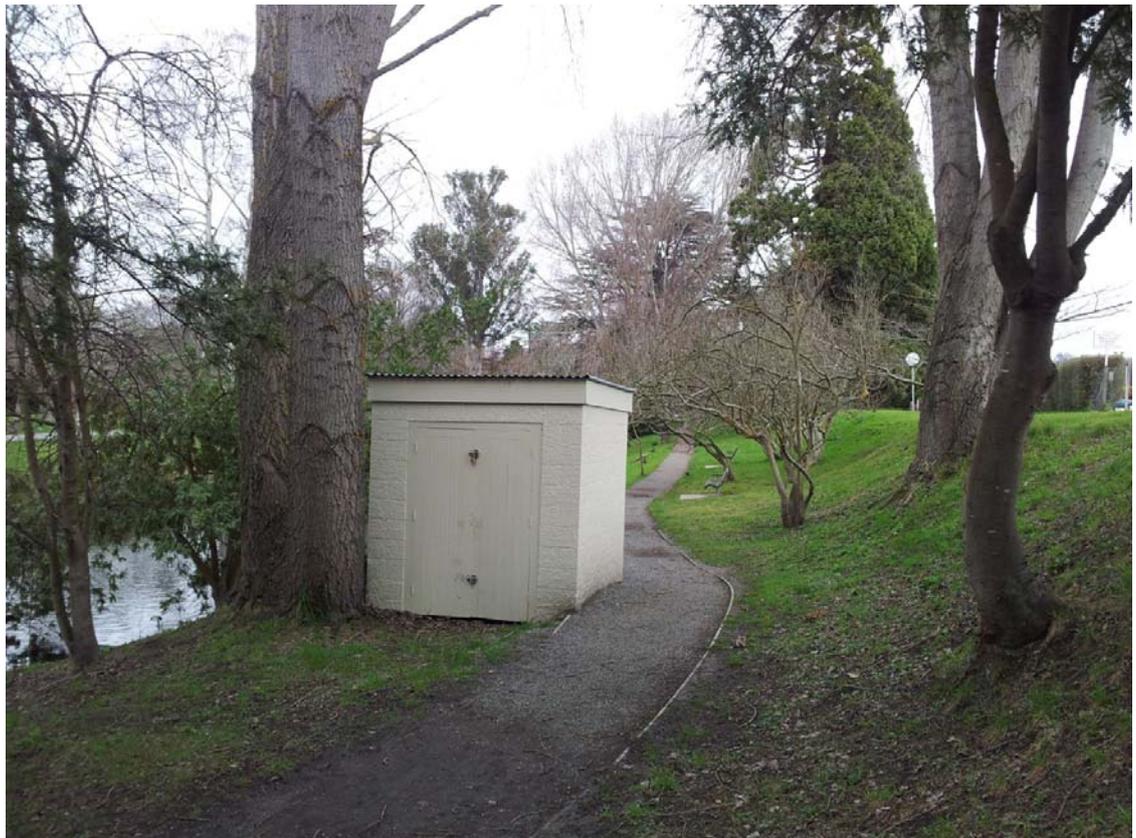
■ **Figure 8 - Overview of the building (northern elevation)**

The building was a masonry block construction with a corrugated sheet metal roof over a timber frame and slab on grade foundation. No significant structural damage was noted from the external site inspection. The Avon River flows approximately 6 m to the east of the building, and there is a tree located next to the building on the north east corner. The ground slopes upward to the west approximately 2 m towards the above driveway.

No apparent evidence of liquefaction or land damage was observed on site. However, resealed patches and undulations in the road surface were observed on the above driveway. These are likely to have occurred as a result of the earthquake however it is not clear what state of repair the driveway was in prior to the earthquake events.
