**Toilet Block – Bishopsworth St /
Hillsborough Park
PRK_0962_BLDG_002 EQ2
Detailed Engineering Evaluation
Qualitative Report
Version Final**

Christchurch City Council

Date
1st October 2012

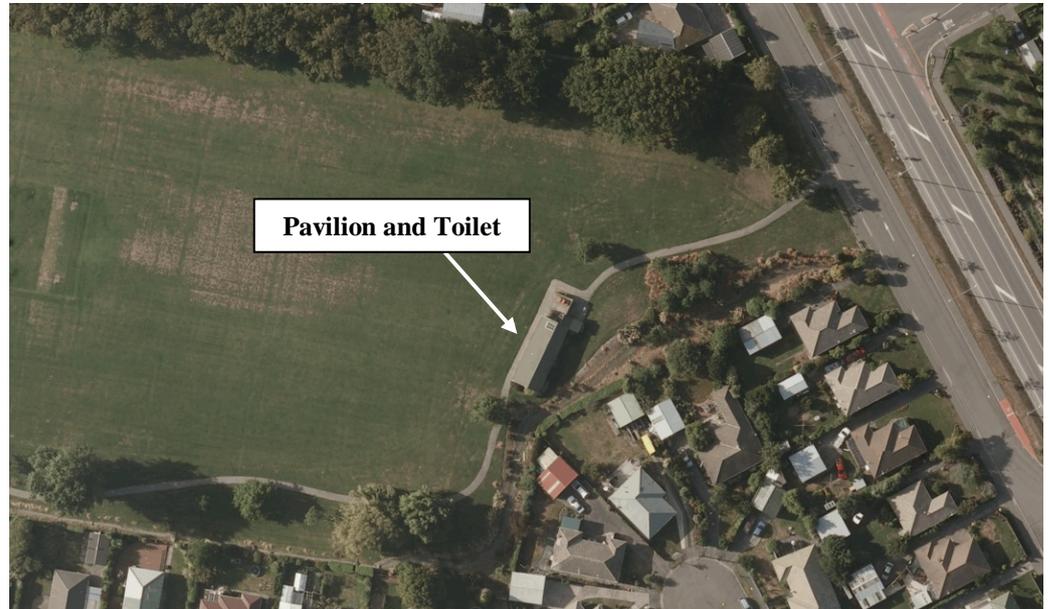
Figure 2 Post February 2011 Earthquake Aerial Photography³

Aerial photography taken following the 22 February 2011 earthquake shows negligible signs of liquefaction outside the building footprint or adjacent to the site, as shown in Figure 2.
