Knightsbridge Lane Complex  
PRO 1265  
Detailed Engineering Evaluation  
Quantitative Report  
Version 2.0 - Final

Knightsbridge Lane, Aranui

Christchurch City Council

**Date**  
15<sup>th</sup> October 2013

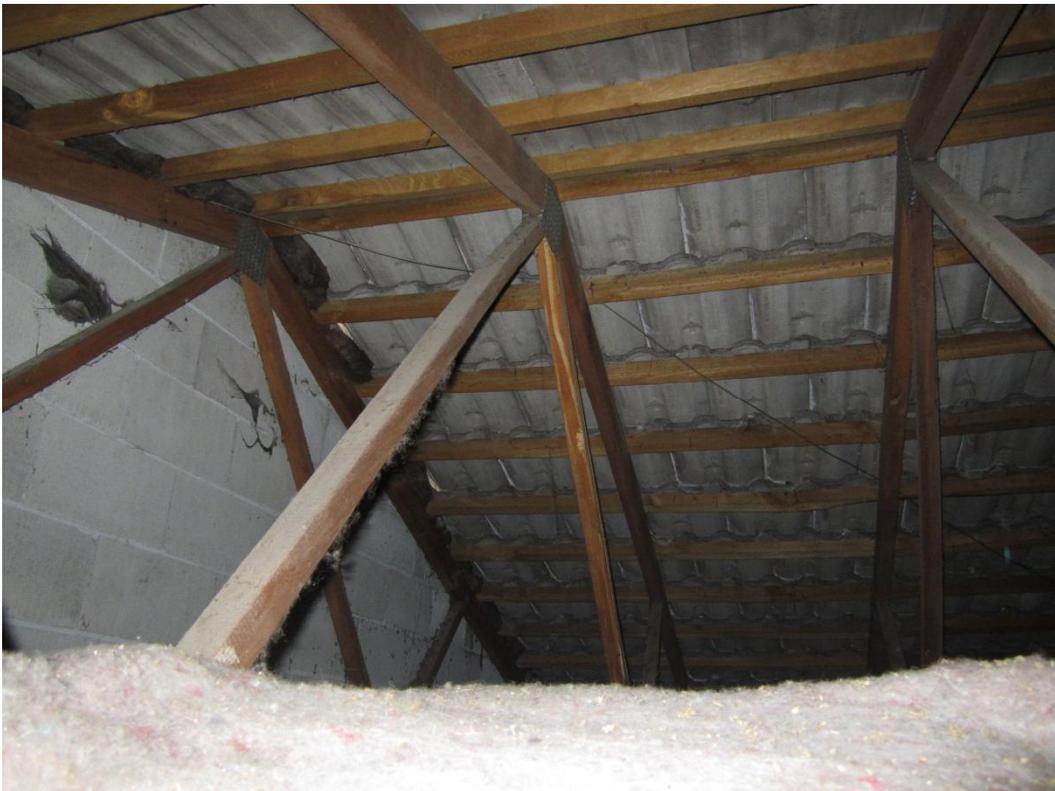
The roof structure consists of timber nail plate roof trusses (shown in Photograph 12) clad with concrete roof tiles. The timber nail plate trusses are spaced at 900mm centres. The ceiling in each residential unit is lined with plasterboard.

**Photograph 12** Timber nail plate roof trusses and concrete tile cladding
