CHRISTCHURCH CITY COUNCIL

Rawhiti Golfcourse West Pumphouse

104 Shaw Ave, New Brighton

QUALITATIVE ASSESSMENT REPORT

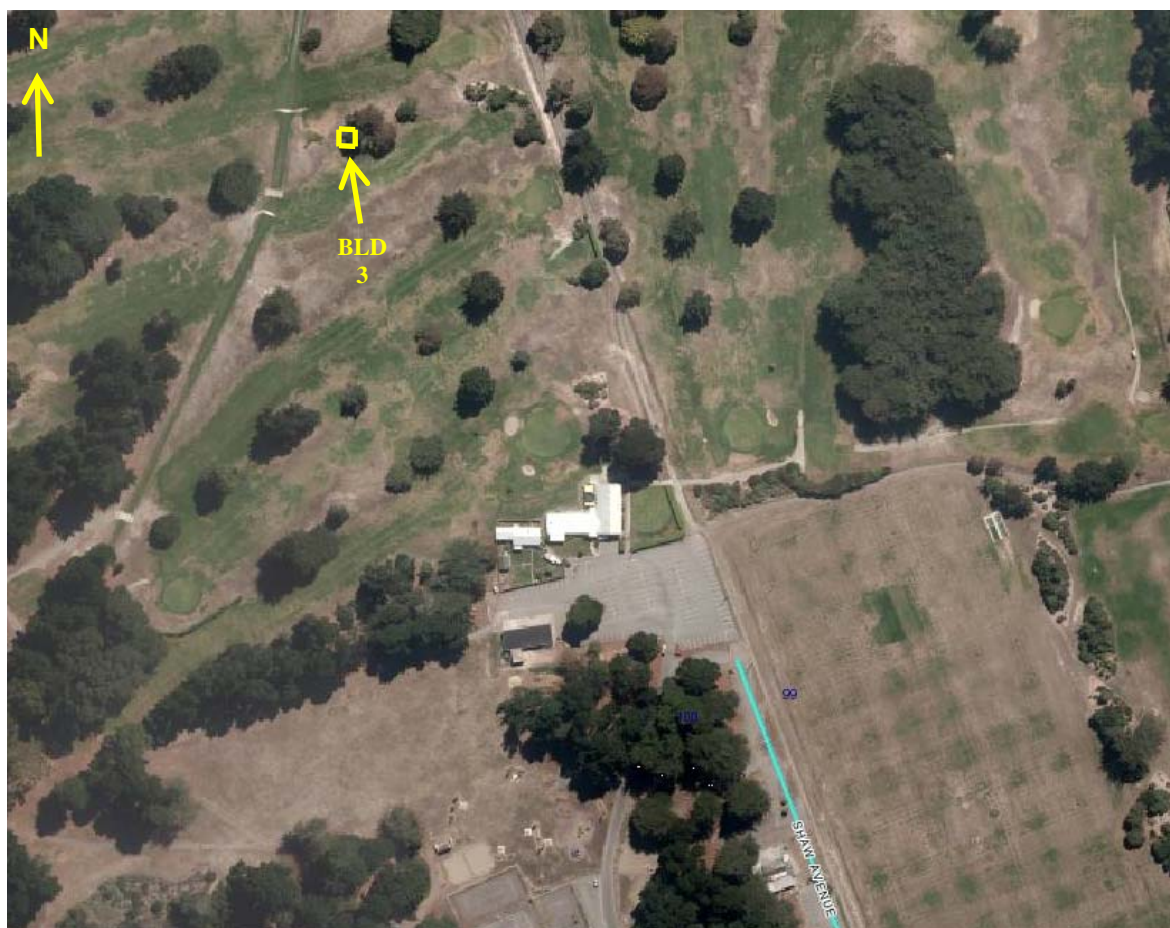
■ Figure 1 Aerial Photograph of the west pumphouse at 104 Shaw Ave

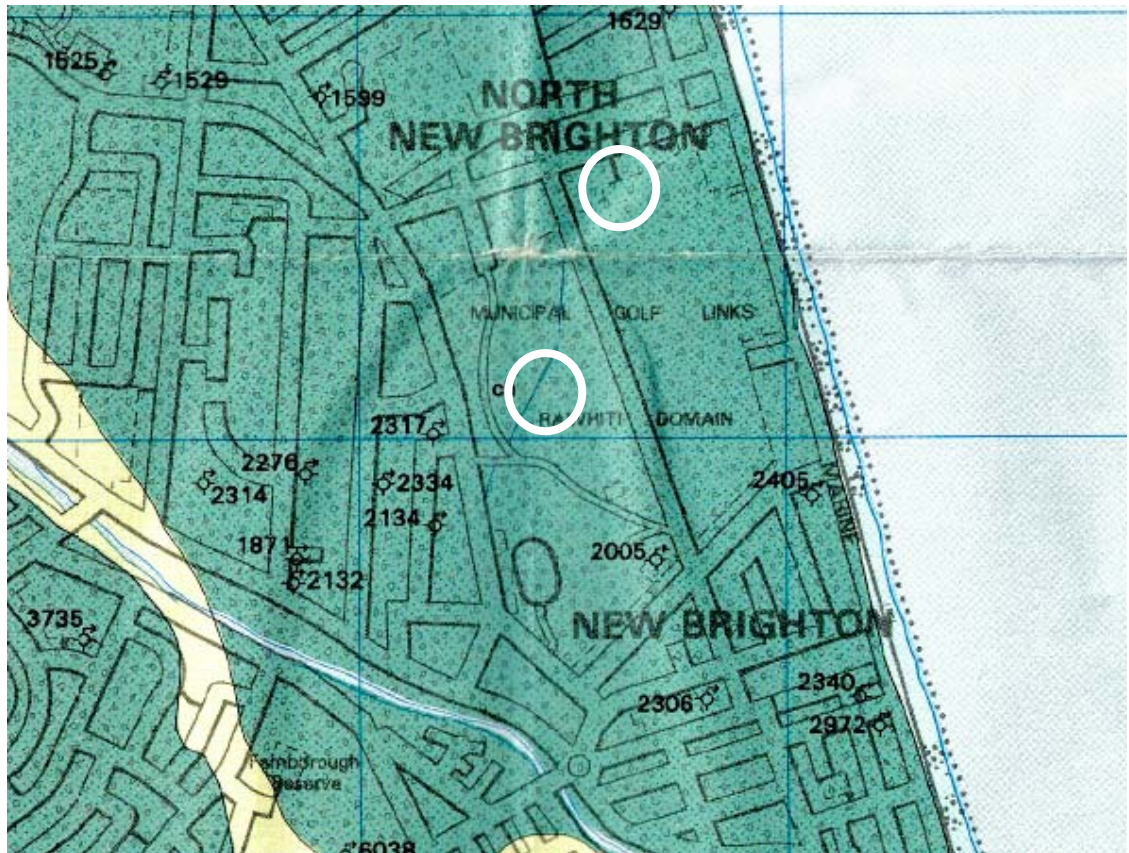
■ Figure 3 – Local geological map (Brown et al, 1992). Site marked in white.

The site is shown to be underlain by Holocene deposits comprising sand of fixed and semi-fixed dunes and beaches of the Christchurch formation.

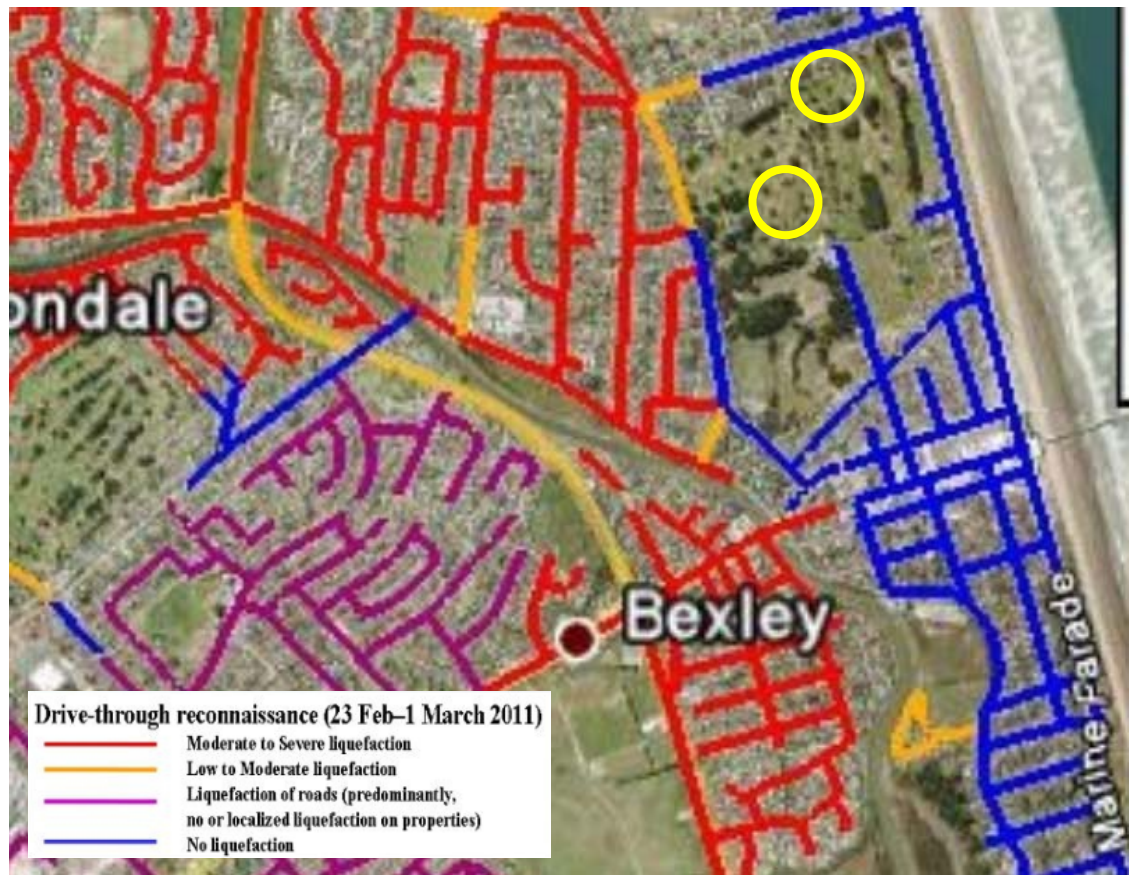
■ **Figure 4 – Liquefaction map (Cubrinovski & Taylor, 2011). Site marked in yellow.**

Following the 22 February 2011 event drive through reconnaissance was undertaken from 23 February until 1 March by M Cubrinovski and M Taylor of Canterbury University. Their findings show no liquefaction at this site.

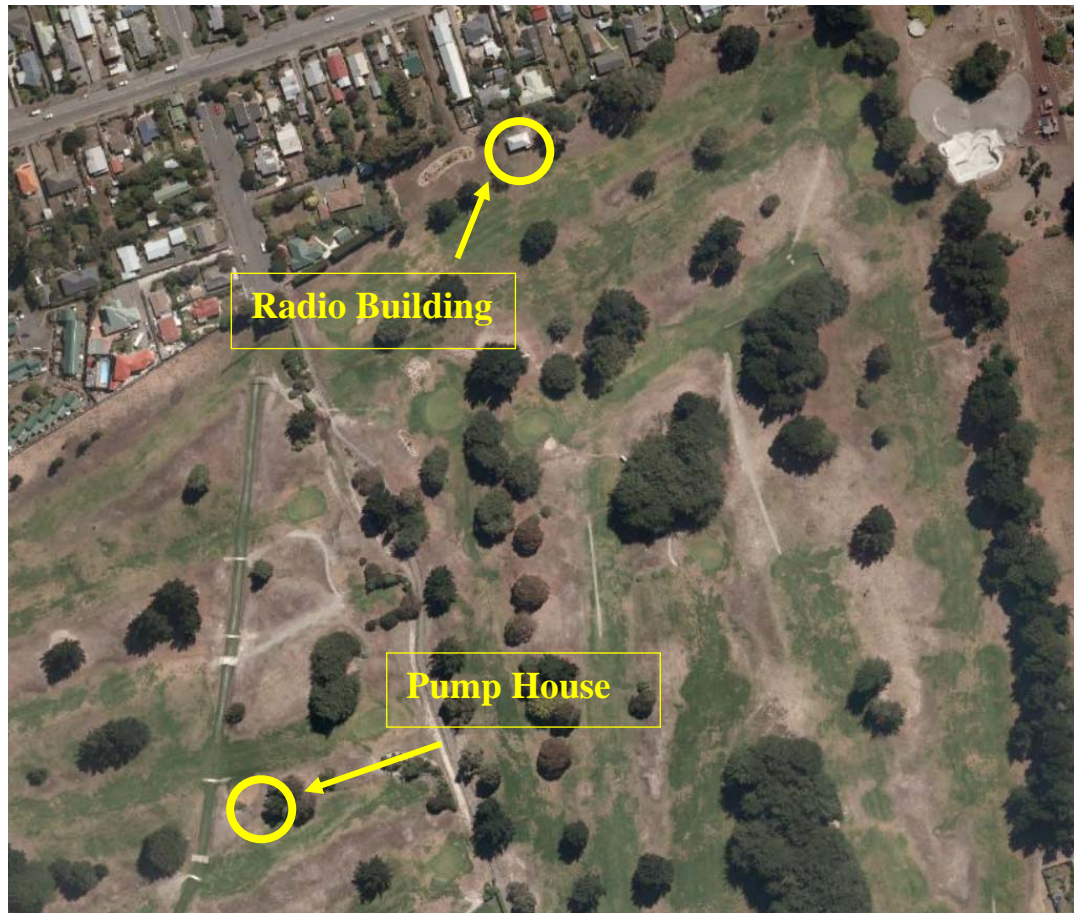
■ **Figure 5 – Aerial photography from 24 Feb 2011 (<http://viewers.geospatial.govt.nz/>)**

No significant evidence of liquefaction or land damage is visible from the aerial photographs. The site is very close to the beach and the patches are likely to be windblown sand or dune sand exposed by lack of vegetation.
