**Quantitative Assessment Report  
THE ROSE CHAPEL – 866 COLOMBO  
STREET**

# The Rose Chapel - Detailed Engineering Evaluation

## Quantitative Assessment Report

Date: 14<sup>th</sup> July 2012  
Reference: 6.DP138.00  
Status: Final

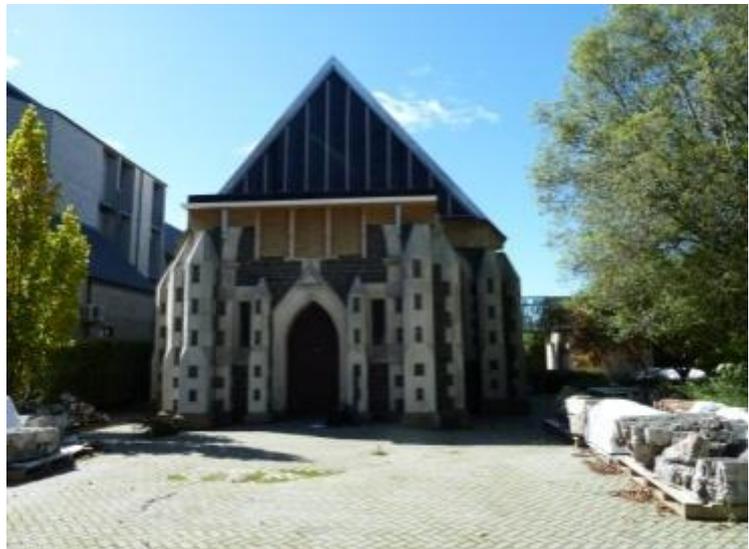
Photograph 2 - After February 2011 earthquake

Following the February earthquake the chapel suffered severe seismic damage and was given a red sticker. The building served as a chapel for weddings and ceremonies however, it is now unoccupied. Currently, the building has been stabilised to facilitate access for contractors and engineers.

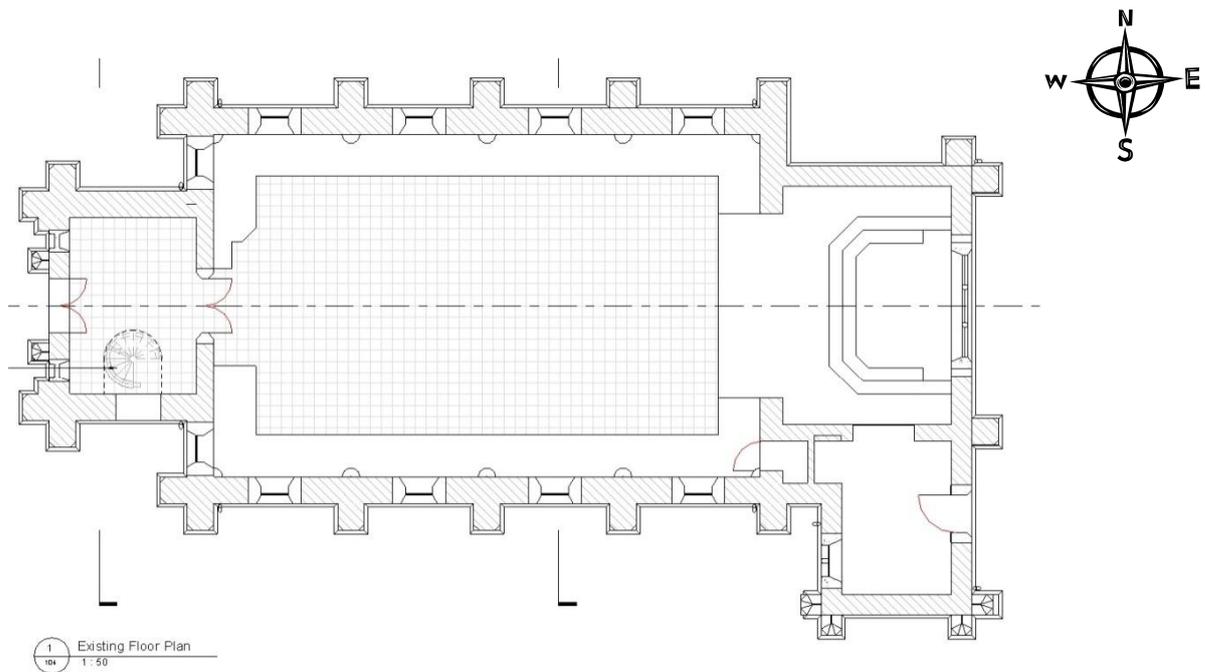
Figure 6 – Orientation of building

Findings from the inspection have shown that the remaining building has not deteriorated significantly since the February 2011 earthquake. However, we have highlighted our main observations and mechanisms of failure throughout the structure, these are shown below:

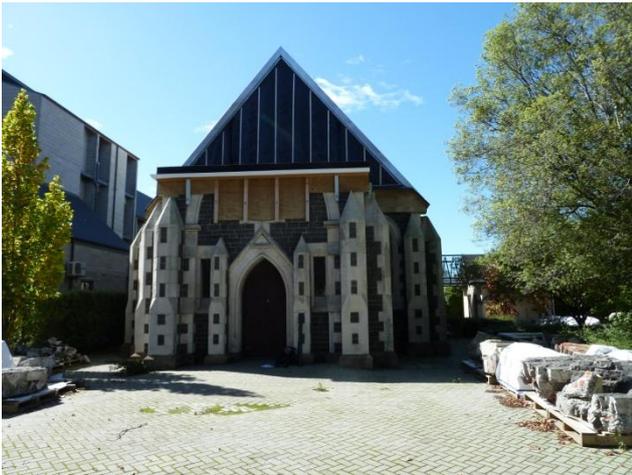
Figure 7 – General front Elevation

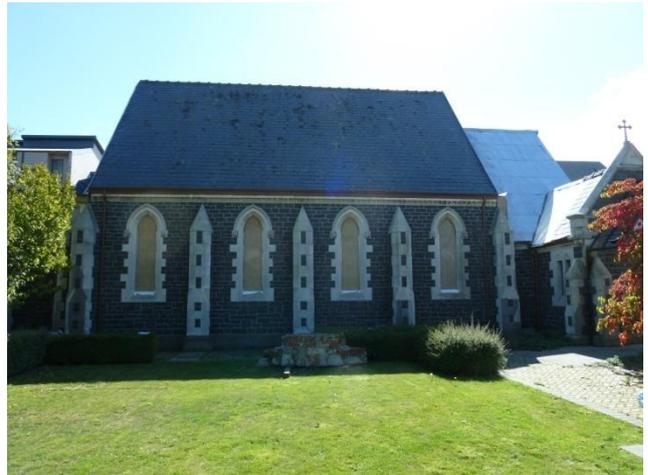
Figure 8 – General South Elevation
