DETAILED ENGINEERING EVALUATION – QUALITATIVE AND QUANTITATIVE REPORT

SCARBOROUGH CLOCK TOWER

SCARBOROUGH CLOCK TOWER (Scarborough Park, 147 Esplanade Rd, Sumner)

Capital Programme Group
Christchurch City Council

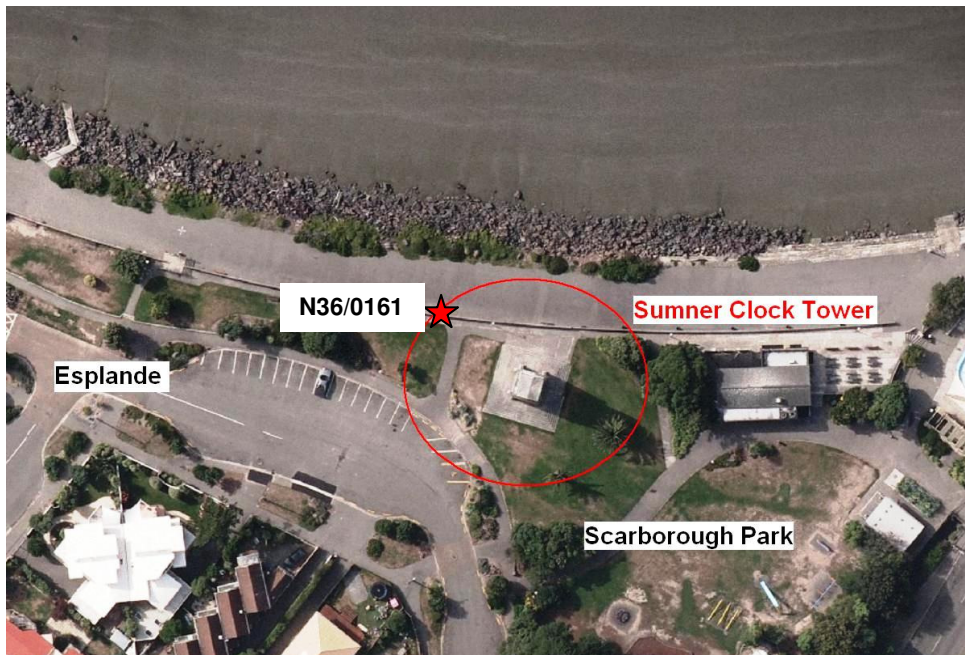
The site is relatively flat and is situated adjacent to the Sumner beach elevated approximately two meters above mean sea level. No liquefaction was observed from the post 22nd February 2011 Aerial survey (Fig 9a).

Fig 9a. post 22nd February 2011 aerial survey and location of Ecan borelog (indicated by the star)
