Treddinick Place Housing Complex PRO 3520

**Detailed Engineering Evaluation
Quantitative Assessment Report**

Treddinick Place Housing Complex Quantitative Assessment Report

58 London Street, Lyttelton

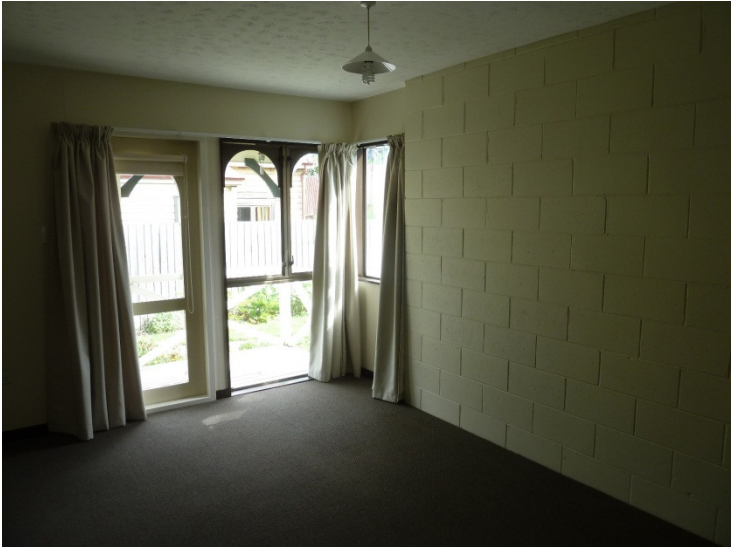
9.	Typical lounge area	 
10.	Typical cracking of internal wall lining

- Cosmetic repairs be undertaken as required.
- Header tanks in the roofs be properly secured.
