**Tyrone Street
Housing Complex
PRO 0376**

**Detailed Engineering Evaluation
Quantitative Assessment Report**

**3-5 Tyrone Street, Belfast Christchurch
8051**

Date: December 2013
Reference: 6-QC410.00
Status: Final

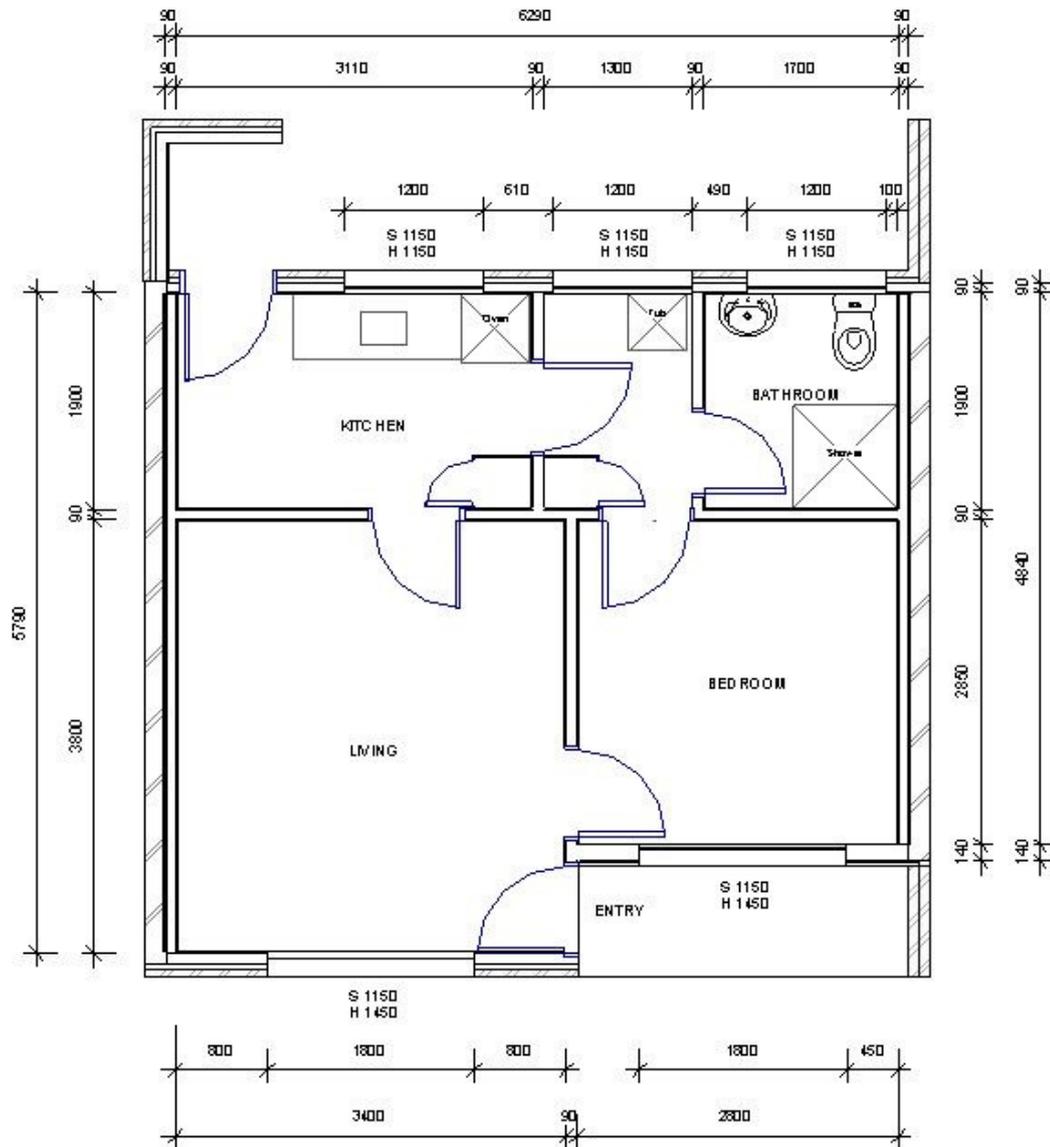
Figure 4: Typical partial floor plan of residential unit blocks.

Figure 4 shows a typical floor plan of a residential unit produced from site measurements by Opus. Unit 1 in each block was an extended version of this layout, with an extended laundry, bedroom, and an entrance area leading into the living room. Figure 5 shows a comparable cross section used in calculations, from Mooray Ave.

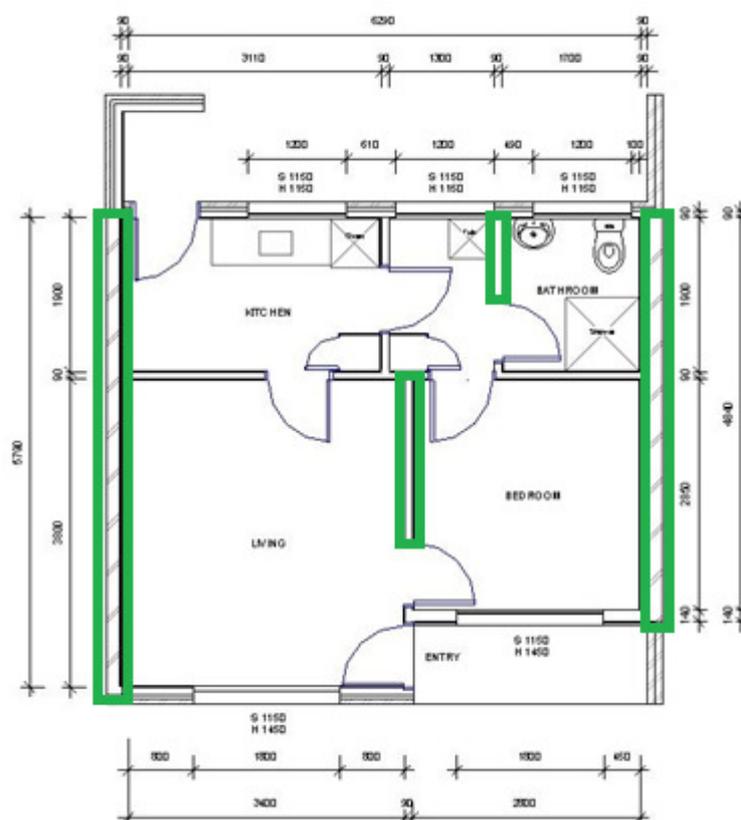
Figure 7: Walls used for bracing in the transverse direction.

Hand calculations were performed to determine seismic forces from the current building codes. These forces were applied globally to the structure and the capacities of the walls were calculated and used to estimate the %NBS. The walls, highlighted in Figure 6 and Figure 7, were used for bracing in their respective directions.

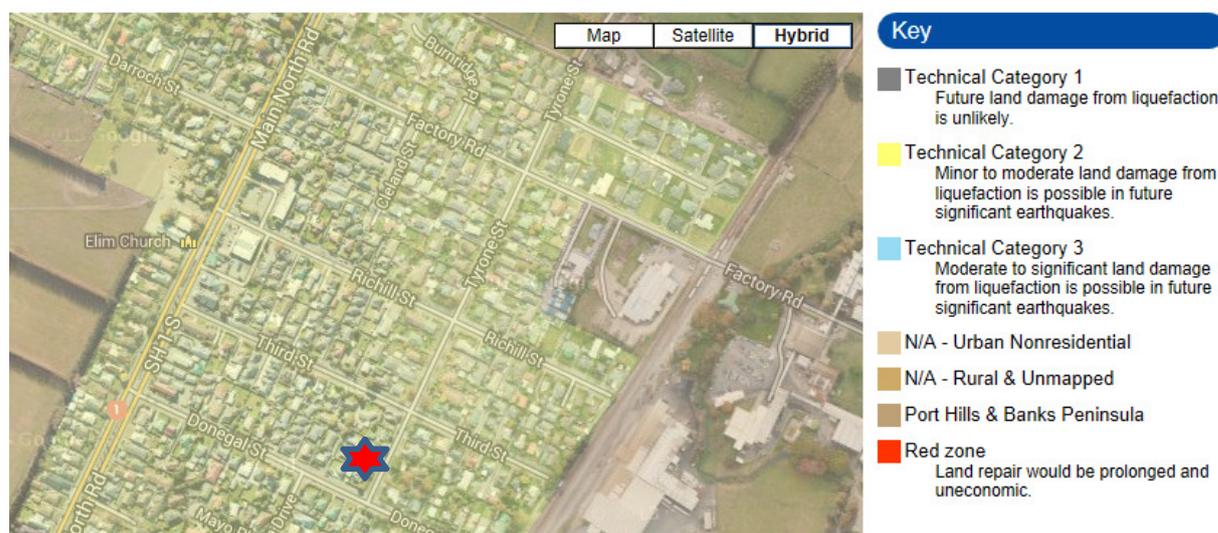
Figure 8: CERA Technical Categories map (loc. starred).

CERA indicates that Tyrone Street is located in a TC2 zone (as shown in Figure 8. This classification suggests future significant earthquakes will cause minor to moderate land damage due to liquefaction and settlement.

There is no evidence to suggest that further geotechnical investigation is warranted for this site.

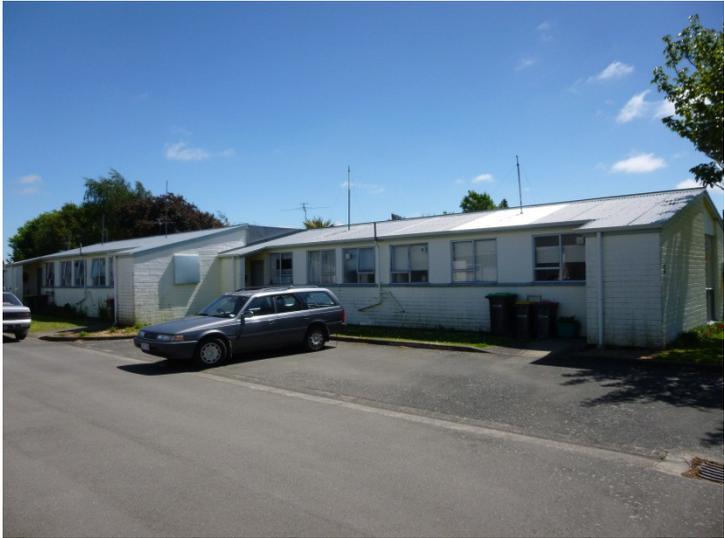
Tyrone Street Housing Complex		
No.	Item description	Photo
Residential Units Layout		
1.	Typical exterior elevation (back)

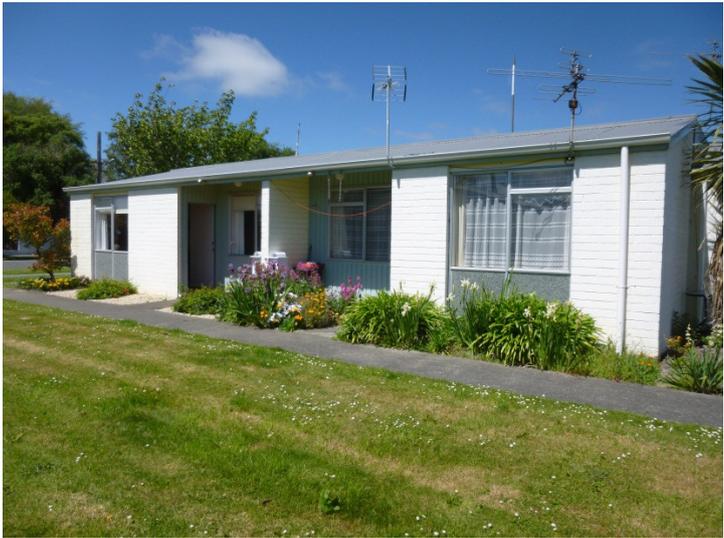
2.	Typical exterior elevation (front)
