Victoria Park – Shed (10x9)
Qualitative Engineering Evaluation

Reference: 228907

Prepared for:
Christchurch City
Council

Date: 25 February 2013

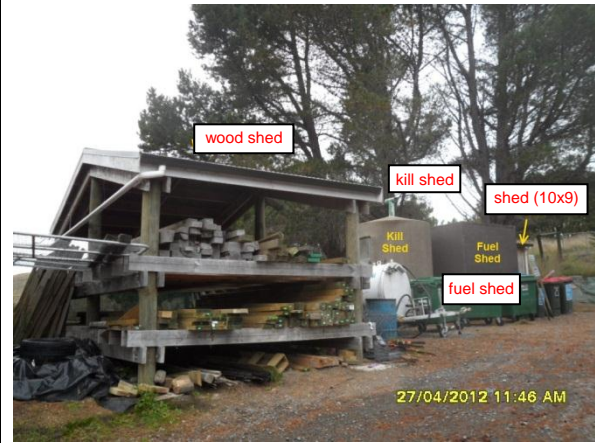
The floor levels for the Victoria Park – Shed (10x9) were found to be over the recommended tolerances. However, the floor level variations appear to be original construction variations and not due to recent seismic activity.

400 2650
