CHRISTCHURCH CITY COUNCIL
PRK_0657_BLDG_004 EQ2
Westminster Park – Community Building
272 Westminster Street, Mairehau

QUALITATIVE ASSESSMENT REPORT
FINAL

- Rev C
- 29 May 2013

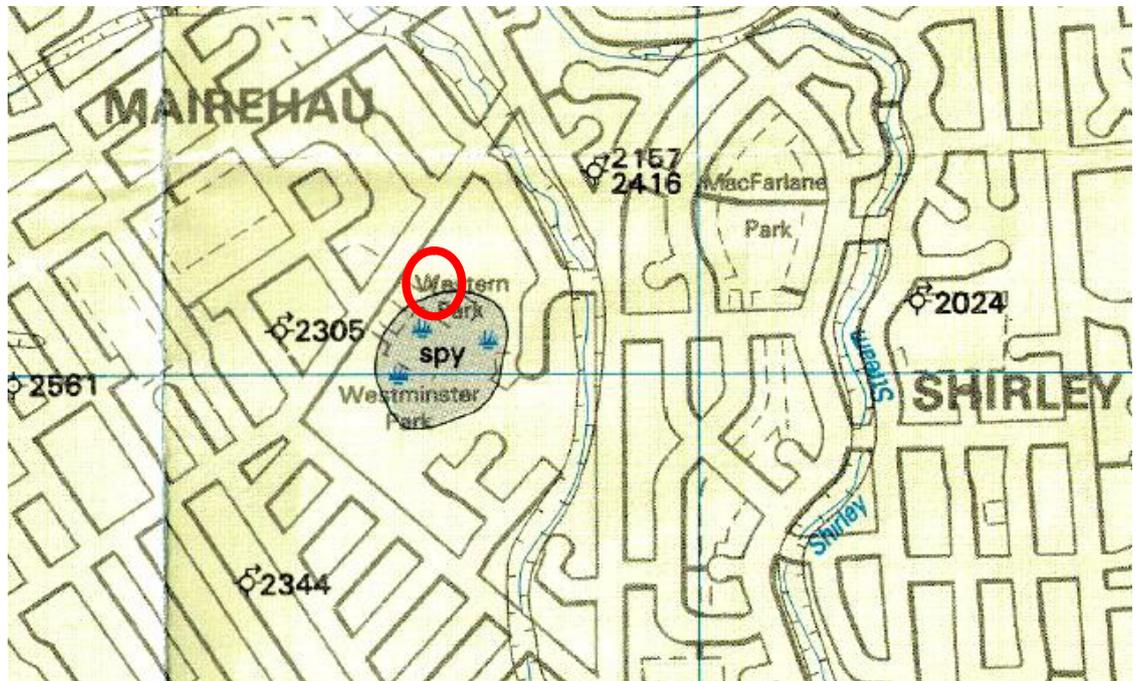
■ **Figure 3 – Local geological map (Brown et al, 1992). Site marked in red.**

Most of the site is shown to be underlain by Holocene deposits comprising predominantly alluvial sand and silt over bank deposits of the Springston Formation. The ground immediately south east of the site is shown to be underlain by peat swamp deposits, now drained, of the Springston Formation.

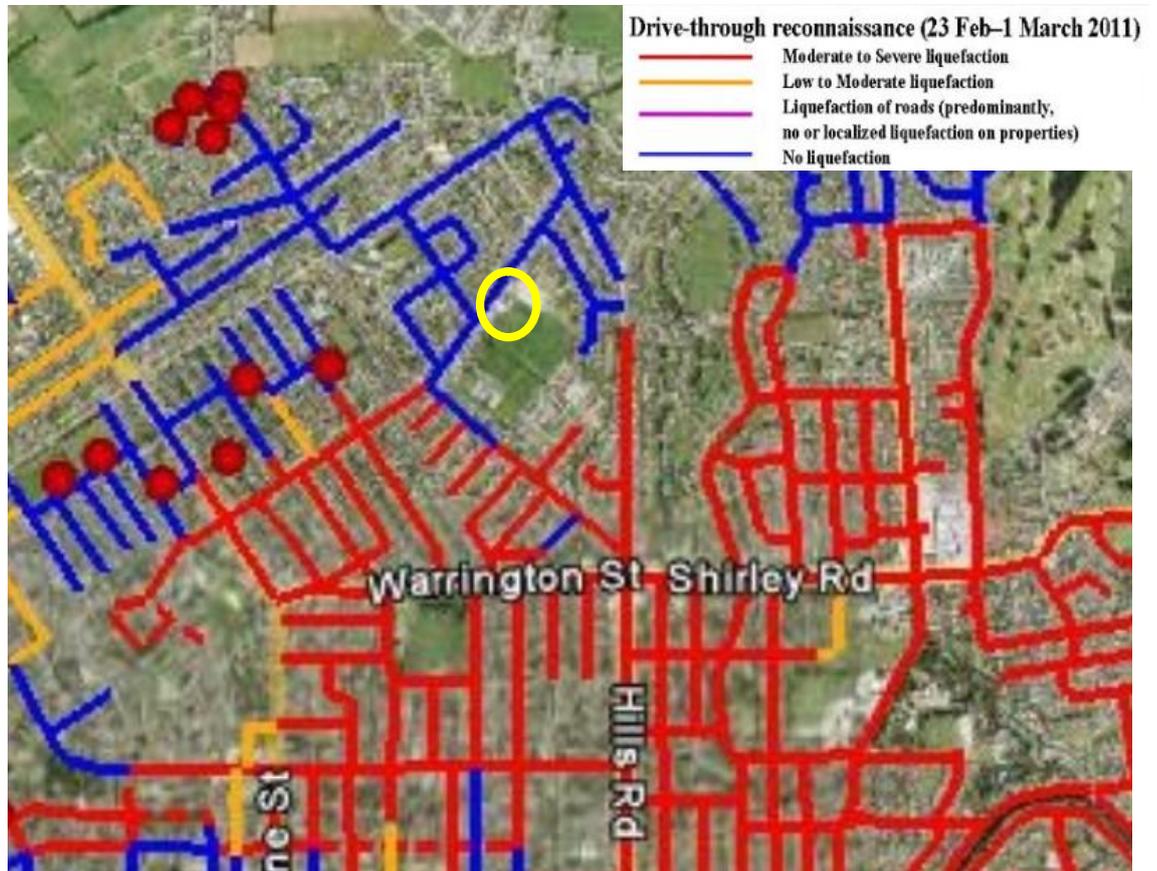
■ **Figure 4 – Liquefaction map (Cubrinovski & Taylor, 2011). Site marked in yellow.**

Following the 22 February 2011 event drive through reconnaissance was undertaken from 23 February until 1 March by M Cubrinovski and M Taylor of Canterbury University. Their findings show no liquefaction at this site.

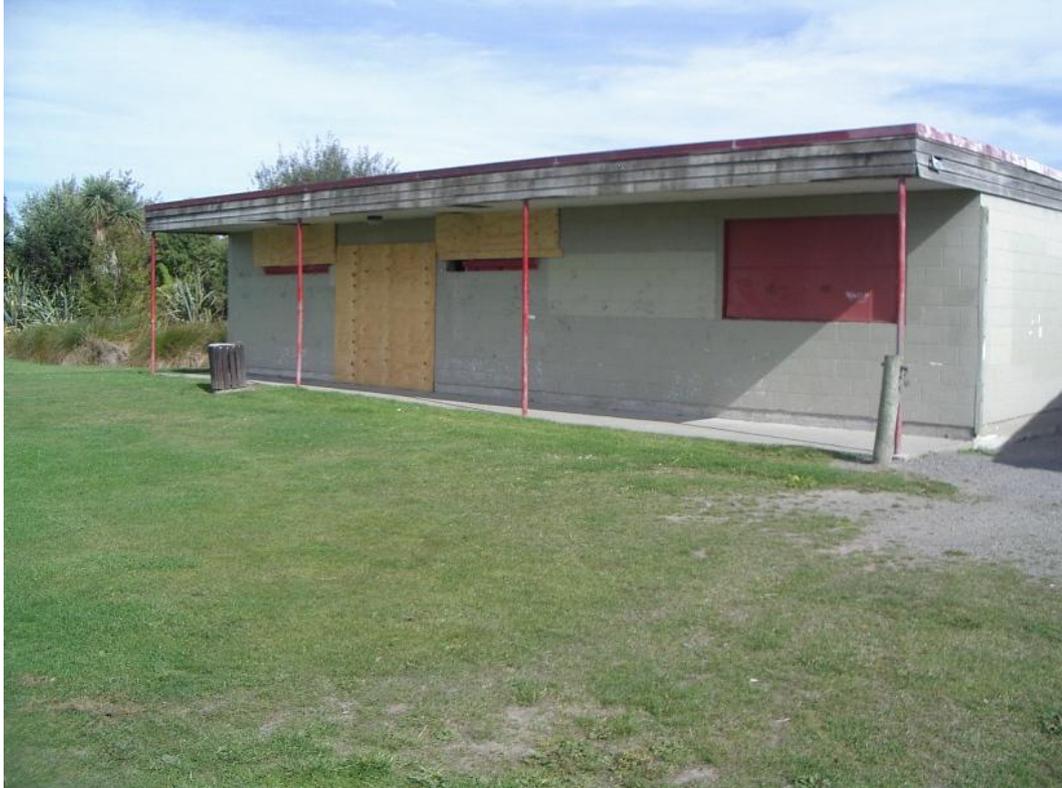
■ **Figure 8 Overview of the Westminster community building**
