**CHRISTCHURCH CITY COUNCIL**  
BU 0697-009 EQ2  
Plant Shed - Woodham Park  
157 Woodham Road, Linwood

QUALITATIVE ASSESSMENT REPORT  
FINAL

- Rev B
- 24 September 2012

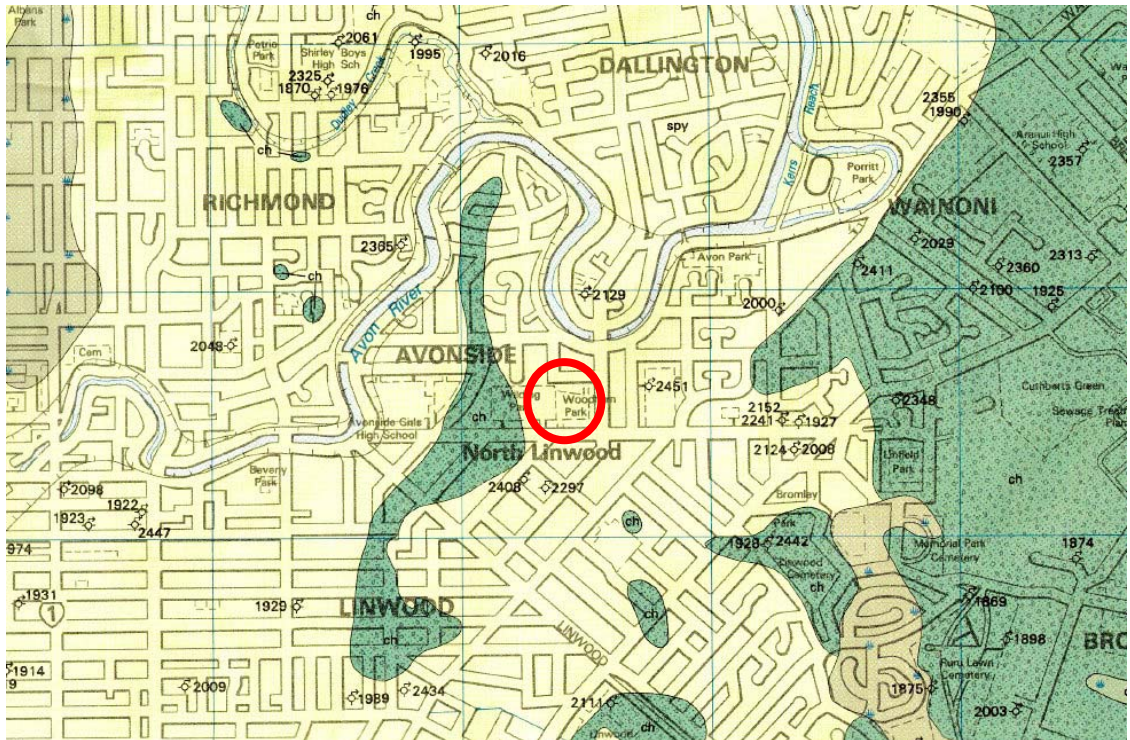
■ **Figure 3 – Local geological map (Brown et al, 1992). Site marked in red.**

The site is shown to be underlain by Holocene deposits comprising predominantly alluvial sand and silt overbank deposits of the Springston Formation.

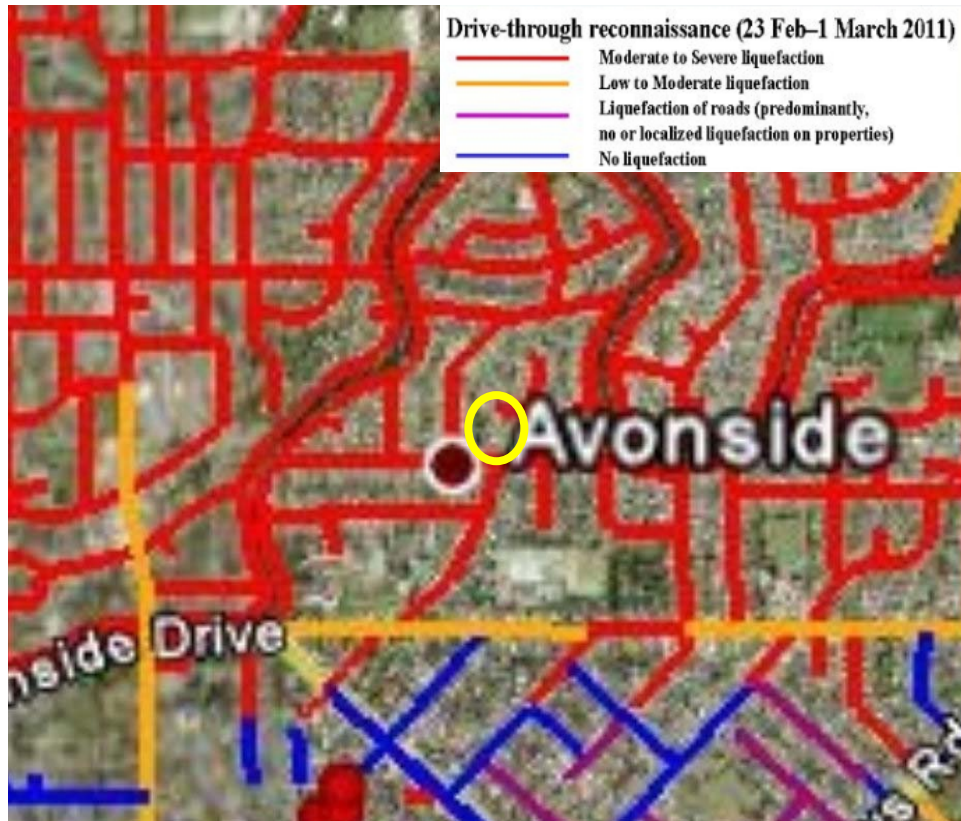
- **Figure 4 – Liquefaction map (Cubrinovski & Taylor, 2011). Site marked in yellow.**

Following the 22 February 2011 event drive through reconnaissance was undertaken from 23 February until 1 March by M Cubrinovski and M Taylor of Canterbury University. Their findings show moderate to severe liquefaction around the site.

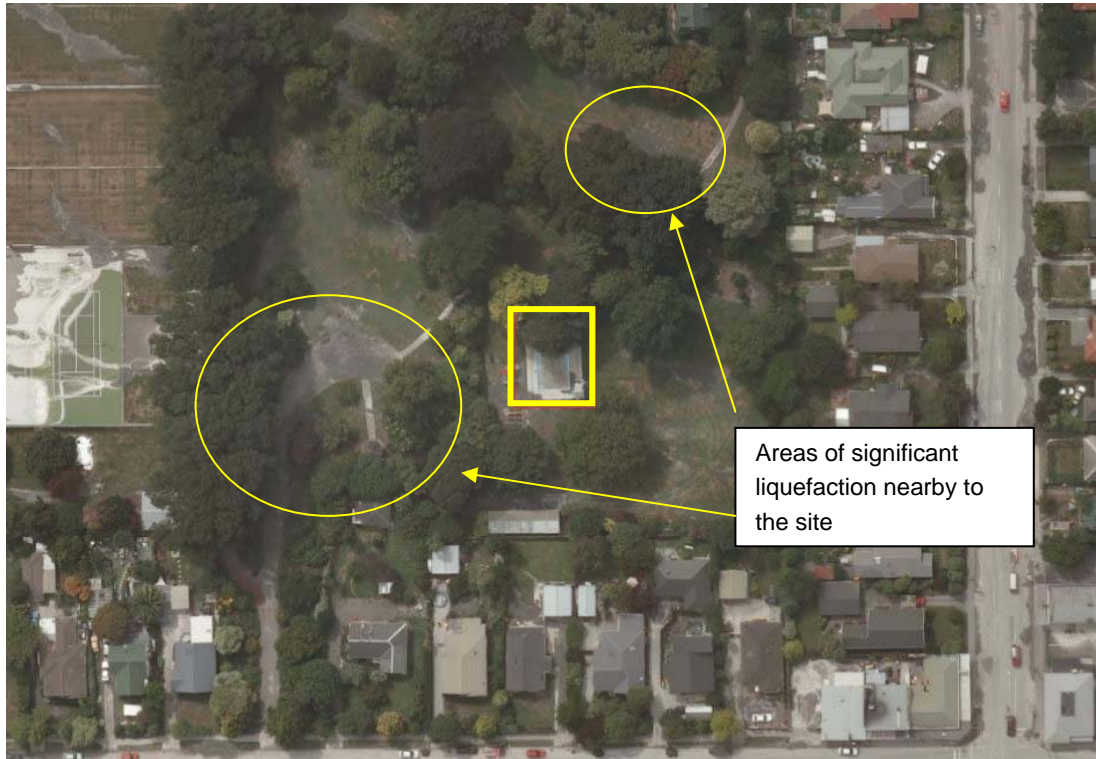
■ **Figure 5 – Aerial photography from 24 Feb 2011 (<http://viewers.geospatial.govt.nz/>)**

Aerial photography shows moderate to significant liquefaction after the 22 Feb 2011 event, particularly to the south and east of the site.

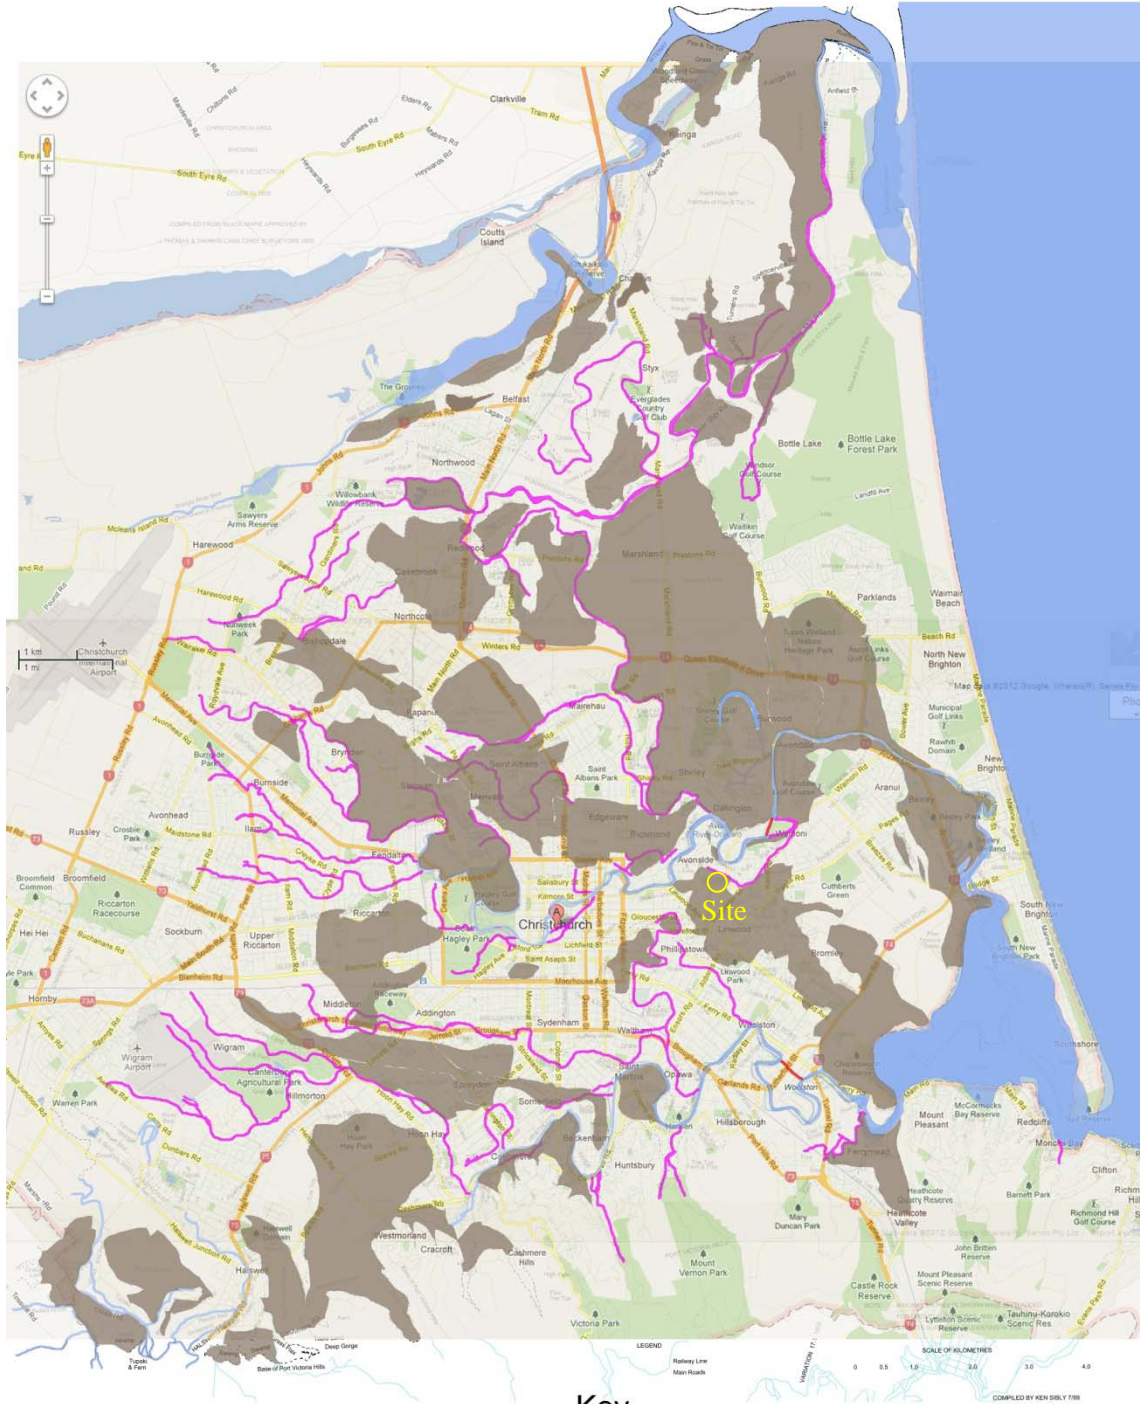
Reference to historical documents (eg Appendix A) shows that the site is located within an old swamp and within close proximity to an old watercourse. It is therefore possible that soft or potentially liquefiable ground could be present near the site.

The swamps and previous creeks/riders from 1856 have been overlaid onto a map of Christchurch in 2012
