LOWER RICHMOND HILL CATCHMENT 12 OCTOBER 2000 FLOODING INVESTIGATION NOTES

Report
Prepared By
John Walter & Peter Wehrmann
City Design

December 2000

Lower Richmond Hill Catchment: 12 October 2000 Storm

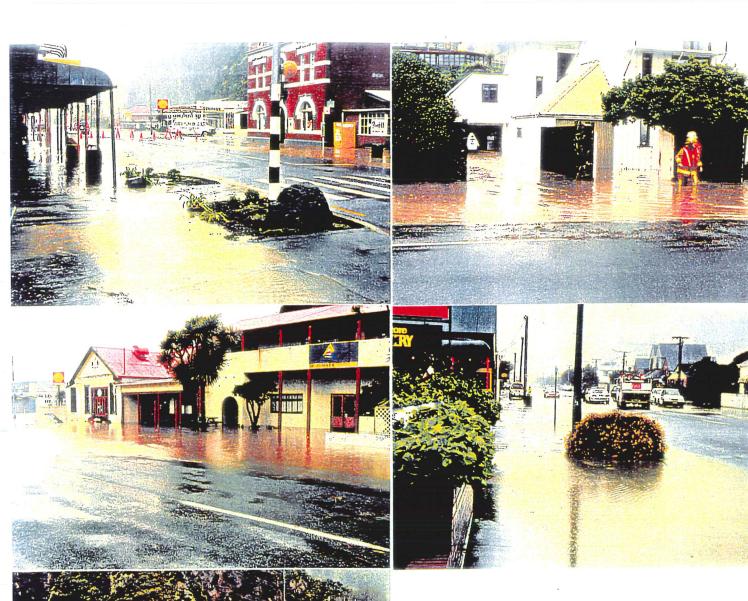
12 Oct = 3:30 pm

At approximately 3:00-4:00pm, 12 October, at 12 Nayland St, John Walter observed silt ladden stormwater still flowing past the intake with no attempt being made to clear the grate, but Nayland St was no longer completely under water. The southern third of Nayland St (between Wakefield and Richmond Hill Rd) was flooded and stormwater was flowing north down Wakefield Ave with about 50mm depth crossing the Wakefield Ave centreline and flowing east down Nayland St.

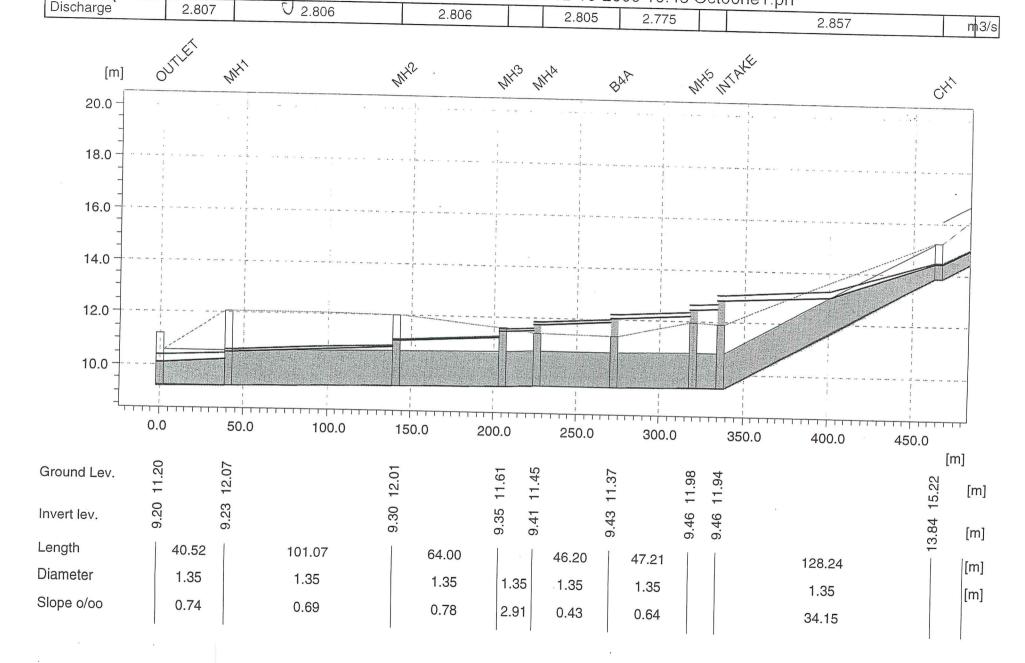
· Option of extending predine upsteam approx 128m pressurising line upto 13.0m by Bowling Club - Capacity & 2.8 m3/see WATER LEVEL BRANCHES - 12-10-2000 10:43 Octoohe1.prf

facilities. Maximum 1350mm capacity was assessed as is at 2.3m³/s. Extending the 1350mm pipeline uphill with a sealed line up to about 13m RL, by the Bowling Club, was modelled. This increased the 1350mm capacity from 2.3m³/s to about 2.8m³/s. To achieve this 20% increase in maximum capacity depends on the further installation of maintenance intensive prone to leakage flapvalves.
