# STORM REPORT

Marine Tavern, Sumner

11 – 13 OCTOBER 2000

Compiled by Ken Couling  
City Solutions  
Christchurch City Council

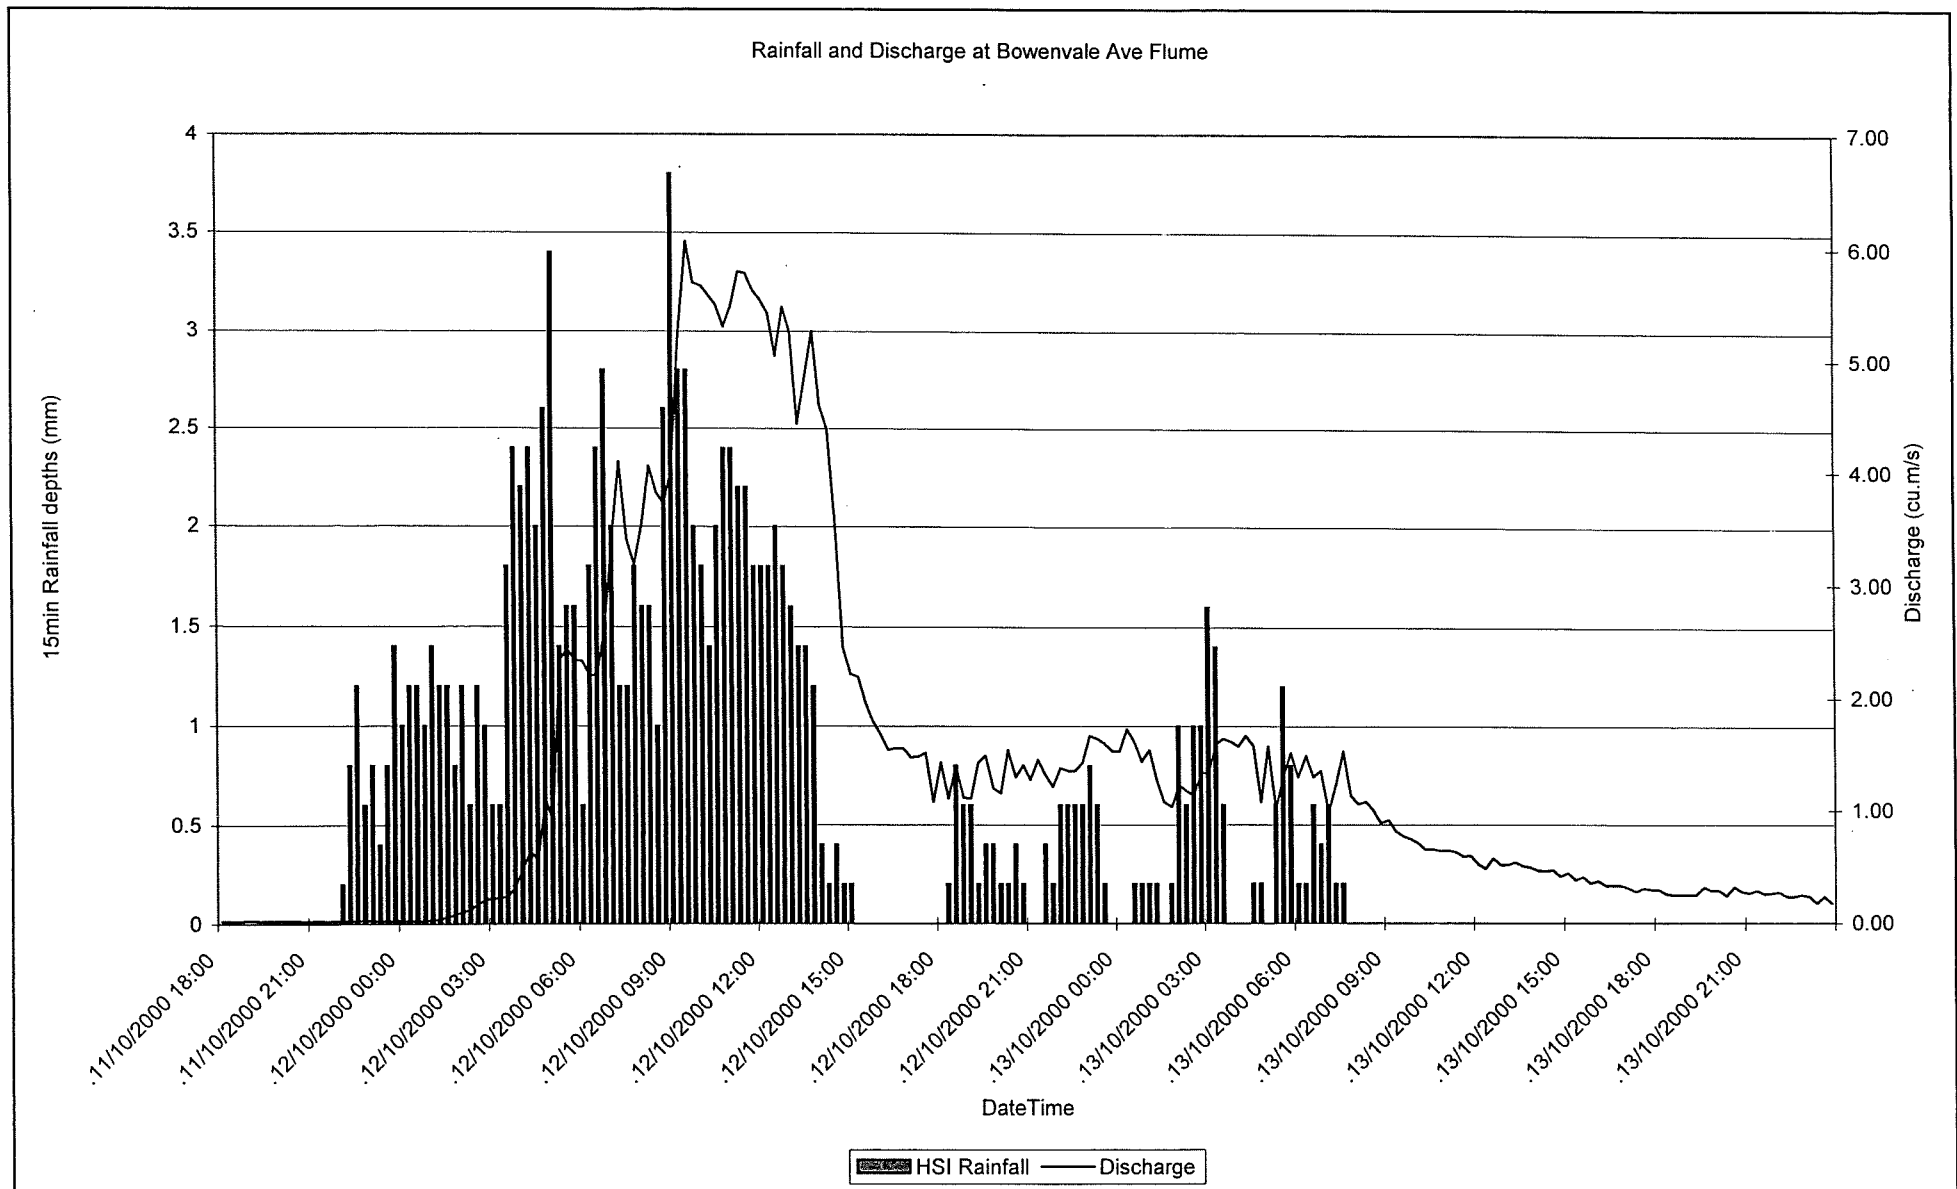
Sheet1 Chart 2

At the recording flume at the head of Bowenvale Avenue, the discharge from the valley responded rapidly to changes in local rainfall, and peaked at 6.0 cu.m/s at 9.30am (see charts 2 and 6 following). The rainfall in Bowenvale eased rapidly over the hour to 2.00pm and the discharge made a similar drop an hour later. Just above the Bowenvale flume, the central gabion of a drop structure was torn out and the rock distributed downstream. However, the sediment trap caught many tonnes of debris.

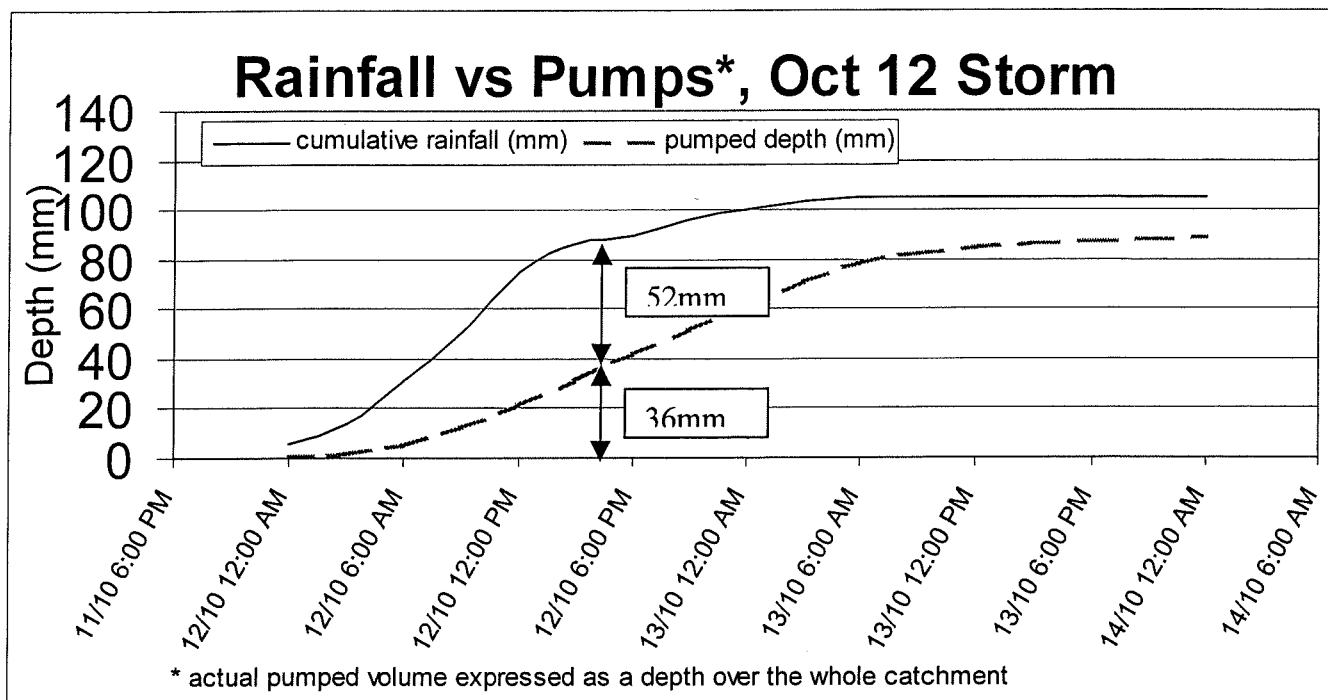
The above graph plots the rain fallen versus the pumps' efforts to remove it. If the rain fallen is greater than amount removed by the pumps, the difference must be stored in the catchment.

The above example shows that at 4pm on 12 October, a total of 88mm of rain (36mm+52mm) had fallen on the Bexley catchment, but the pumps had only managed to pump out 36mm. The other 52mm was ponding and causing the flooding in the catchment. Clearly, the intense rainfall has exceeded the pump capacities to remove the stormwater.

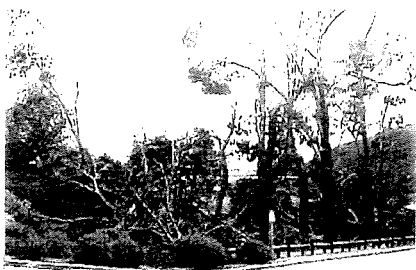
A large stand of trees on the corner of Bridle Path and Port Hills Roads was decimated.

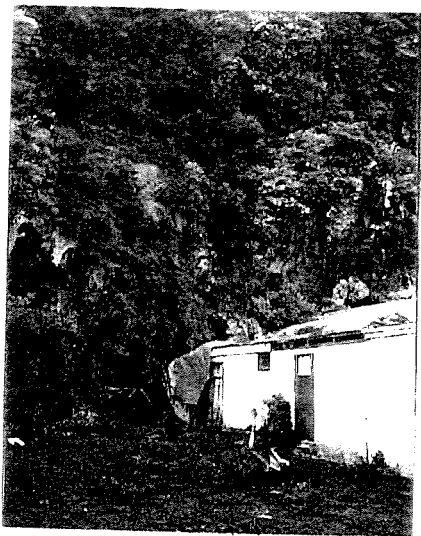
Luckiest guy around, Terry Papps, Security Manager of the Sumner RSA Club, walked out of his office into the club rooms three minutes before it was demolished by a landslide. Yes, Terry went out and bought a Lotto ticket; it wasn't a winner though!

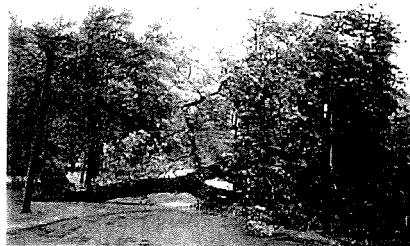
One of Truro Street's mighty oaks, probably approaching a century old, torn from the ground and brushing a house on the other side of the road.

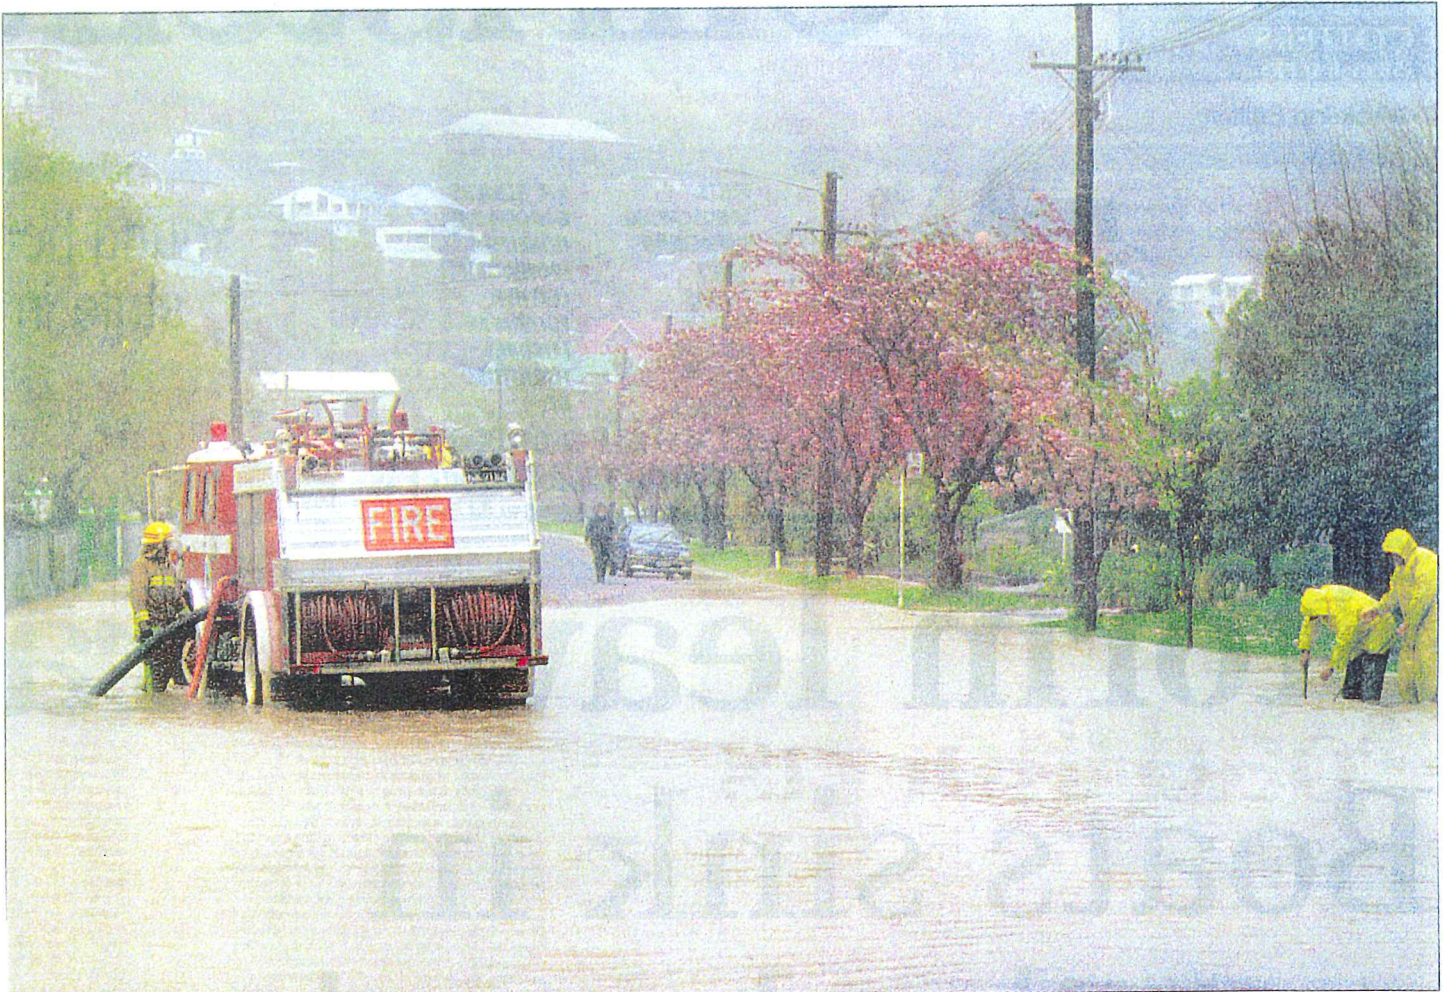
Firemen worked to unblock drains in Sumner as floodwaters rose during the afternoon yesterday. Flooding was worst towards the back of Sumner valley and throughout Redcliffs.

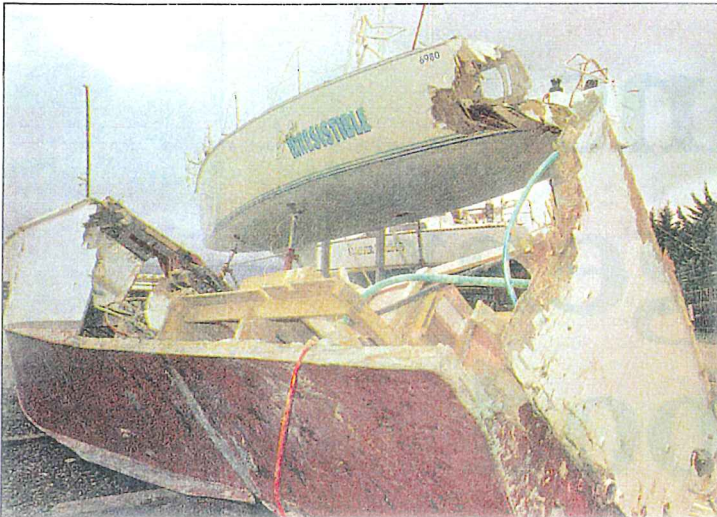
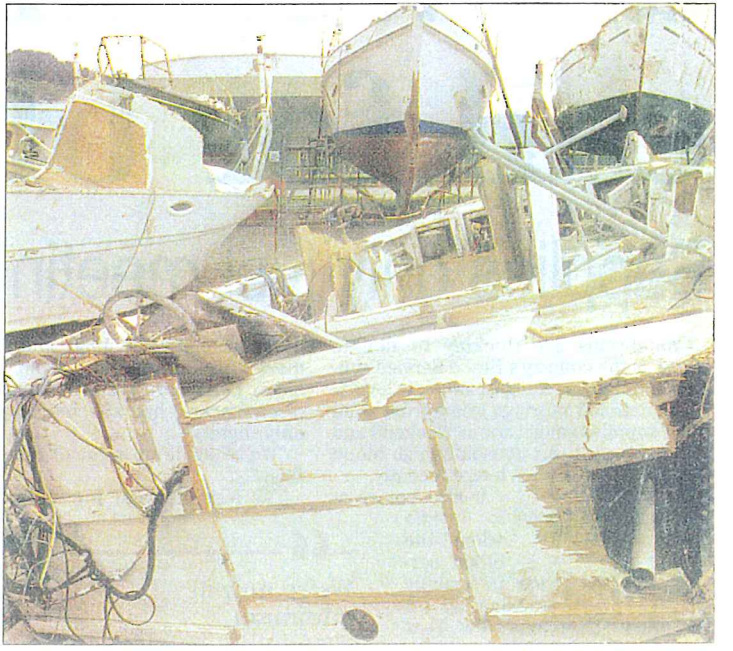
What remains of boats damaged in last month's storm lie in the Lyttelton marina. The insurance bill for boats that were lost or needing repair is between \$1.5 million and \$2 million.
