Detailed Environmental Site Investigation

711 Johns Road

Harewood

13396.000.000_04

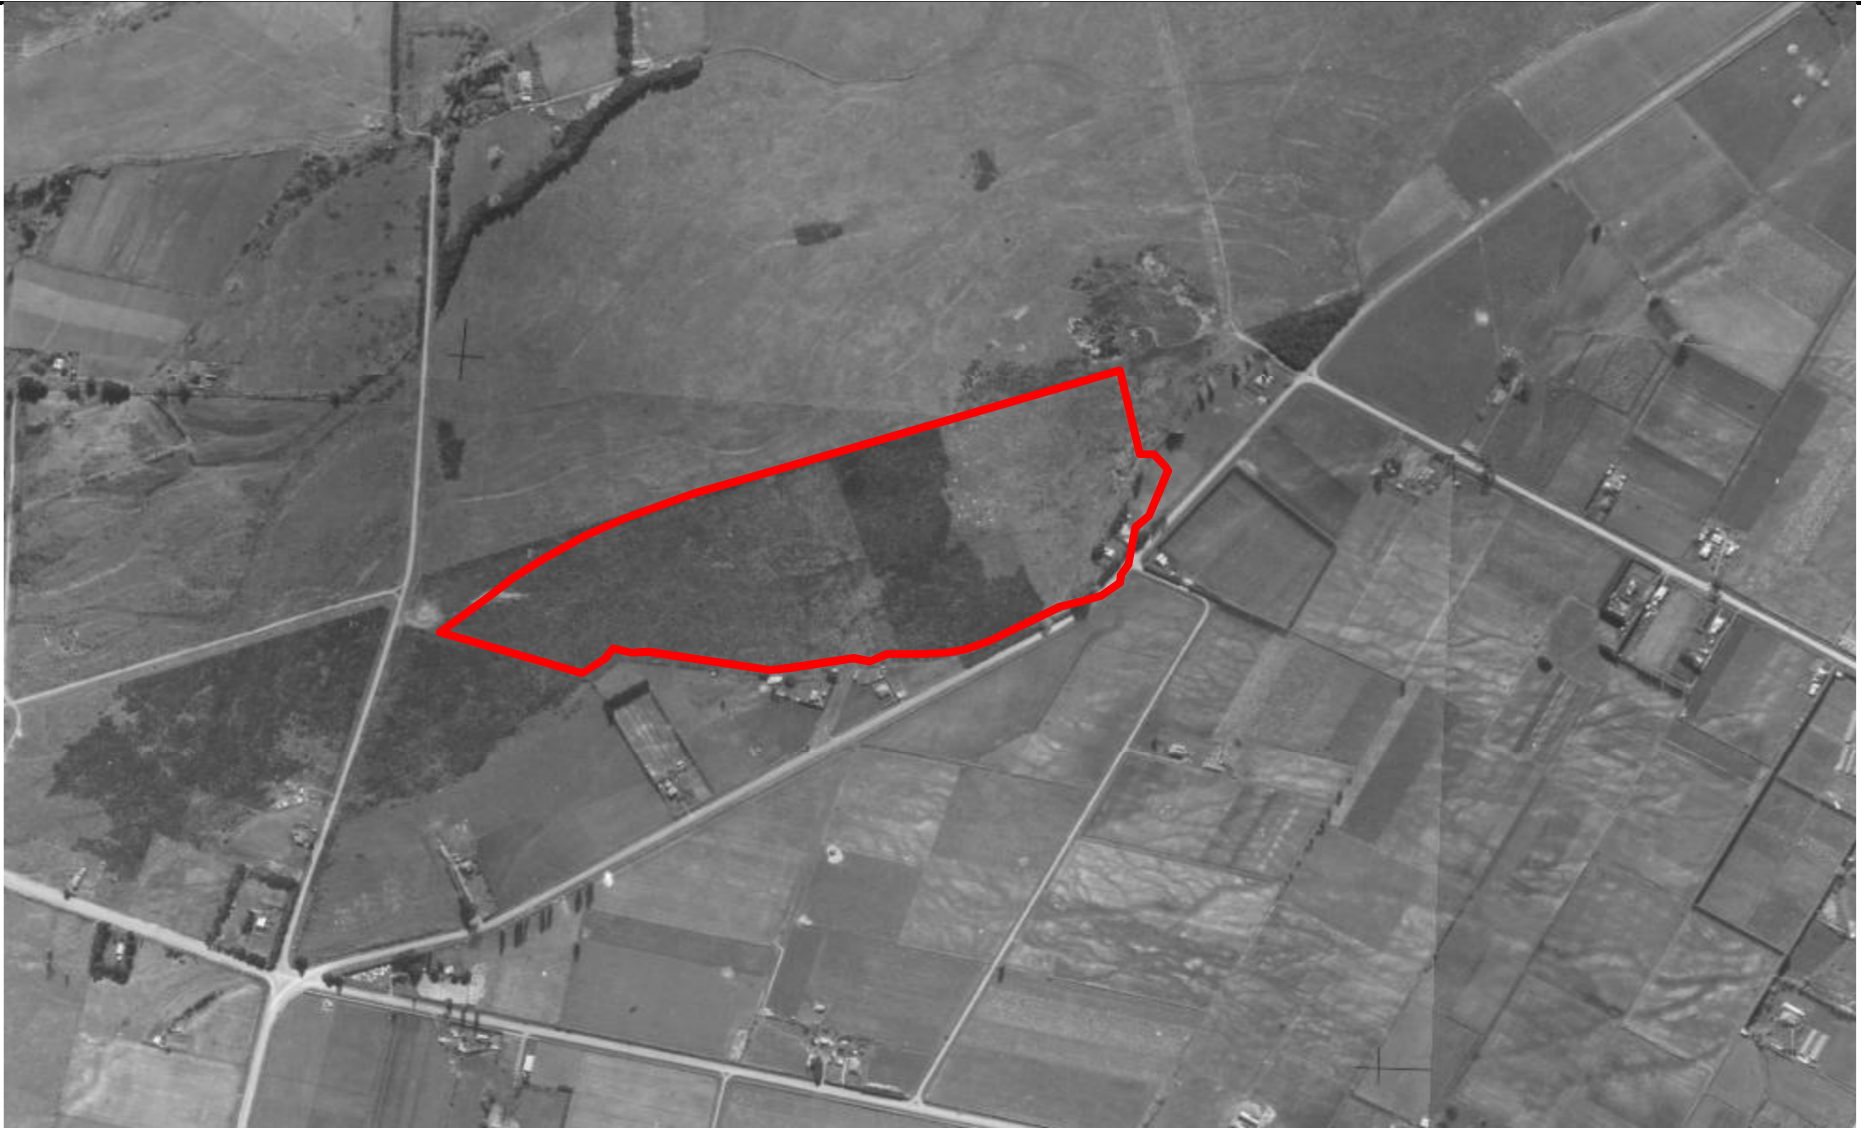
Date	Sept 2016	Client	McCracken & Associates Ltd		
Drawn by	JL	Project	711 Johns Road, Belfast, Christchurch		
Approved by	DR	Description	Historical Aerial Photograph - 1941		
Scale	NTS	Figure Number	3	Project Number	13396

Date	Figure No.	Description
1941	3	The site appears to be used for agricultural purposes. Land to the west, south, and east of the site appears to be agricultural as well. Land to the north appears to be undeveloped. No structures are visible on the site. A roadway, in the approximate configuration of present-day Wairakei Road, is visible south of the site.
1946, 1955	4, 5	The site is heavily vegetated. Areas surrounding the site are relatively unchanged from the 1941 photograph.
1965	6	The eastern half of the site has been cleared of vegetation. Residential development has increased significantly to the southeast of the site. An industrial looking storage yard is visible on the parcel adjacent north of the site.
1973	7	Materials has been excavated and stockpiled on an eastern section of the site. A road following the alignment of the current Johns Road is visible along the northern boundary of the site.
