Massey, C. I.; Della Pasqua, F.; Lukovic, B.; Yetton, M. D.; Archibald, G.; Ries, W. 2014. Canterbury Earthquakes 2010/11 Port Hills Slope Stability: Risk assessment for Clifton Terrace. *GNS Science Consultancy Report 2014/76*. 125 p. + Appendices

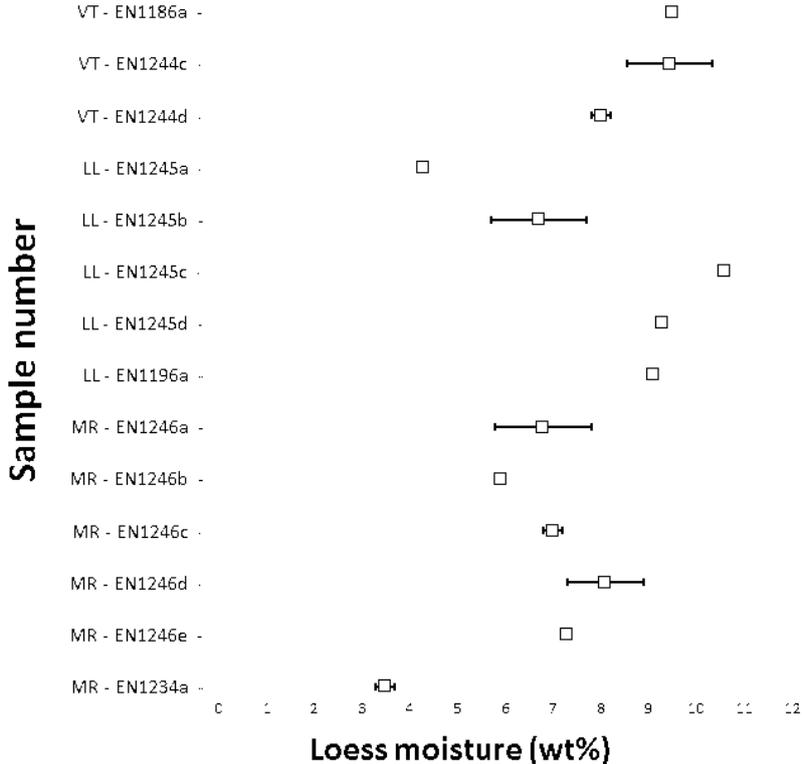
water contents are therefore thought to represent the lower end of the seasonal range (Figure 16). The samples were taken from an east-facing loess slope. Even if the samples had been collected in winter, the water contents of the loess at this accessible site would still not be representative of the water content of the loess deeper in the slope, as the outside face of the slope is free draining.

The water contents of the loess in drillhole samples were all substantially higher than those for the block samples. However, drilling uses water to flush the drill bit, and block sampling does not use water (Table 7).

**Figure 16** In-ground moisture (water, wt%) content of collected loess samples.

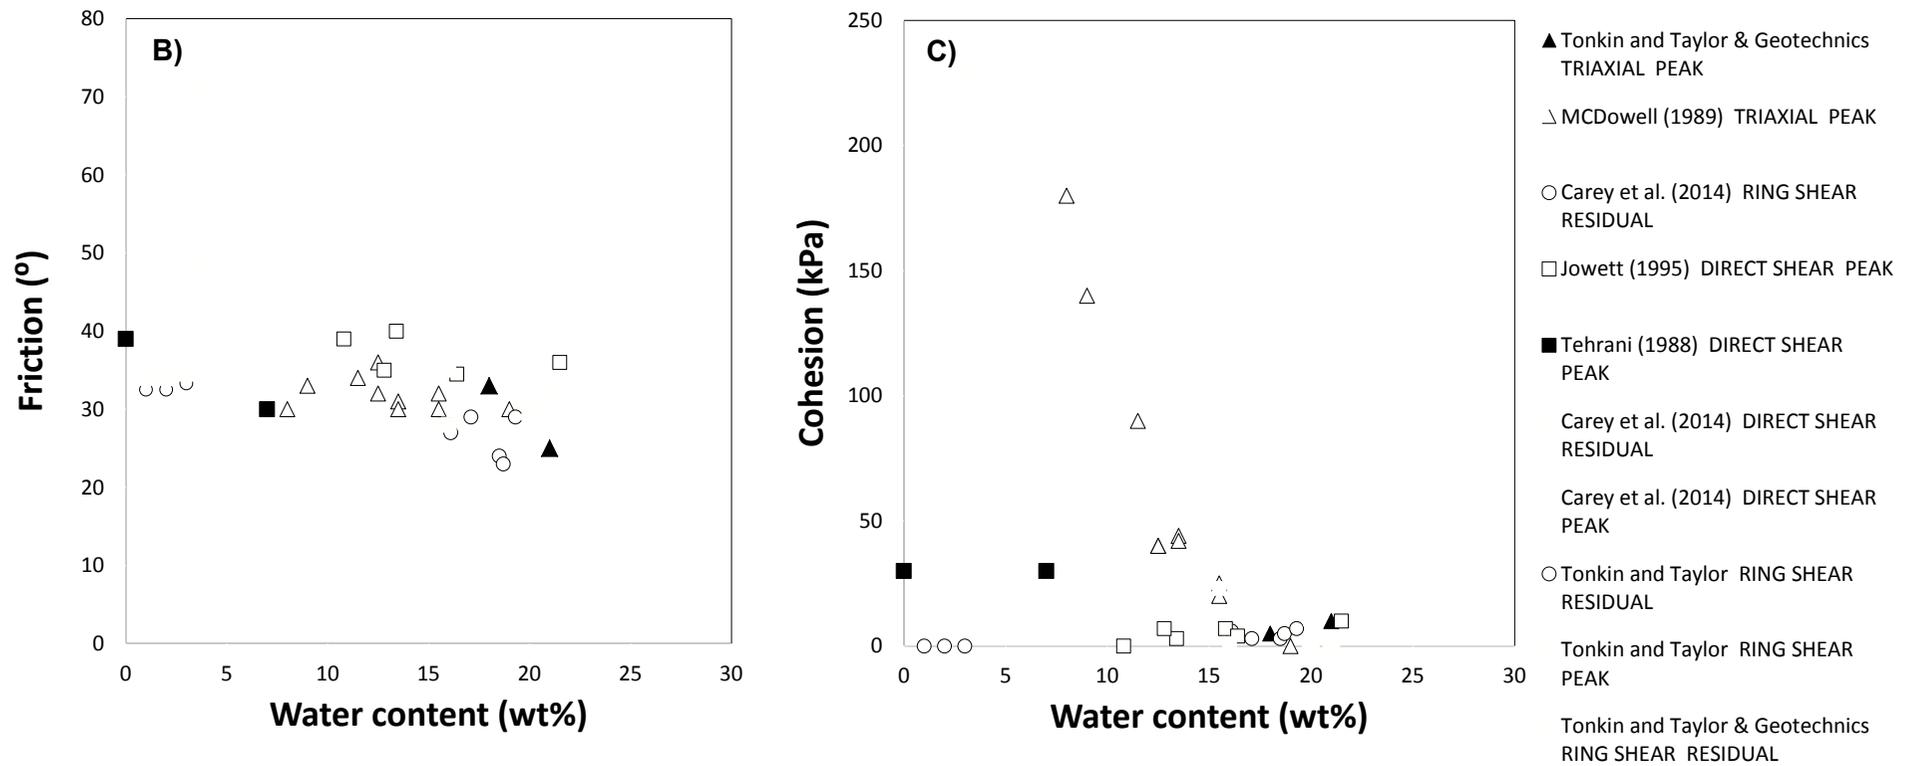
For water contents less than 20 wt% the cohesion of the tested loess is very sensitive to changes in water content. These results illustrate a large variability in the strength parameters of the loess in the Port Hills, and show that the loess strength is critically dependent on water content. These results are consistent with the findings of others (e.g., McDowell, 1989; Goldwater, 1990).

During periods of prolonged wet weather it is feasible for water contents in the loess to increase leading to a reduction in the cohesion and increased susceptibility to failure. The data plotted in Figure 17 probably represent the range of strength parameters at the likely range of moisture contents that could be anticipated in the Port Hills loess.

**Figure 17** Loess residual shear strength results (from Table 11 and Table 12). A) Cohesion and friction laboratory results plotted for loess. B) Loess residual cohesion plotted against water content. C) Loess residual friction plotted against water content. The Tonkin and Taylor Ltd. and Geotechnics Ltd. triaxial results are from samples of loess taken from drillhole BH-KSY-9a.

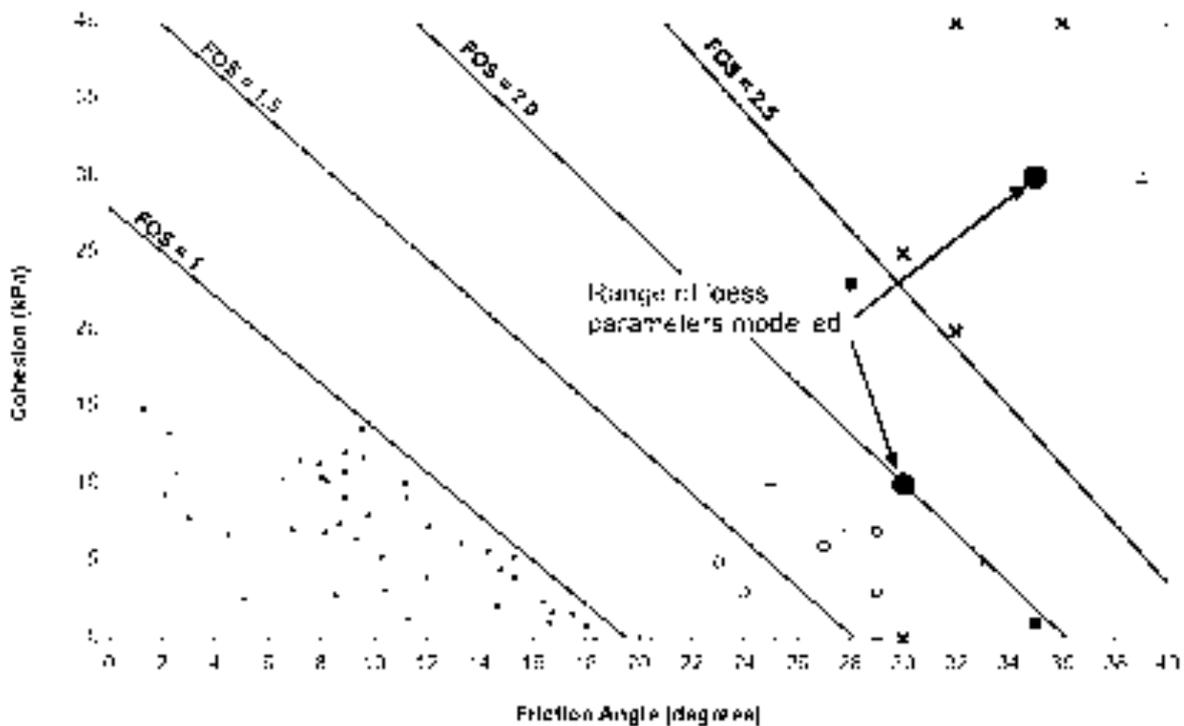
A lower estimate of the shear strength of the loess, needed to derive a static factor of safety for the slope of one, was a friction ( $\phi$ ) of 20° and cohesion (c) of 0 kPa, or any other combination of friction and cohesion on the factor of safety = one line. Such values are much lower than the range of shear strengths derived from laboratory testing of the loess, and they are even lower than those test results on samples where water contents were close to the liquid limit of the loess. The slope isn't moving, therefore the factor of safety is greater than 1.0 and the material strength parameters have to be greater than the black dots in Figure 19a.

Typical lower estimates of the bulk shear strength parameters of loess in the Port Hills adopted by local geotechnical consultants are friction ( $\phi$ ) = 30° and cohesion (c) = 10 kPa (Port Hills Geotechnical Group personal communication, 2013). These data are shown as black circles on Figure 19a. The results show that for the typical range of loess parameters adopted by engineering consultants in Christchurch, the factors of safety of slide surfaces in the loess are typically greater than 1.9, under dry conditions.

**Figure 19a** Numerical slope stability back-analysis of the loess material for cross-section 2, representing source area A. Note: each datapoint represents a modelled slide surface, adopting the geometries shown in Figure 18, at a given combination of cohesion and friction adopted for the loess. Those slide surfaces (adopting the path-search function), shown as black dots, represent those combinations of cohesion and friction that would yield a static factor of safety of less than one. The results from the laboratory testing (Figure 17) are also shown for comparison purposes.

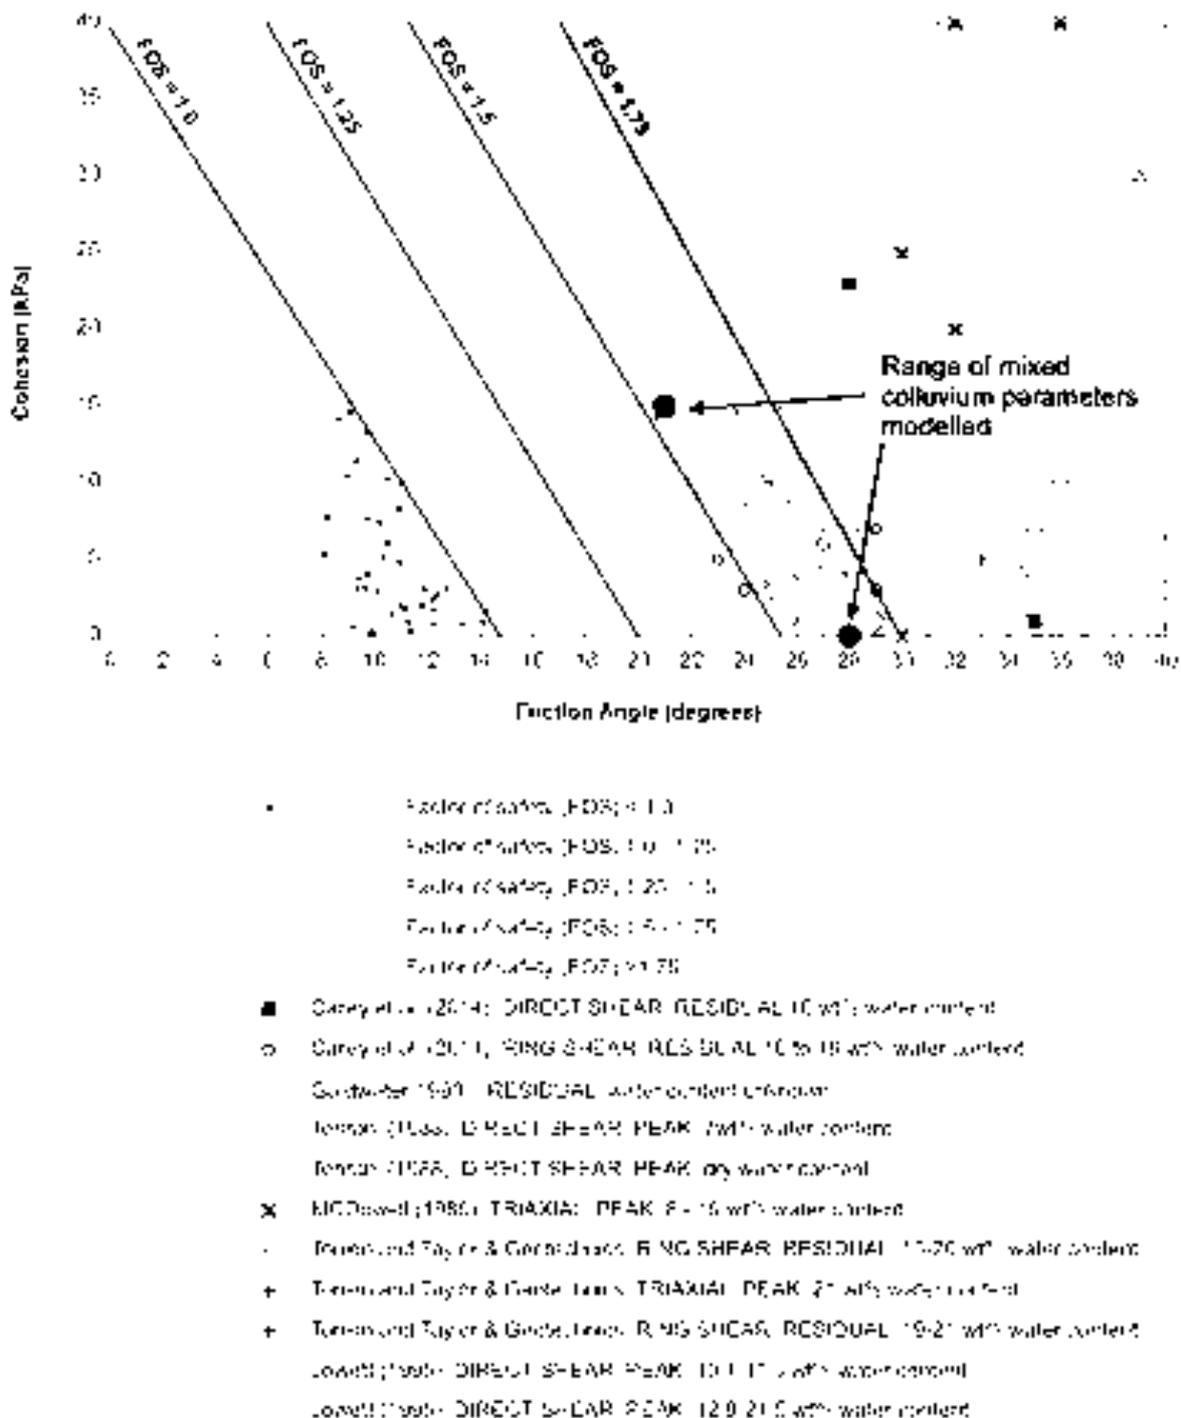
The results show that by including a weak layer of mixed colluvium in the model the factors of safety of the modelled slide surfaces reduce. A lower estimate of the shear strength of the mixed colluvium, needed to derive a static factor of safety for the slope of one, was a friction ( $\phi$ ) of 15° and cohesion (c) of 0 kPa, or any other combination of friction and cohesion on the factor of safety = one line. Such values are significantly lower than the range of shear strengths derived from laboratory testing of the loess. The slope isn't moving, therefore the factor of safety is greater than 1.0 and the material strength parameters have to be greater than the black dots in Figure 19b.

The results from ring-shear testing of the matrix material from the drillcore sample of clay from the highly weathered basalt breccia (friction ( $\phi$ ) of 21° and cohesion (c) of 15 kPa) are shown on the Figure 19b, and correspond to factors of safety of about 1.5–1.7. Although this material is clay dominated, the lower ranges of results from ring-shear testing of the loess (silt dominated) also yield similar factors of safety.

**Figure 19b** Numerical slope stability back-analysis of the mixed colluvium for cross-section 2, representing source area A. Note: each datapoint represents a modelled slide surface, adopting geometries similar to those shown in Figure 18, at a given combination of cohesion and friction adopted for the mixed colluvium. Those slide surfaces (adopting the path-search function), shown as black dots, represent those combinations of cohesion and friction that would yield a static factor of safety of less than one. The results from the laboratory testing (Figure 17) are also shown for comparison purposes.

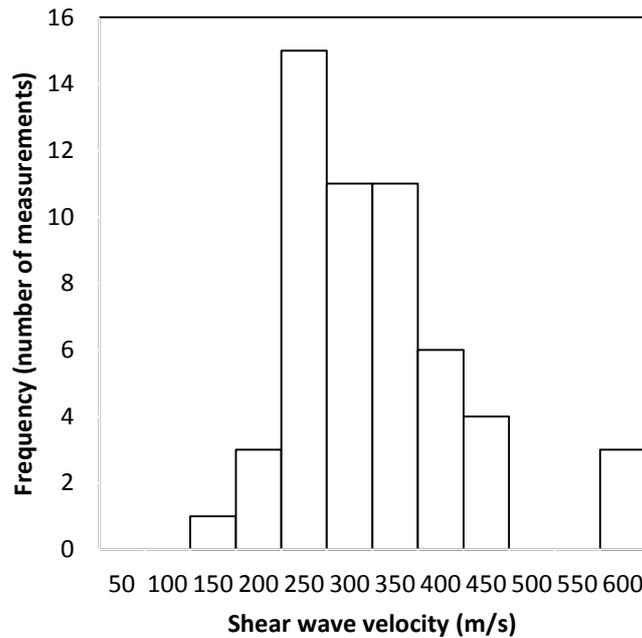
The results from the dynamic probing are summarised in Figure 20. The mean shear wave velocity is 306 m/s (±93 m/s at one standard deviation) and the mode is 222 m/s. Based on these results reported by Tonkin and Taylor (2012a), there is no measurable difference between the shear wave velocities of the loess and the colluvium, mean velocity of 297 (±121) m/s (errors at one standard deviation), and the data are plotted together in Figure 20.

**Figure 20** Loess and colluvium shear wave velocity results from dynamic probing reported by Tonkin and Taylor (2012a) for the loess at Clifton Terrace.

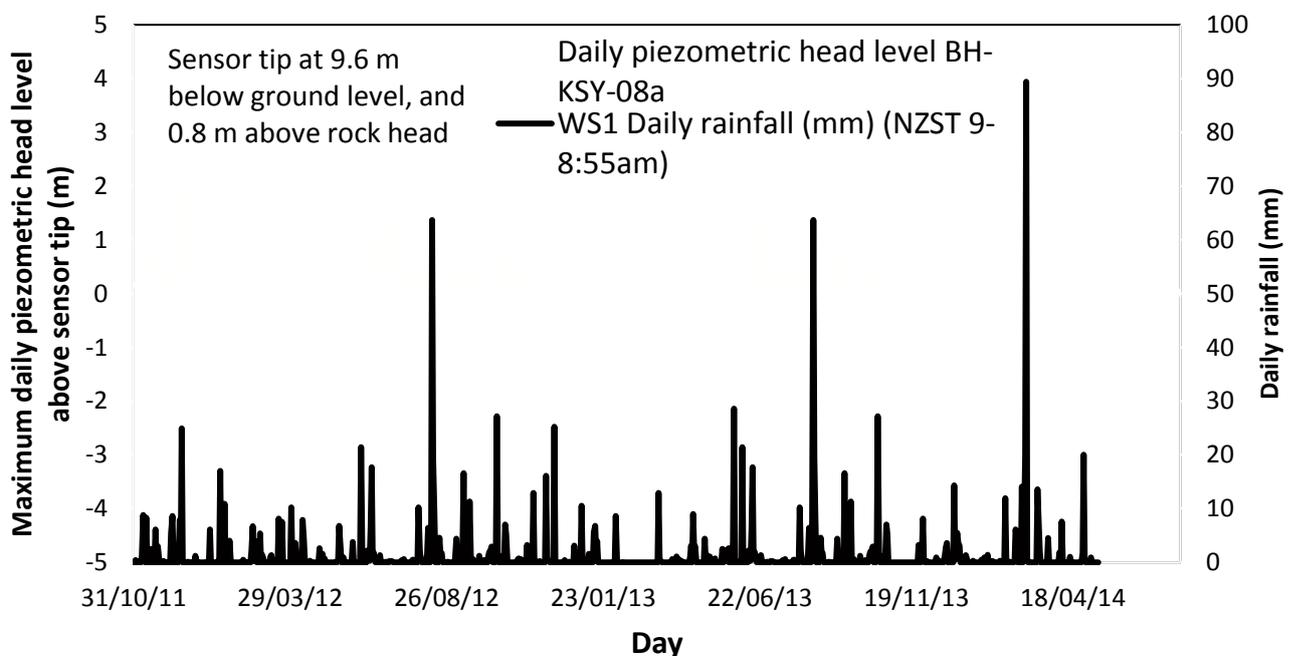
These results show that the larger piezometric response occurred during the rain event 11–17 August 2012, following a period when piezometric head levels were seasonally high. In comparison, the piezometer response to the larger rain event on 3–5 March 2014 was negligible, as this rain occurred when piezometric head levels were seasonally low.

**Figure 23** Daily rainfall recorded at the GeoNet gauge installed at Clifton Terrace (next to cGPS CLS5, Appendix 2), and piezometric head levels recorded in the standpipe in drillhole BH-KSY-8a (Figure 6).

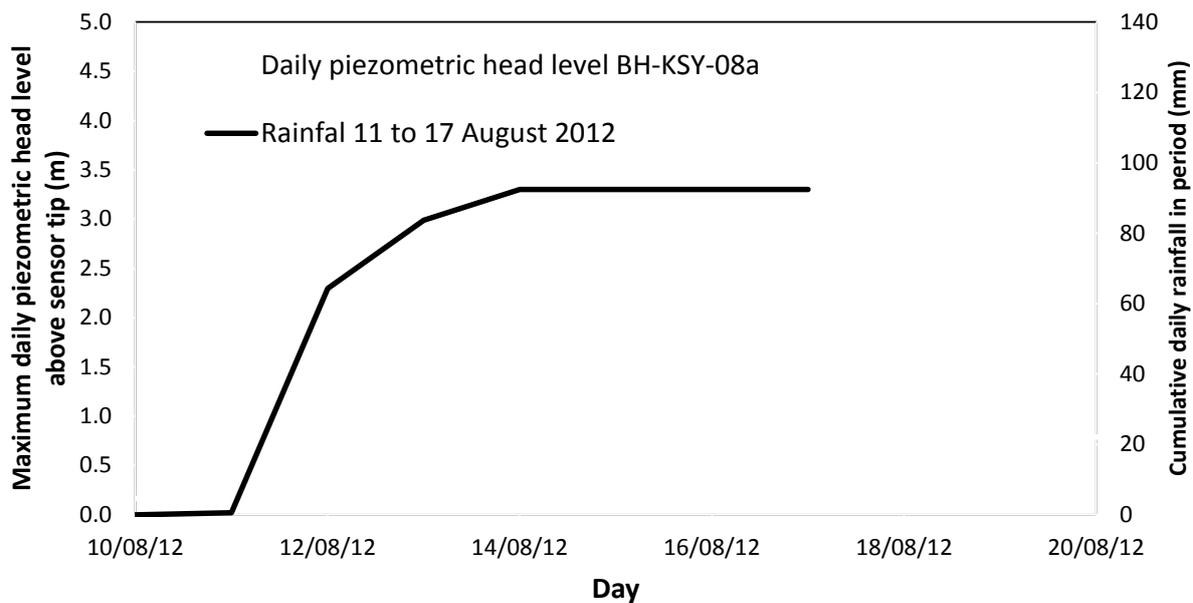
**Figure 24** Daily rainfall recorded at the GeoNet gauge installed at Clifton Terrace (next to cGPS CLS5, Appendix 2), and piezometric head levels recorded in the standpipe in drillhole BH-KSY-8a (Figure 6), for rain event 11–17 August 2012.

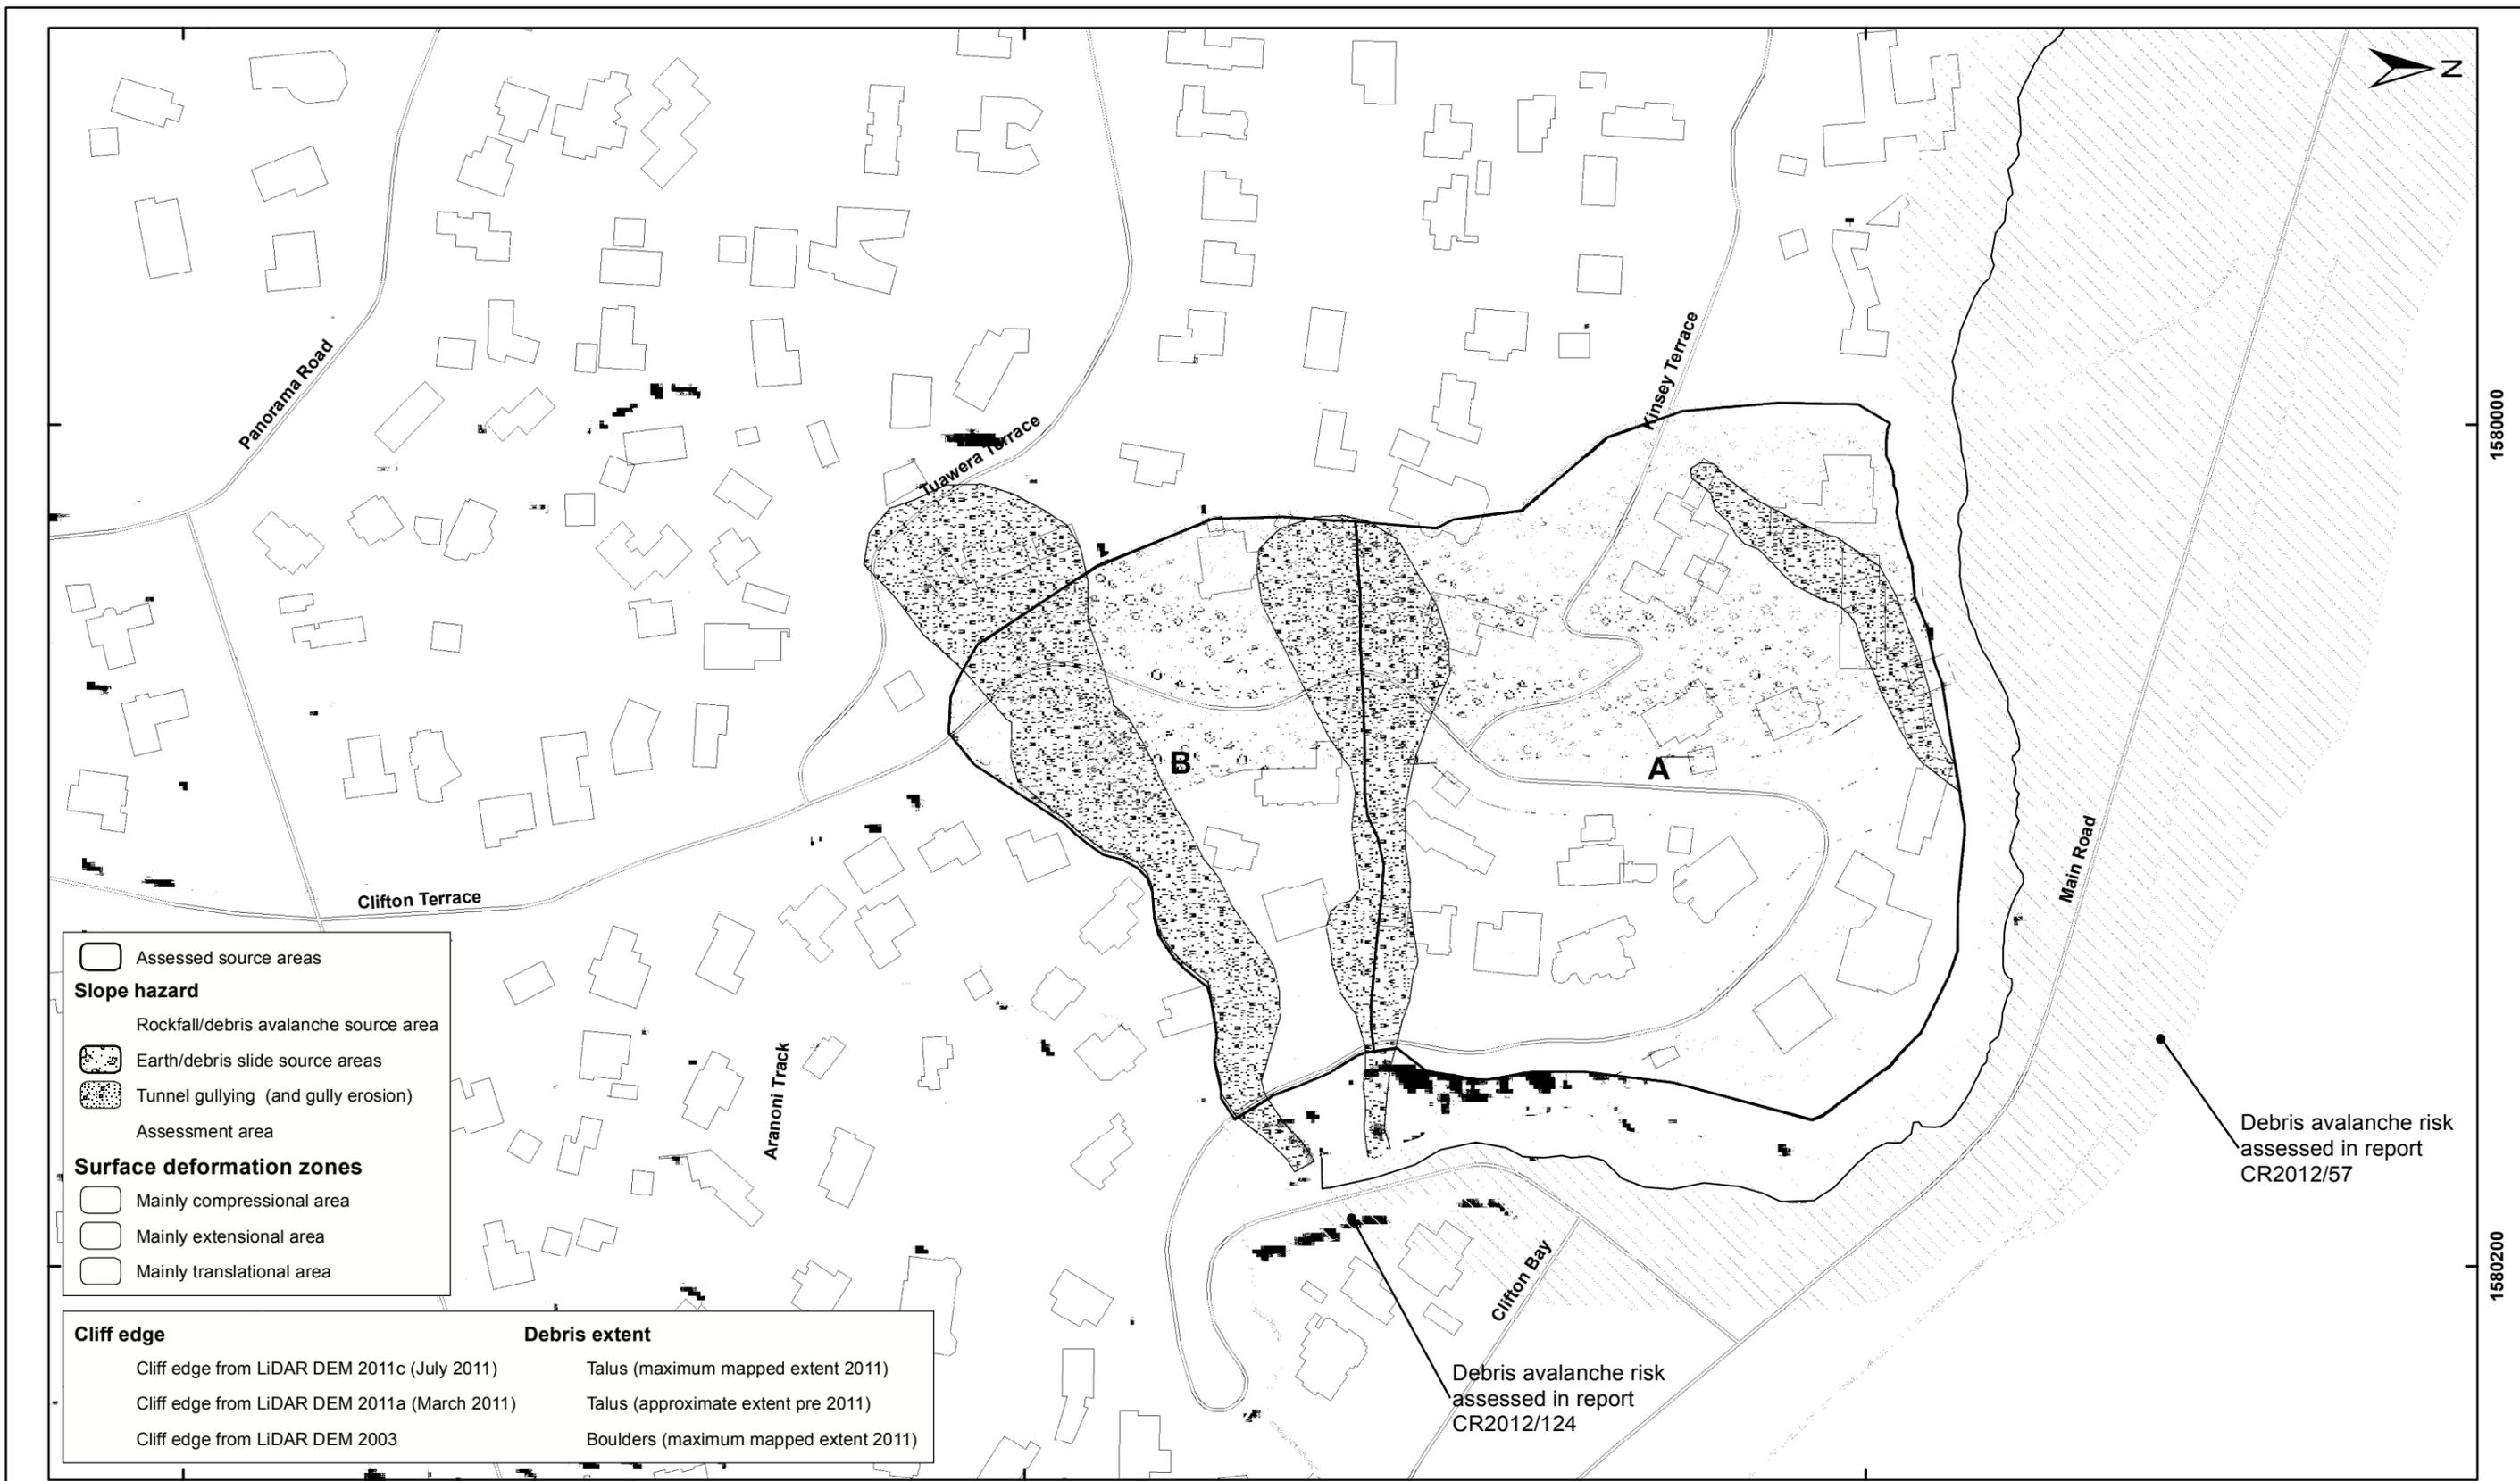
**FIGURE 26**

Figure 26, from earlier in the report, is a map showing the locations of the different types of landslide hazard identified in the assessment area. These landslide hazards are:

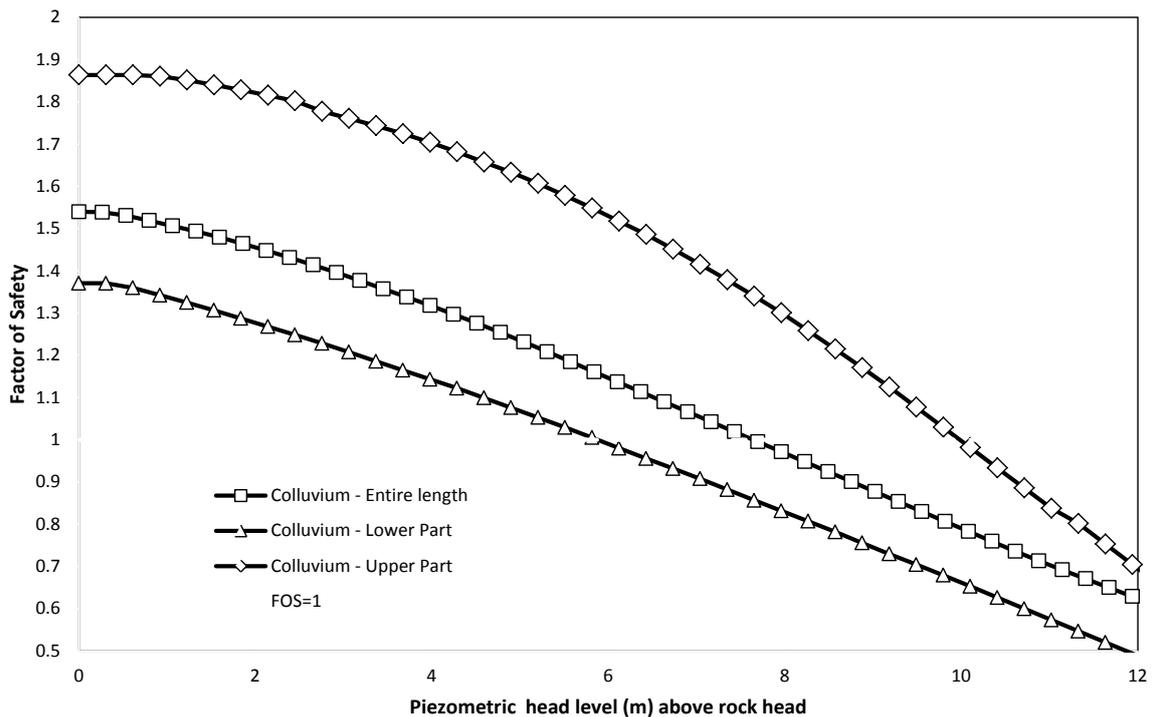
For failure surfaces in the colluvium and weathered breccia (mechanisms 2 and 3), the results show that an increase in piezometric head levels of about 6–10 m above rock head reduces the factor of safety to about one, adopting the lower estimates of the colluvium and weathered breccia shear strength (cohesion ( $c$ ) = 0-15 kPa and friction ( $\phi$ ) = 21–28°). Adopting the maximum recorded piezometric head levels, the factor of safety is between 1.2 and 1.5 for the upper, lower and entire parts of cross-section 2.

The groundwater levels recorded by GeoNet in standpipe piezometers (BH-KSY-2a and BH-KS8a) in loess, have reached levels of 4.0 and 3.3 m above rock head respectively, which are significantly lower than those needed to initiate movement (factor of safety equal to one).

**Figure 32** Sensitivity assessment of the slope factor of safety (cross-section 2, source area A) in response to changing piezometric head levels above rock head for slide surface in the lower, upper and entire parts of source area A. The assessment assumes pore pressures increase uniformly across the entire rock head boundary.

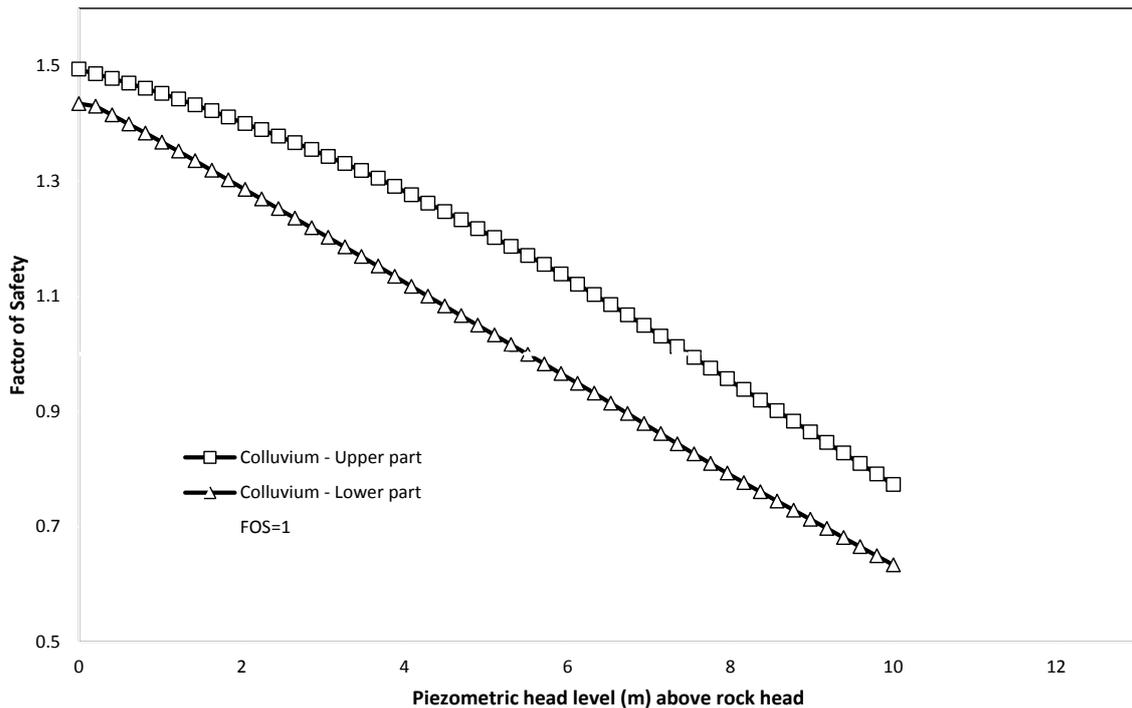
For failure surfaces in the loess or colluvium (mechanisms 1 and 2), the results show that an increase in piezometric head levels of about 5.5–7.5 m above rock head reduces the factor of safety to about one, for the lower estimates of the loess and colluvium shear strength (cohesion ( $c$ ) = 10 kPa and friction ( $\phi$ ) = 30°).

There are currently no groundwater records from this area of the site. Therefore it is not known whether a piezometric head level rise of between 5.5 and 7.5 m above rock head and across the entire slope is feasible, or under what weather conditions such increases might occur. The groundwater levels in this area are not currently being monitored.

**Figure 33** Sensitivity assessment of the slope factor of safety (cross-section 3, source area B) in response to changing piezometric head levels above rock head for slide surfaces in the upper and entire parts of source area B. The assessment assumes that pore pressures increase by a given amount across the entire rock head boundary.

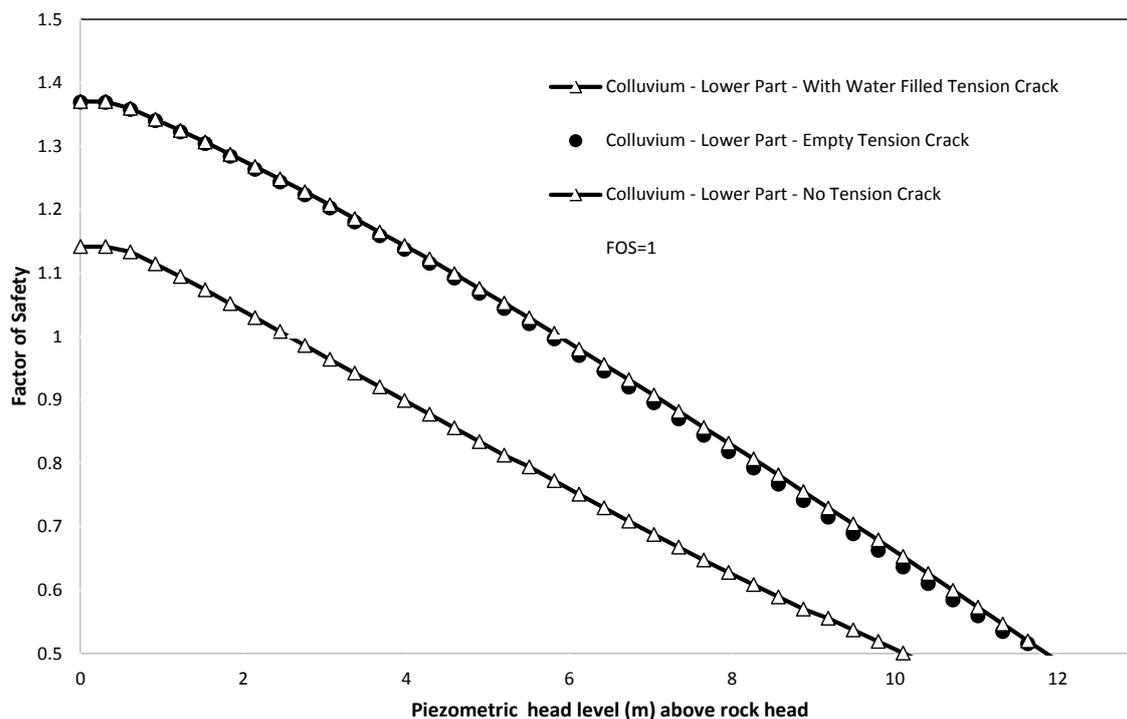
Water filled tension cracks have been included in the model as a zone extending from the surface to rock head. It should be noted that the mapped tension cracks logged in test pits do not extend all the way down to the base of the loess. The inclusion of water filled tension cracks within the model reduces the piezometric head levels needed to yield a factor of safety of one, for slide surfaces in the lower part of assessed source area A, from 6 m to about 2.5 m, when adopting colluvium shear strengths of cohesion ( $c$ ) of 15 kPa and friction ( $\phi$ )  $21^\circ$ . However, 3.3 m of piezometric head, above rock head, has been recorded in drillhole BH-KSY-8a, in the lower slope near the section line, and no such slope movement has been recorded.

The results show that the factor of safety for the modelled slide surfaces is sensitive to the inclusion of water filled tension cracks in the model. However, the absolute modelled factors of safety are thought to be conservative, as it has been inferred that the weak colluvium extends into the lower slope, although drillhole records do not support this, and that the lower slope contains tensions cracks, which have not been mapped on the ground. Further work is needed to quantify the effects tension cracks have in the model.

**Figure 34** Sensitivity assessment of the lower slope factor of safety (in source area A, section 2) in response to including filled tension cracks in the model. Tension cracks were assumed to be 100% filled.

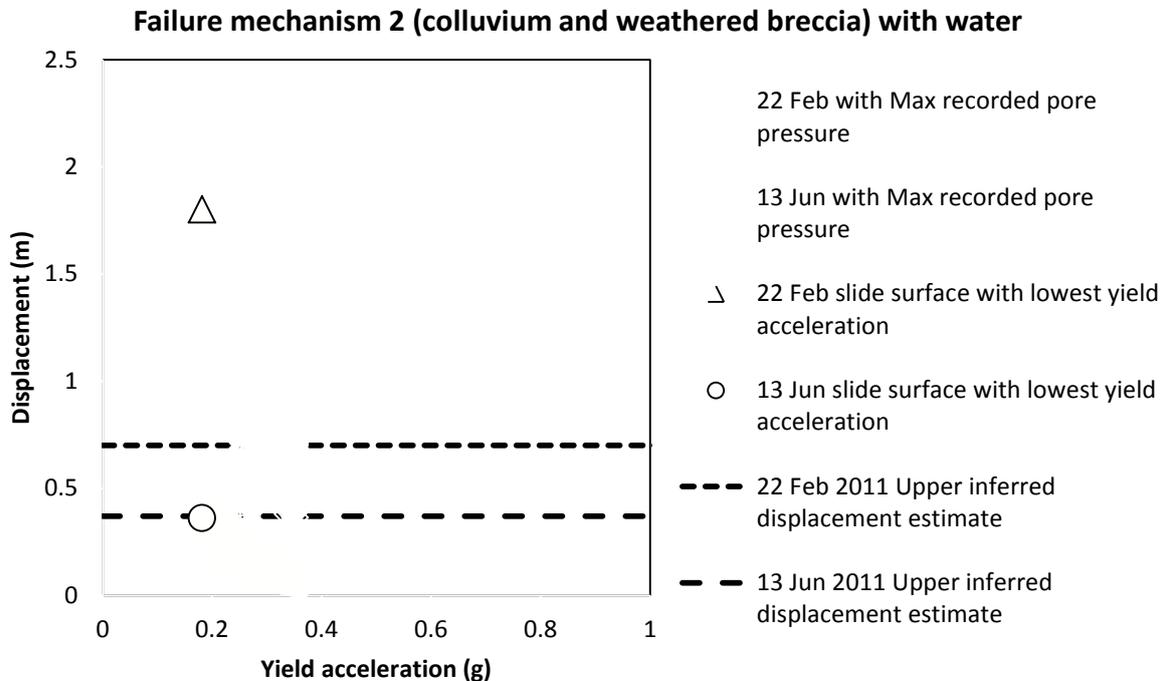
- The results where water levels (Figure 44) were included in the modelling suggest, as expected, permanent displacements would be greater when the slope is wet, as the factors of safety and therefore yield accelerations reduce (from 0.3 to 0.2 g) when modelled using the maximum recorded piezometric head levels.

- The results show a good match between the recorded permanent coseismic displacement and modelled displacements for the 22 February and 13 June earthquakes, with the lower bound colluvium and weathered basalt lava breccia material strength parameters, if slope conditions are assumed to have been dry at the time of the 22 February 2011 earthquake (which occurred in summer) (Figure 41), and wet during the 13 June 2011 earthquake (which occurred in winter) (Figure 44).

**Figure 44** Failure mechanisms 2 and 3. Modelled Slope/W decoupled displacements of cross-section 2 for the 22 February and 13 June 2011 earthquakes. Adopting the maximum recorded piezometric head levels and material strength parameters for the mixed colluvium and weathered basalt lava breccia of cohesion ( $c$ ) = 15 kPa, and friction ( $\phi$ ) = 21°, and for the loess of cohesion = 30 kPa and friction = 35°. Each data point represents a modelled slide surface and the corresponding estimate of its displacement as a result of the modelled earthquakes – adopting the synthetic free-field rock outcrop earthquake acceleration time histories. The dashed lines represent the total inferred coseismic permanent displacement of the slope along the cross-section during the given earthquake.

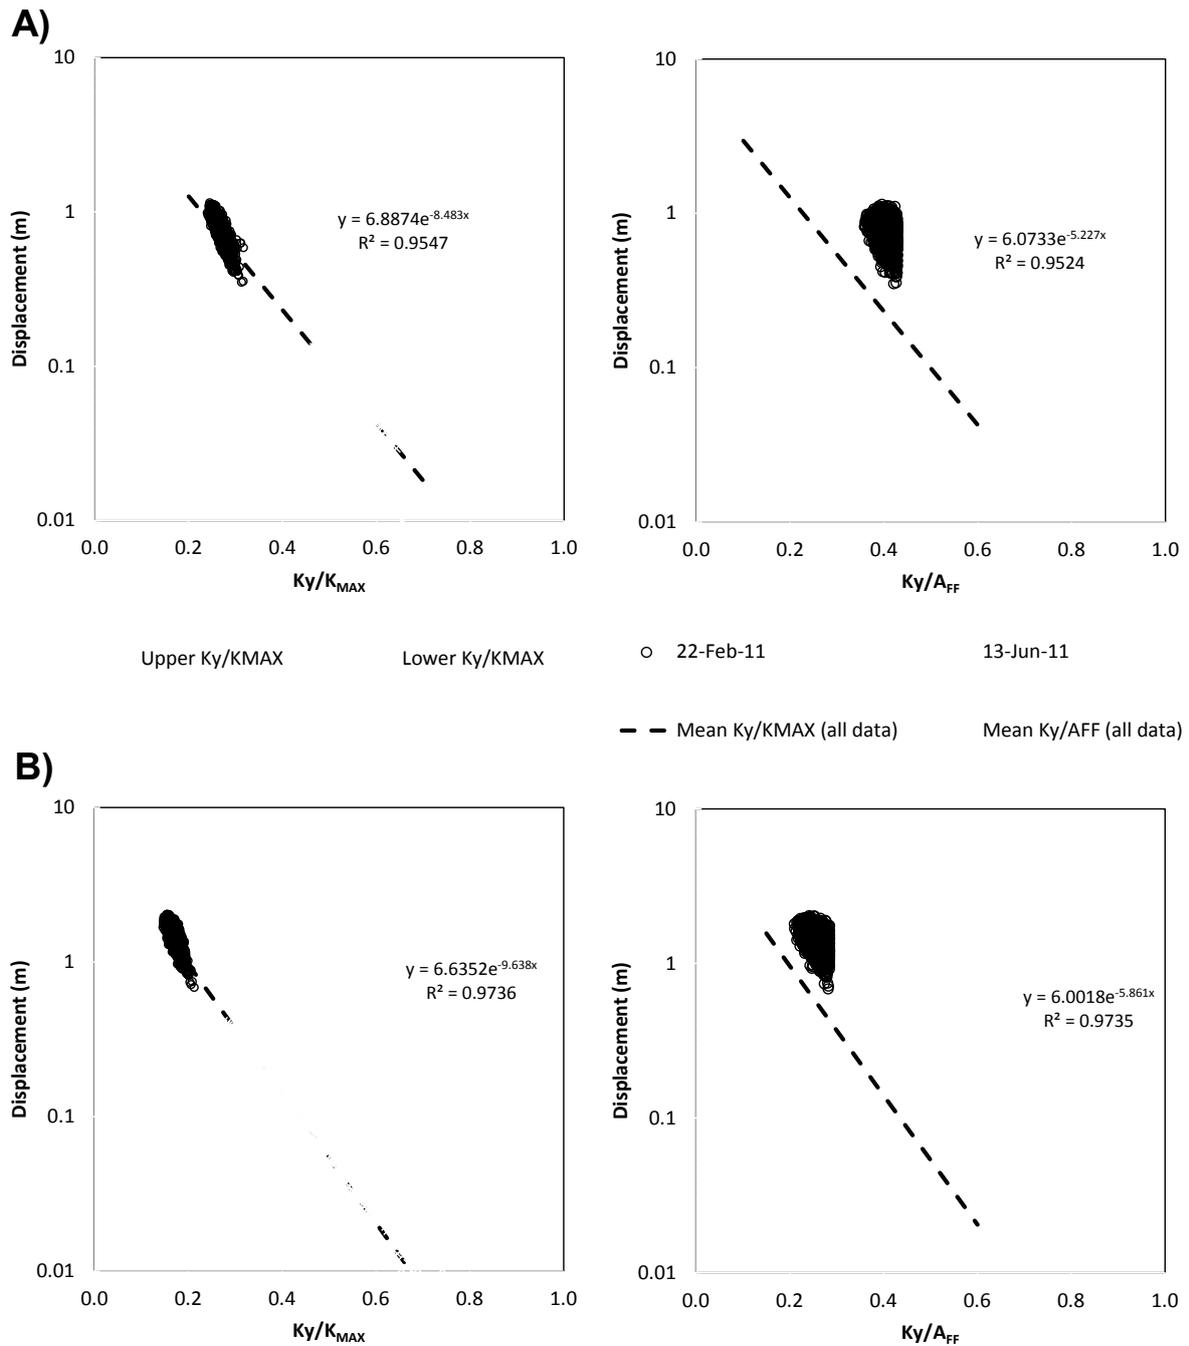
The results from the assessment, adopting failure mechanisms 2 and 3, are shown in Figure 45, for those slide surface shown in Figure 39. The results indicate that between  $K_y/K_{MAX}$  values of 0.1 and 0.6, and  $K_y/A_{FF}$  values of 0.2 and 0.7, the data are well fitted to a straight line (an exponential trend line) in semi-log space. The coefficient of determination ( $R^2$ ) is 0.96 for  $K_y/K_{MAX}$  and 0.95 for  $K_y/A_{FF}$ , and includes all of the plotted data (N = 2000).

The peak ground acceleration of the input motion ( $A_{FF}$ ) does not take into account amplification caused by the slope geometry, or at this site, the material contrasts within the slope, between the loess/colluvium and the underlying rock (Appendix 4). From the data in Figure 45, the mean ratio of  $K_{MAX}$  to  $A_{FF}$  for cross-section 2 is 1.6 ( $\pm 0.1$  at one standard deviation), meaning that  $K_{MAX}$  is 1.7 times greater than the peak horizontal ground acceleration of the input motion, if assuming the mean plus one standard deviation of the mean.

For ratios of  $K_y/A_{FF}$  in Figure 45, the estimated displacements are consistent with those reported by Jibson (2007), where these data plot between the ranges for earthquakes of M6.5–7.5 as reported by Makdisi and Seed (1978) and plotted by Jibson (2007).

**Figure 45** Cross-section 2, failure mechanisms 2 and 3. Decoupled Slope/W displacements calculated for different ratios of yield acceleration to maximum average acceleration of the mass ( $Ky/K_{MAX}$ ), and maximum acceleration of the mass ( $Ky/A_{MAX}$ ), for selected slide-surface geometries, and material shear strength parameters of cohesion ( $c$ ) of 0-15 kPa and friction ( $\phi$ ) of 21-28°.  $A_{FF}$  is the peak acceleration of the input earthquake time acceleration history. Synthetic rock outcrop time acceleration histories for the 22 February and 13 June 2011 earthquakes were used as inputs for the assessment ( $N = 2000$ ). The dashed lines are exponential trend lines fitted to the semi-log data. The formula and the coefficient of determination ( $R^2$ ) for the trend lines are shown. **A)** Results for dry conditions. **B)** Results for when the slope is wet, when piezometric head levels are at the maximum recorded levels.
