Massey, C. I.; Della Pasqua, F.; Lukovic, B.; Yetton, M. D.; Archibald, G.; Ries, W. 2014. Canterbury Earthquakes 2010/11 Port Hills Slope Stability: Risk assessment for Clifton Terrace. *GNS Science Consultancy Report 2014/76*. 125 p. + Appendices

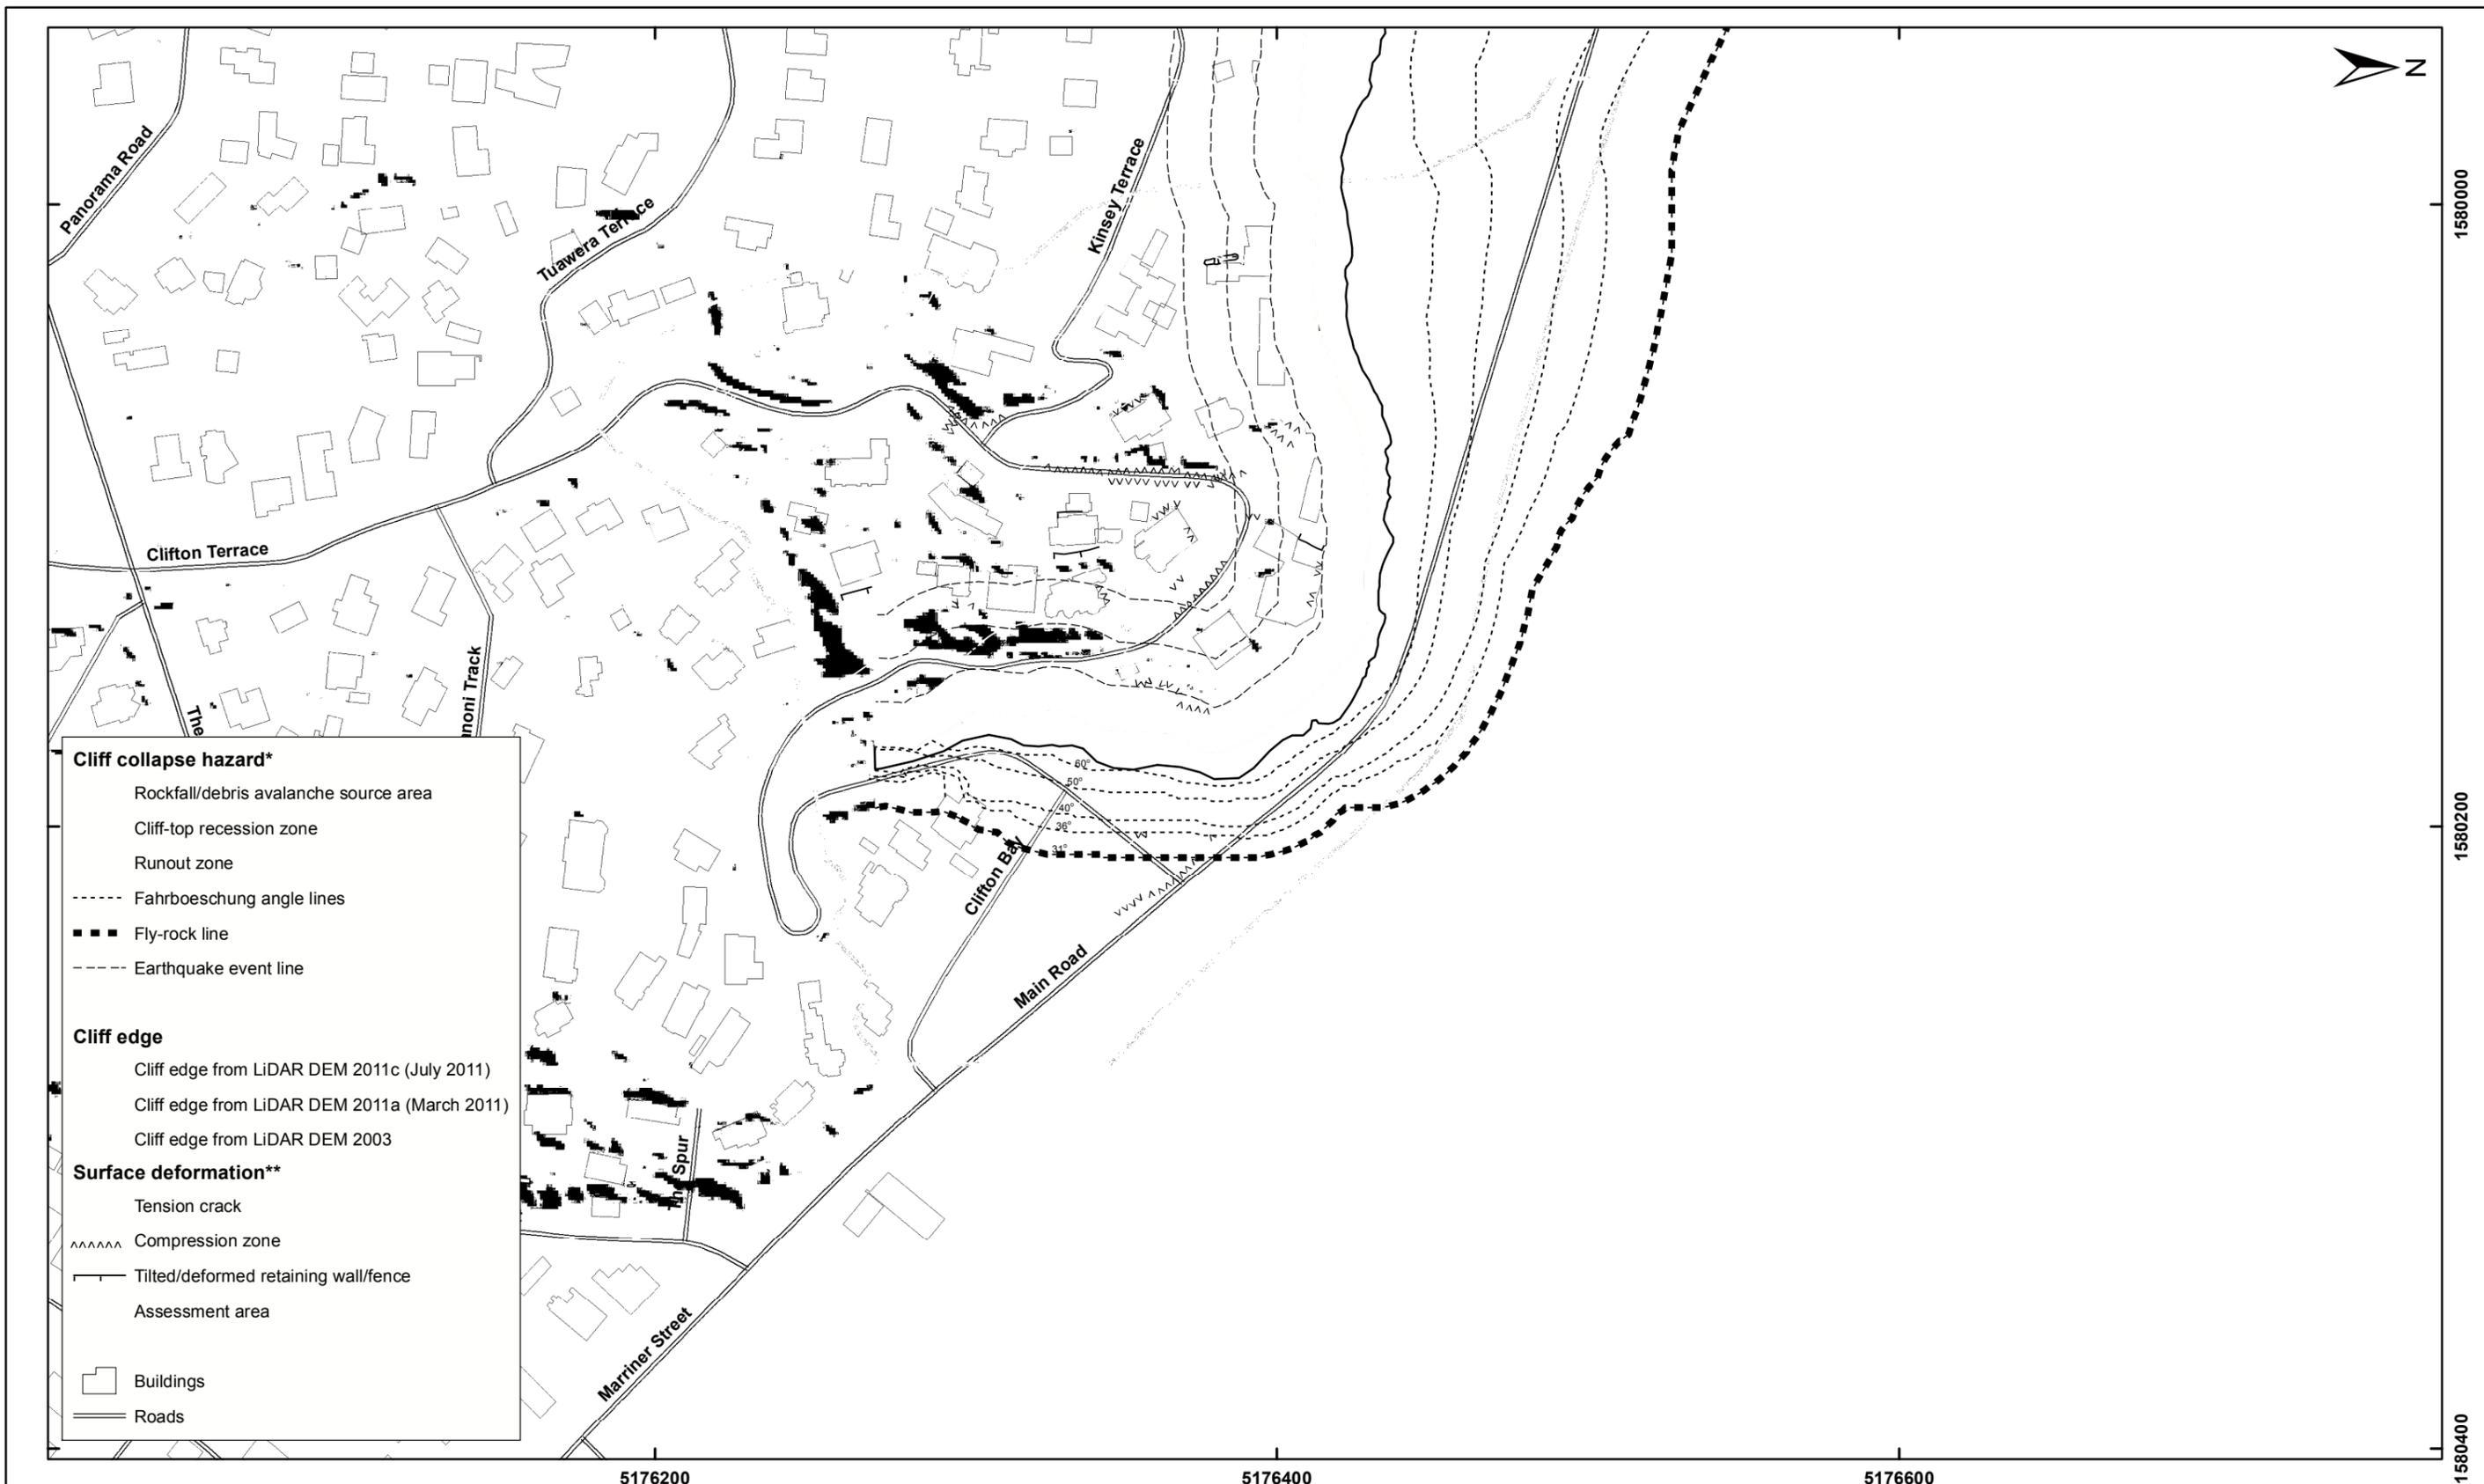
**CLIFF COLLAPSE HAZARD MAP**

A 10-m wide zone is included around the boundary of the Class II hazard exposure area, where the area of slumping and cracking may enlarge in the future in an up-slope or lateral direction beyond the currently recognised boundary. This has been termed a “Class II relative hazard exposure 10 m enlargement area” (Figure 46).

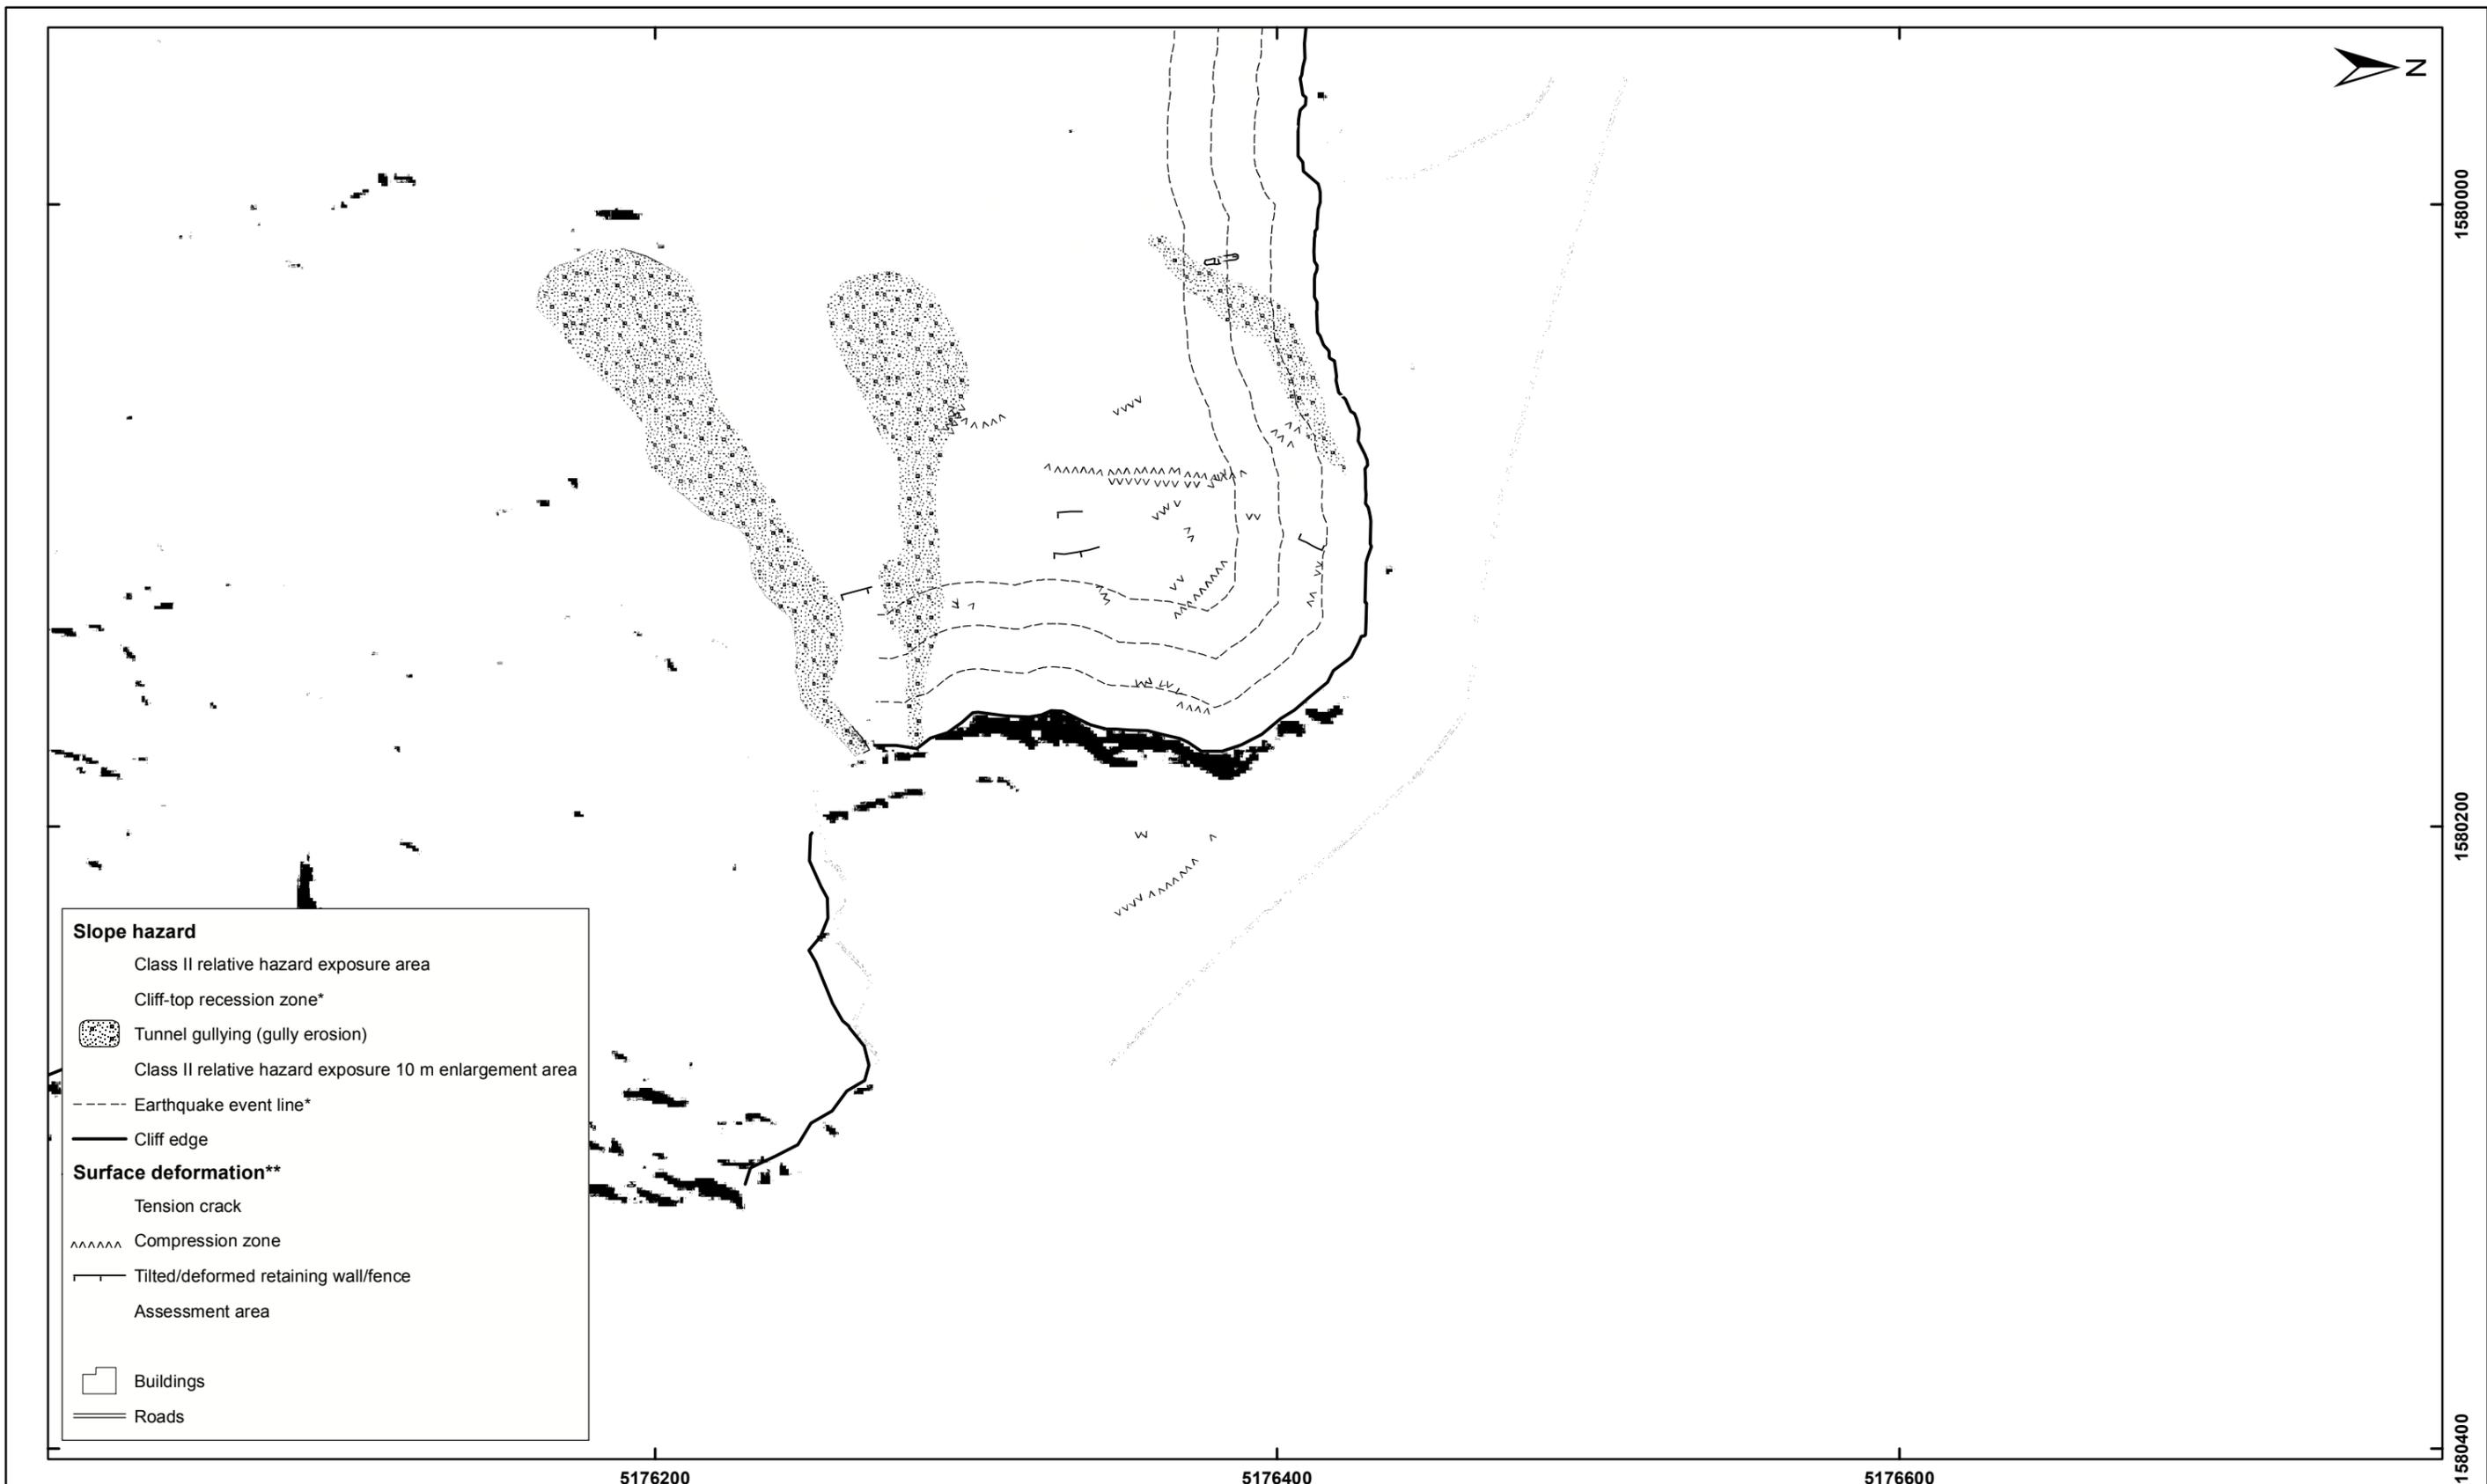
**CLASS II RELATIVE HAZARD EXPOSURE AREA**

**Slope hazard**

- Class II relative hazard exposure area
- Cliff-top recession zone\*
- Tunnel gullying (gully erosion)
- Class II relative hazard exposure 10 m enlargement area
- Earthquake event line\*
- Cliff edge

- Tension crack
- ^^^^ Compression zone
- Tilted/deformed retaining wall/fence
- Assessment area

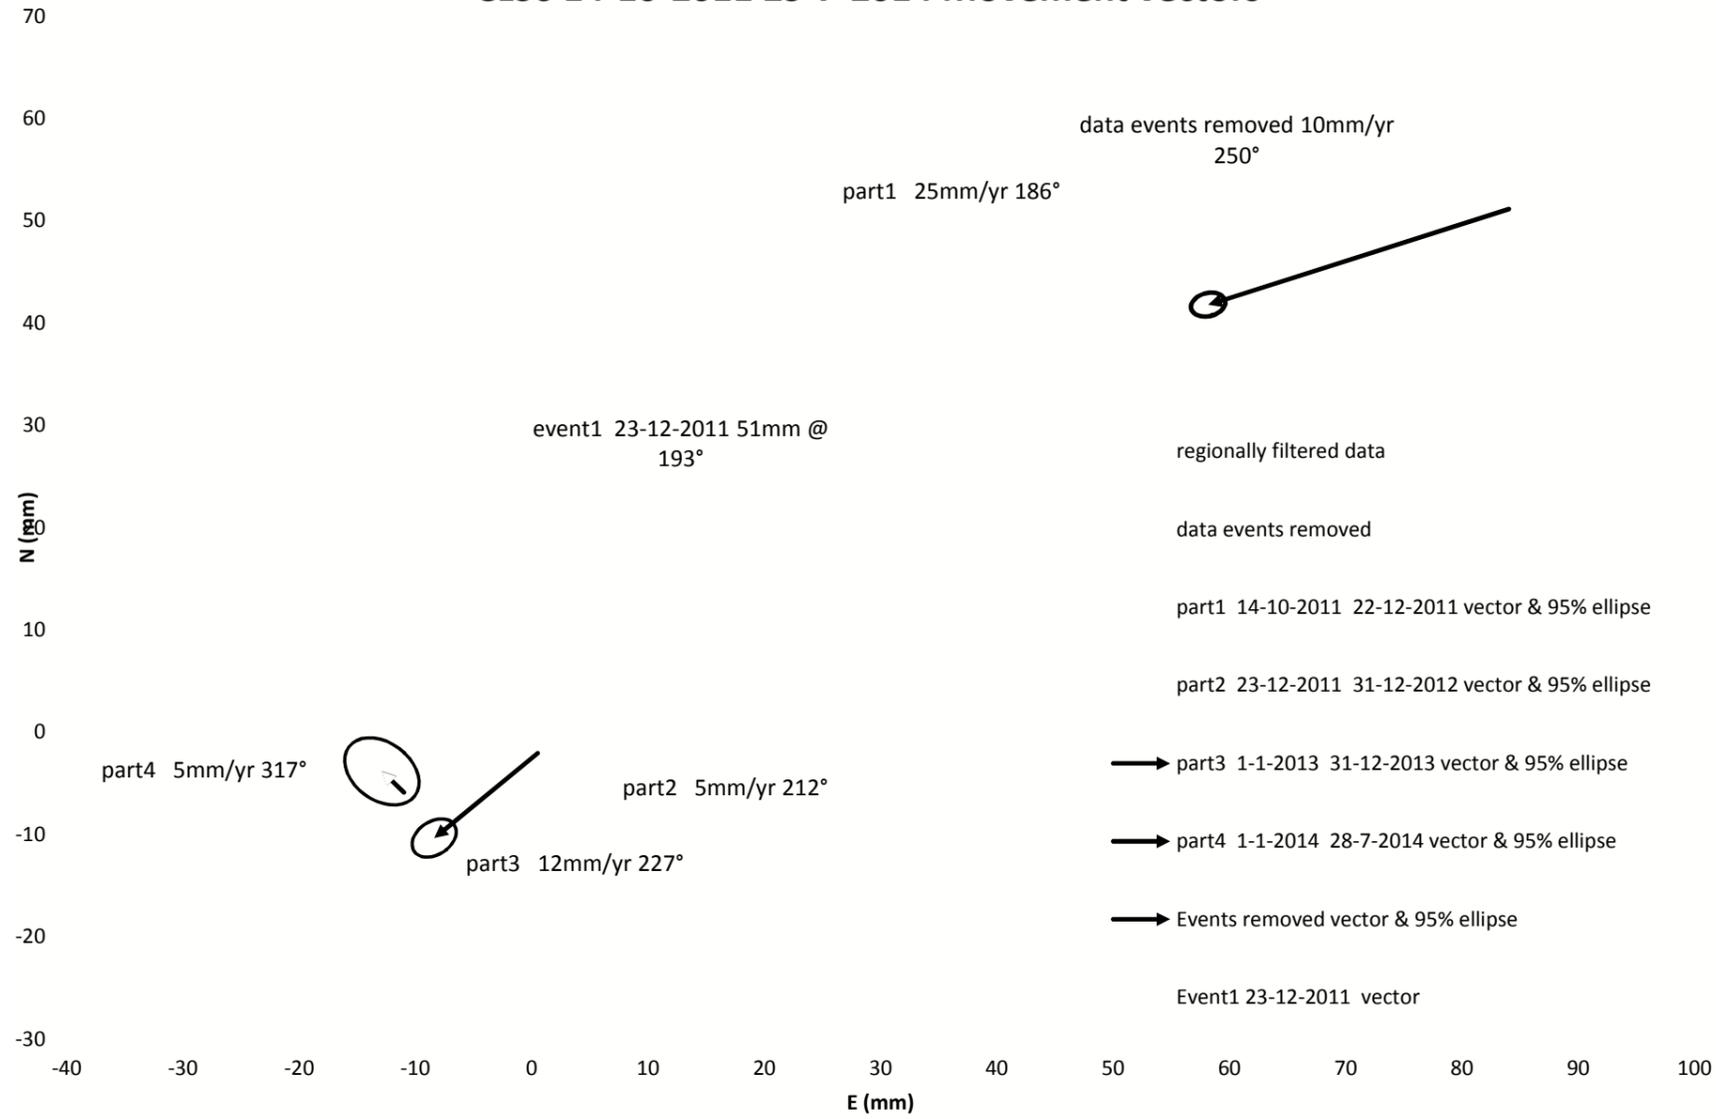
# CLS6 14-10-2011 29-7-2014 Movement vectors

CLS6	offset (mm)	bearing (deg)	up (mm)	comments	date	event	
Event1	51	193	-10		23/12/2011	M6.2	
Event2					1/01/2013		
Event3					1/01/2014		
Event4					29/07/2014		
Event5					29/07/2014		
Event6					29/07/2014		
	rate (mm/yr)	bearing (deg)	95% CE (mm)	#days	#obs	startdate	enddate
Part1	25	186	24	70	70	14/10/2011	22/12/2011
Part2	5	212	2	375	370	23/12/2011	31/12/2012
Part3	12	227	2	365	360	1/01/2013	31/12/2013
Part4	5	317	7	210	200	1/01/2014	29/07/2014
Part5							
Part6							
Part7							
data events removed	10	250	1	1020	1000	14/10/2011	29/07/2014

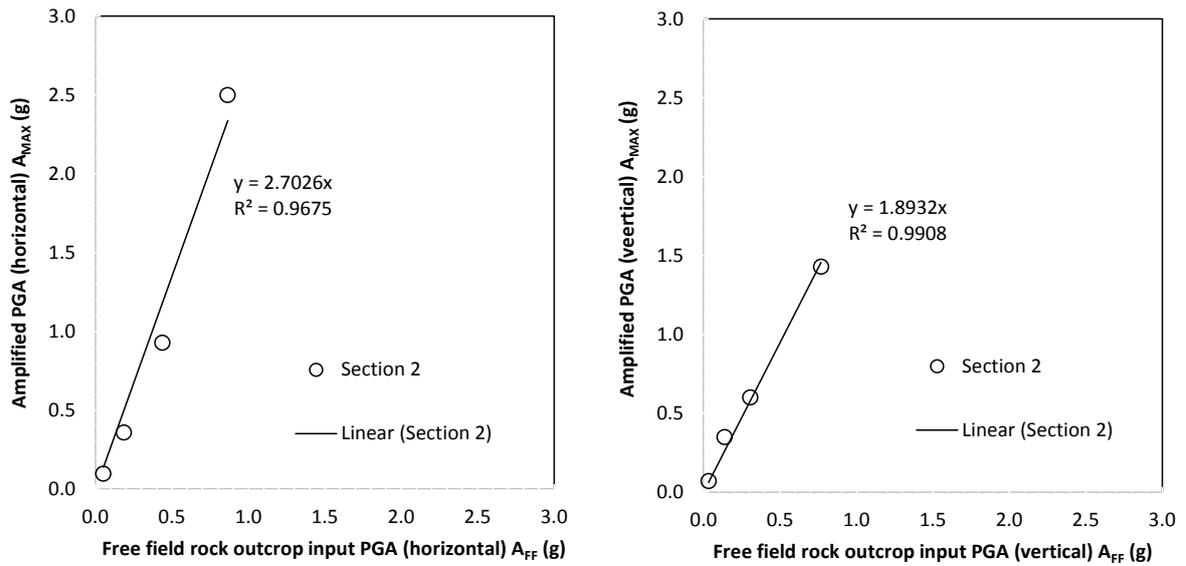
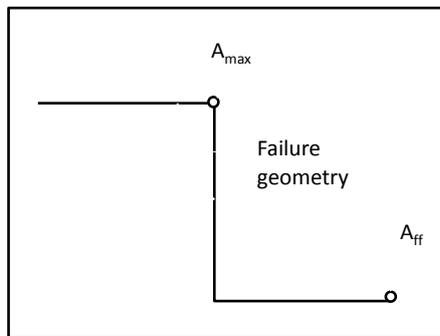
**Figure A4.1** Amplification relationship between the synthetic free-field rock outcrop input motions ( $A_{FF}$ ) and the modelled cliff crest maximum accelerations ( $A_{MAX}$ ) for cross-section 2. A schematic diagram showing the locations of the various recorded accelerations is shown.

Results from this assessment have shown that the relationship between the peak ground acceleration of the free-field input motion and the corresponding modelled peak acceleration at the slope crest ( $A_{MAX}$ ) is approximately linear. In the range of modelled peak horizontal accelerations, the horizontal amplification factor ( $S_T$ ) is typically in the order of about 2.7 times the input free-field peak horizontal acceleration.

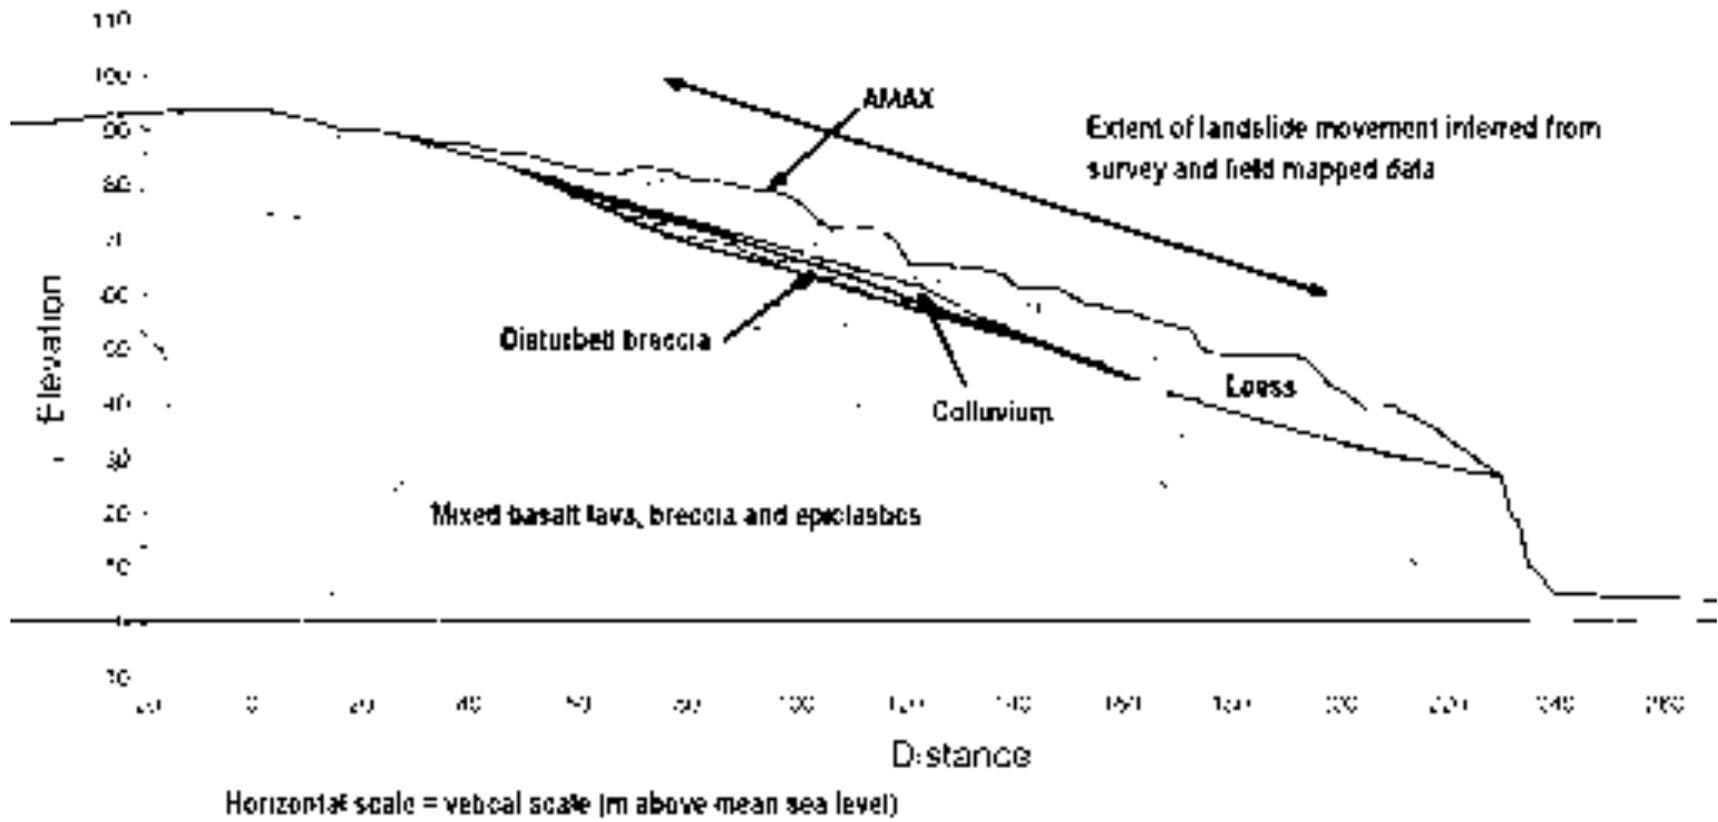
The extent of the coseismic landslide, inferred from survey data, crack mapping and slope morphology, is about 130 m in length and about 150 m wide. The modelled peak ground accelerations at the surface across the landslide are, therefore variable given the extent of the landslide. The highest modelled peak ground accelerations during the 22 February 2011 earthquake coincide with the convex break in slope ( $A_{MAX}$ ).

**Figure A4.2** Modelled horizontal peak ground acceleration contours for the 22 February 2011 earthquake at Clifton Terrace, cross-section 2.

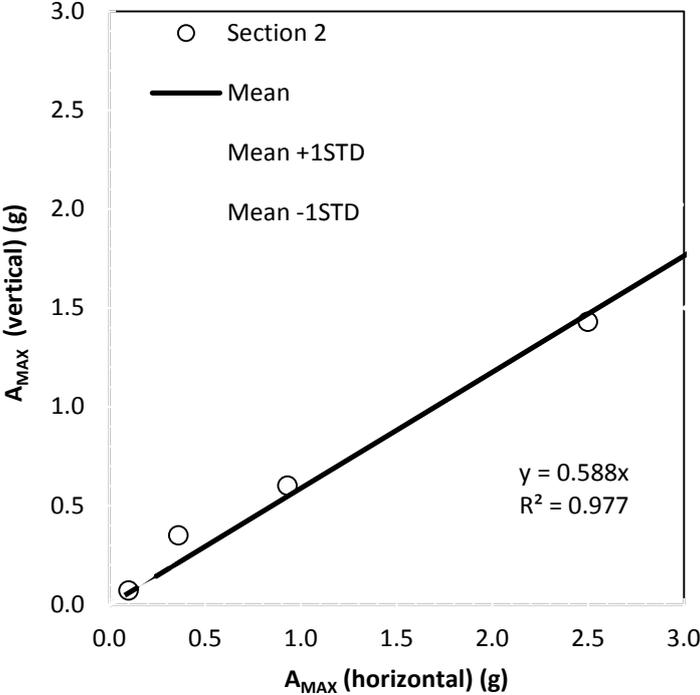
The relationship between the modelled vertical and horizontal peak ground accelerations recorded at the slope crest ( $A_{MAX}$ ) is shown in Figure A4.3. The gradient of the linear fit is  $0.59 (\pm 0.03)$  – errors at one standard deviation. The relationship between horizontal and vertical peak ground accelerations appears more curved than linear.

**Figure A4.3** Relationship between the modelled horizontal and vertical maximum accelerations modelled at the convex break in slope ( $A_{MAX}$ ) for cross-section 2, using the synthetic free-field rock outcrop motions for the Clifton Terrace site by Holden et al. (2014) as inputs to the assessment. The mean and standard deviation trend lines are fitted for  $A_{MAX}$  all data. Errors are shown as the mean  $\pm$  one standard deviation (1 STD).

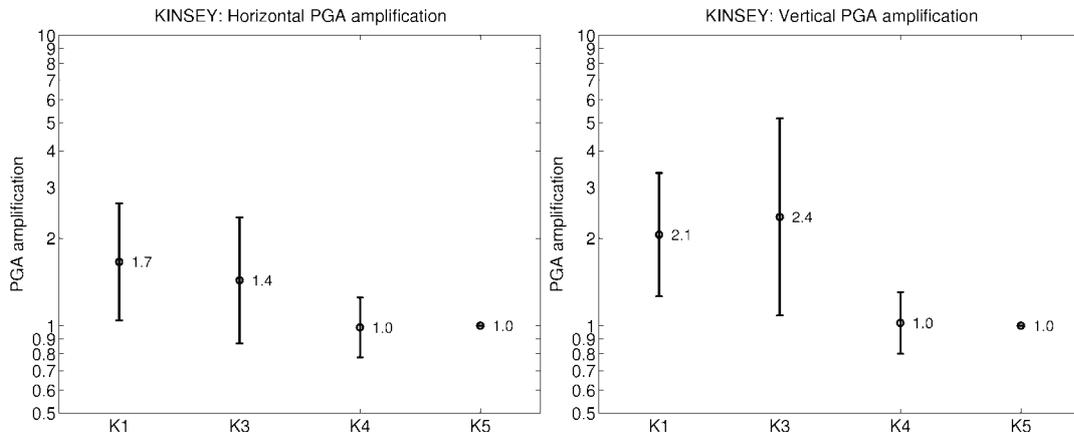
Results from the assessment of the data collected by the seismic array instruments installed on Clifton Terrace reported by Kaiser et al. (2014) show significant differences in mean peak ground acceleration amplification between stations of up to 1.7 times horizontal and 2.4 times vertical (Figure A4.4). Kaiser et al. (2014) report that there was significant variation in these values across individual events, as seen from the range of values within one standard deviation of the mean shown in Figure A4.4. Furthermore, these values are derived from small to moderate sized earthquakes dominated by high-frequency ground motions and

therefore they cannot be considered appropriate for larger magnitude shaking without further study. However, these results do show that the stations located on source area A (station K1 and K3) have higher amplification factors to the ones located outside the area of cracking (K4 and K5, where K5 is the reference station).

**Figure A4.4** Peak ground amplification (PGA) with respect to the reference station in the horizontal (left) and vertical (right) directions recorded between stations at Clifton Terrace (Figure 6 for instrument locations). The horizontal PGA is taken to be the larger of the two horizontal components. Geometric mean and standard deviations of the amplification factors across individual events are shown as error bars.
