# Christchurch Tide Gates and Other Fish Barriers

September 2025

Prepared for: Christchurch City Council

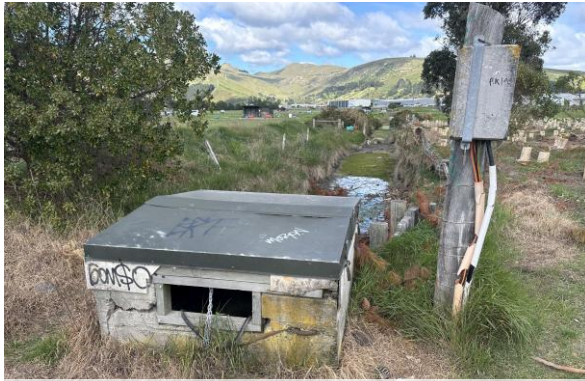
Structure 1: Unnamed Waterway

Aquatic habitat is minimal upstream of the structure, and thus, the structure is a low priority for fish passage remediation. However, removal of the structure would facilitate additional saltwater ingress into the surrounding paddock area, in line with CCC's long-term plans to enhance the ecological values of the area (Ferrymead Park Development Plan Stage 2, December 2023). Increased connectivity with the estuary would help restore the area to a more natural state, providing fish habitat, supporting the expansion of saltmarsh vegetation, and delivering significant benefits for shore and wading birds (Pers. Comm., Robbie Hewson, CCC, September 2025). Naturalisation of the upstream channel could further enhance these values.

The hydrological impacts of removal would need to be modelled to assess potential changes in upstream flood risk (Pers. Comm., Emily Tredinnick, CCC, September 2025). CCC is also considering a lidar survey to provide elevation data for the paddocks and to identify low-lying land suitable for wetland restoration (Pers. Comm., Robbie Hewson, CCC, September 2025). Together, hydrological modelling and lidar analysis would provide an understanding of the potential flood risk, while also identifying the potential ecological benefits, associated with the removal of the structure.

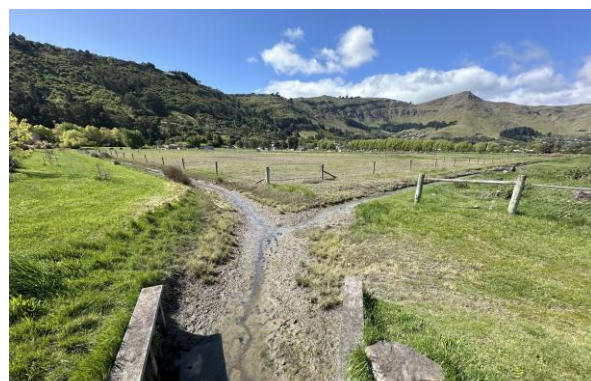
Structure 5: Munning Habitat

This structure includes two top-hung flap gates. At the time of our site visit (10 October 2024), they were moving freely and appeared to be functioning as intended. Under baseflow conditions, they rest in almost completely closed position and thus, they are a high risk to fish passage. Aquatic habitat is extremely limited upstream of the gates (Figure 11), and therefore, they are low priority for fish passage remediation. However, removal of these gates may increase saltwater ingress into the paddocks upstream, and facilitate the establishment of salt-marsh vegetation communities. While the removal of these gates is likely to improve ecological values in the area, through the promotion of salt-marsh vegetation, we recognise that the sections upstream are beyond the extent of the Ferrymead Park Development Plan Stage 2 (December 2023) and are currently actively grazed.
