Akaroa Main Wharf Replacement, Akaroa Archaeological Assessment

Prepared for Christchurch City Council

Status: Final

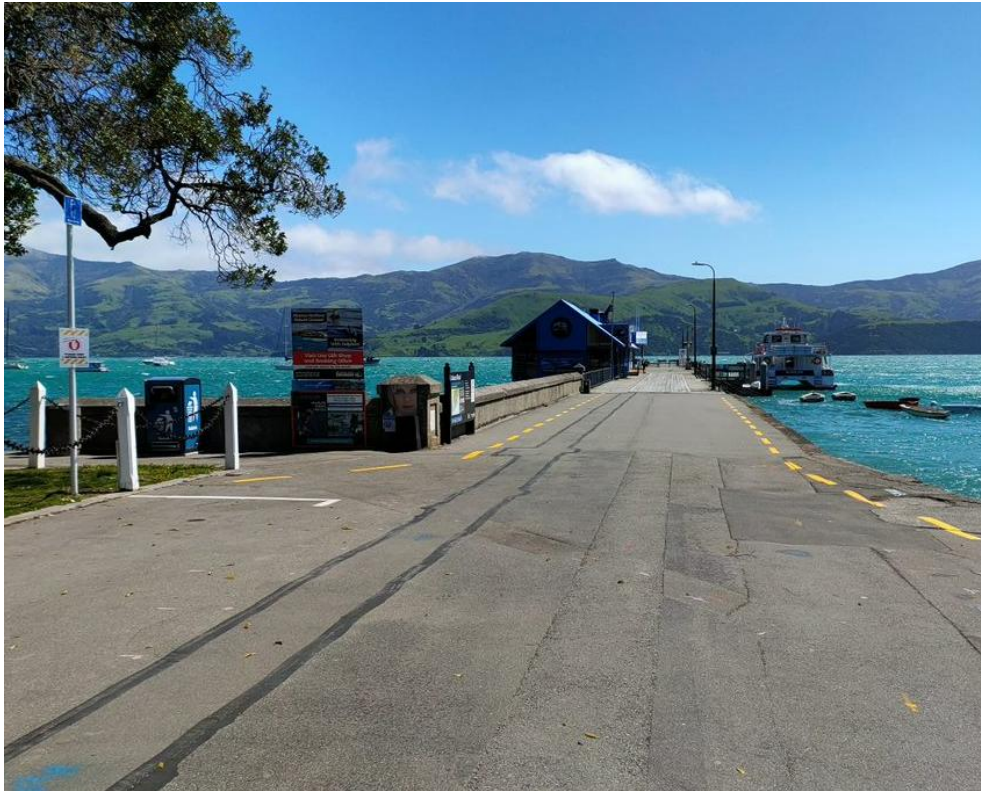
Figure 64. View of concrete abutment portion of Akaroa Main Wharf taken from the landward approach to the wharf. Visible in the image is the concrete parapet wall that tops the concrete abutment of the north side of the structure (to left in image). The grassed area on left of image is part of Britomart Reserve. The image was taken looking west. Source: SIA 2021.

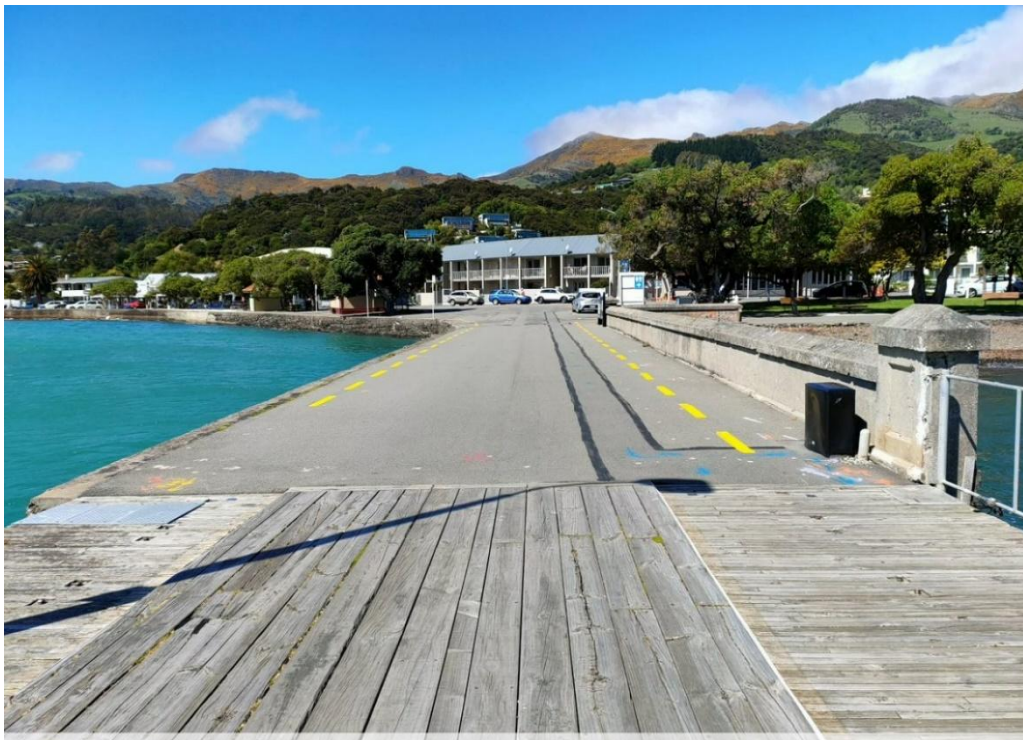
Figure 65. View of concrete abutment portion of Akaroa Main Wharf taken from the timber portion of the wharf. The wharf approach is on the landward side of the wharf. Visible in the image is the concrete parapet wall that tops the concrete abutment of the north side of the structure (to right in image). The image was taken looking east. Source: SIA 2021.

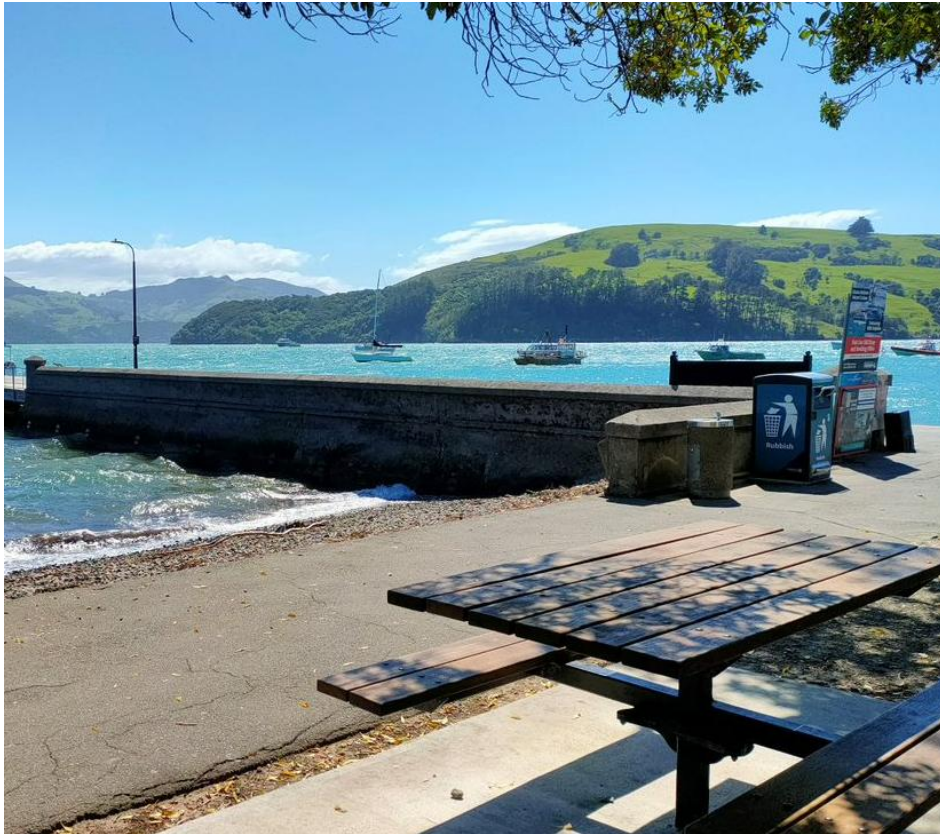
Figure 66. View of south elevation of the concrete abutment of the Akaroa Main Wharf. Visible in the image is the main concrete portion topped by concrete parapet wall. Image also shows an associated protective concrete wall running a short distance along the foreshore atop the sea wall. The image is taken looking northwest. Source: SIA 2021.

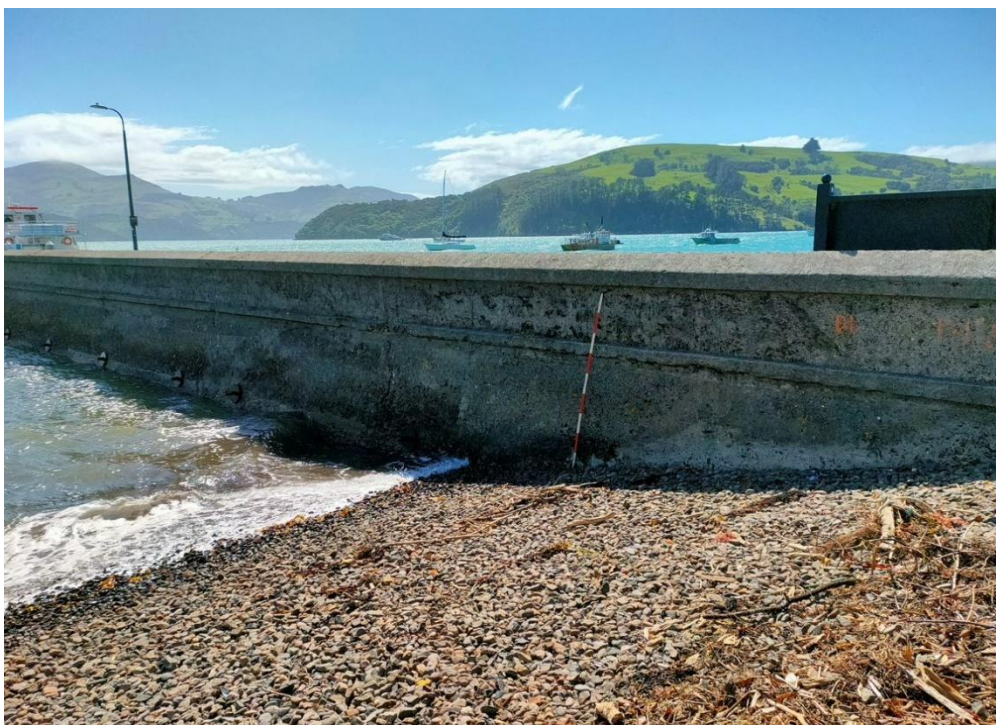
Figure 67. View of south elevation of the concrete abutment of the Akaroa Main Wharf. Visible in the image is the main concrete portion with parrass plates towards its lower portion. The main concrete portion is topped by concrete parapet wall. At the base of the parapet wall is a protruding and extended concrete kerb and the wall is topped by chamfered pier caps. The image is taken looking north. Source: SIA 2021.

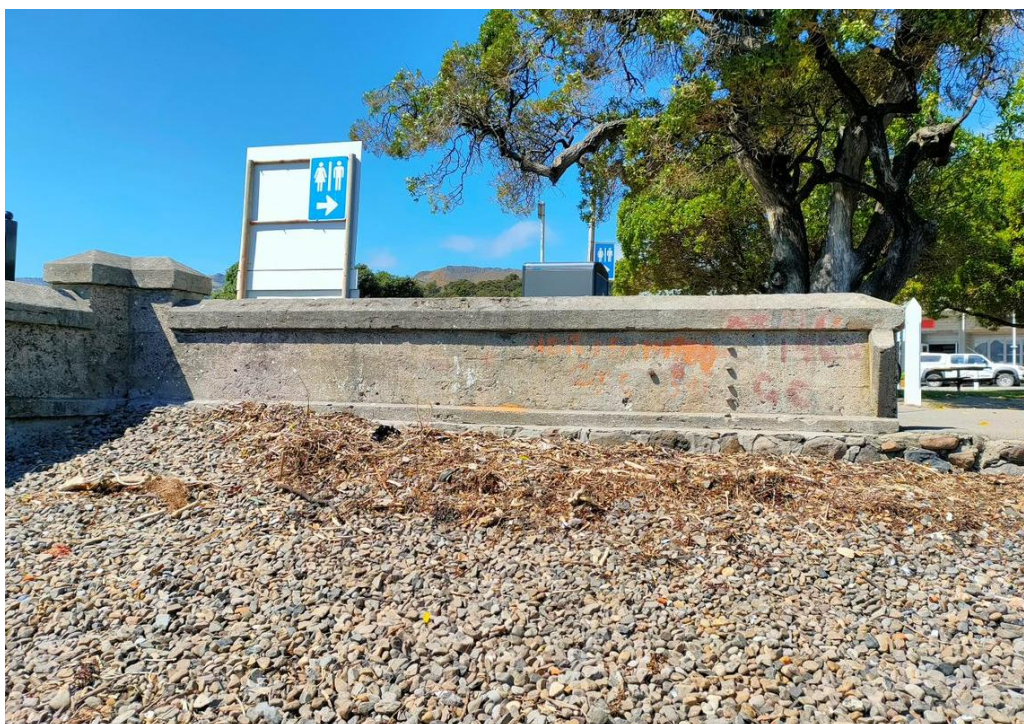
Figure 68. View of protective concrete wall running a short distance along the foreshore. It appears to be constructed atop a buried portion of the Akaroa Sea Wall. The image is taken looking east. Source: SIA 2021.

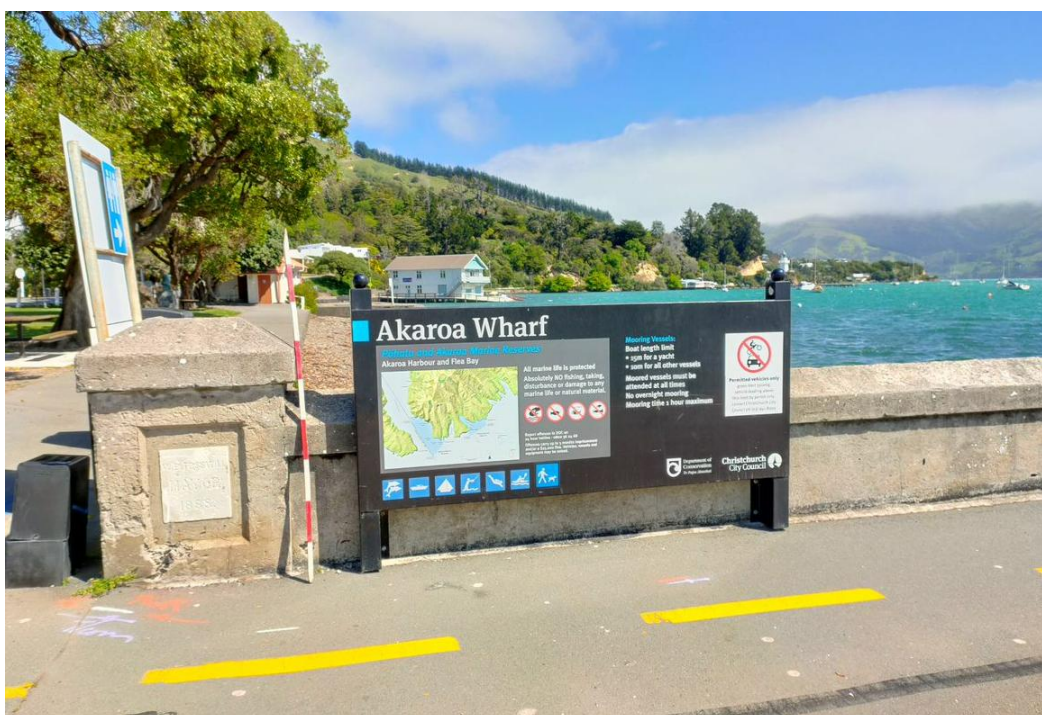
Figure 69. View of interior side of parapet wall on southern side of concrete abutment of the Akaroa Main Wharf. The marble date plaque with the name of the Mayor, W. B. Tosswill is on left side of image. The incised letters and small drill holes indicate that the plaque should have lead lettering, and this has either fallen out or been removed. Image was taken looking south. Source: SIA 2021.

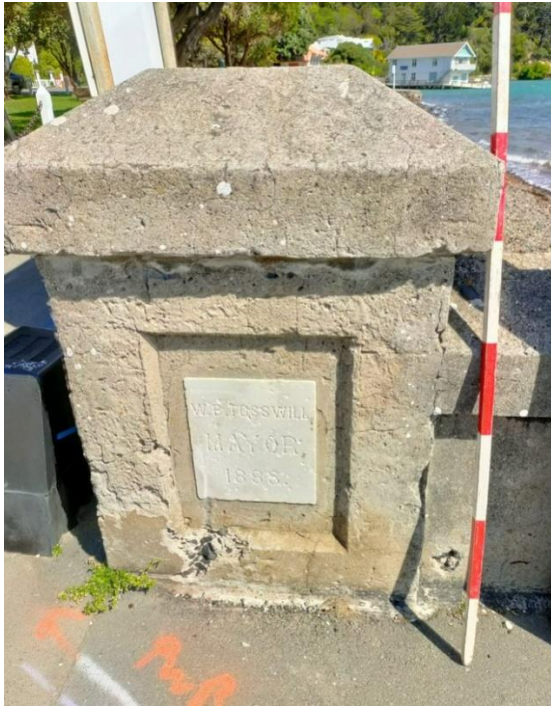
Figure 70. View of marble date plaque with the name of the Mayor, W. B. Tosswill. The incised letters and small drill holes indicate that the plaque should have lead lettering, and this has either fallen out or been removed. The image was taken looking south. Source: SIA 2021.

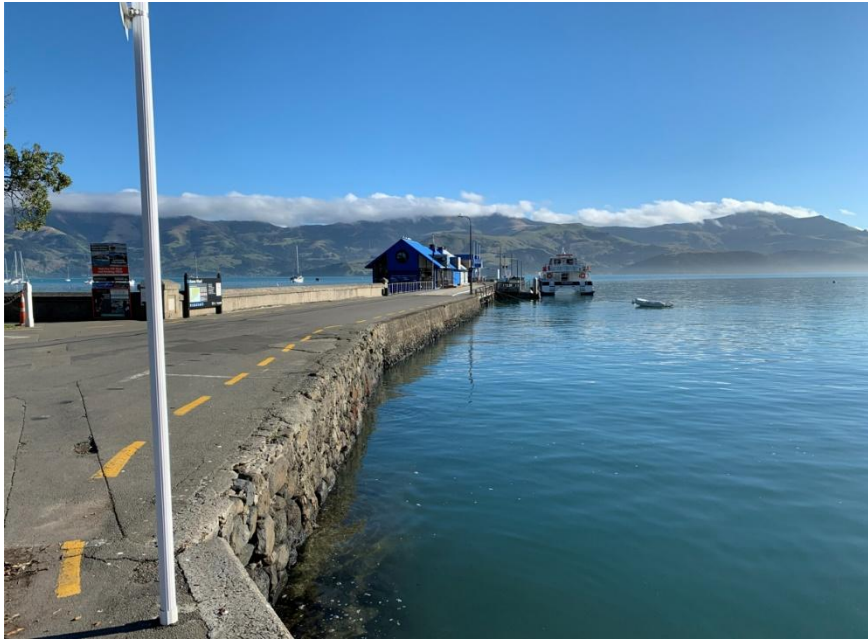
Figure 72. View of junction of Akaroa Sea Wall and north facing elevation of Akaroa Main Wharf (concrete abutment). The image is taken looking southwest. Source: SIA 2021.

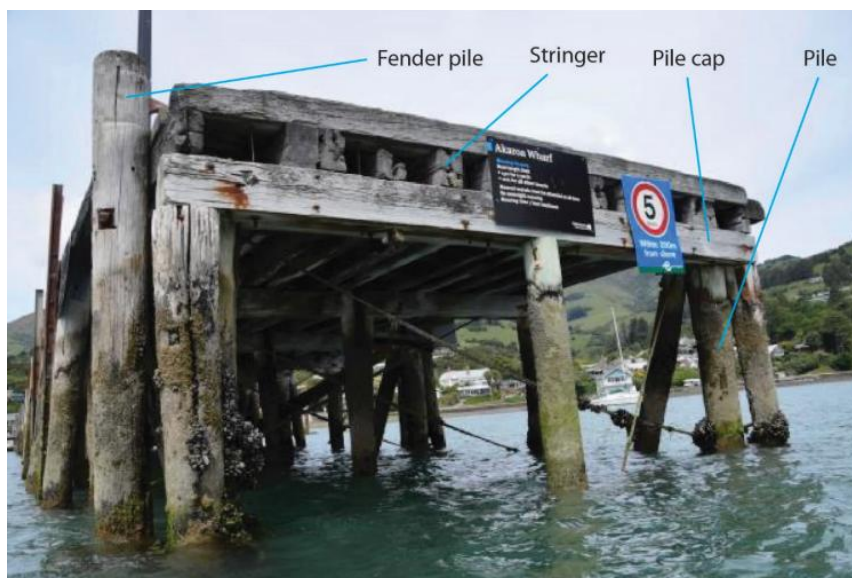
Figure 73. The end of the wharf with the principal parts of the structure identified in Origin report (2021). The whole assembly of the five piles with the pile cap running across them comprises a single 'bent.'

Only a small amount of hardwood timber bracing, which may be original or date back to the 19th century, seems to remain. This is located at the inner end of the wharf (see Figure 73). This bracing appears to be in poor condition. Most of the original hardwood bracing appears to have been replaced by steel tension only bracing, presumably in the 20th century (see Figure 77).

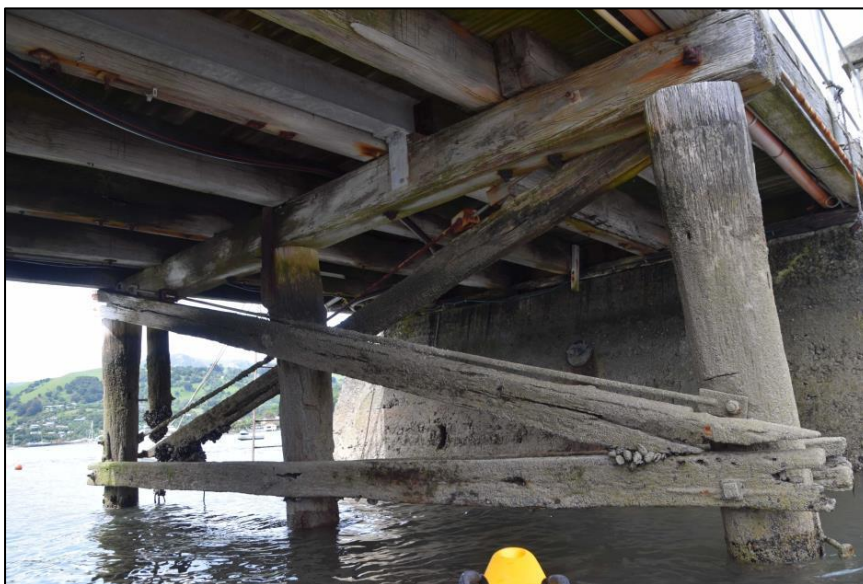
Figure 75. The first bent and the stringer/deck connection to the abutment. This part of the structure contains many original elements, including the pile cap, central pile with wrought iron strap connection to the cap, bracing timbers and horizontal wale between the piles, and timber stringers between the pile cap and modern decking boards (Origin 2021).

Stringers or 'floor beams' provided a place to fix the wharf decking. Section and elevation details in the original wharf drawings show how the piles and bracing were to be installed with iron fixings. A review of images taken by Origin (2021) of the underside of the timber wharf structure indicates that many of the stringers have been replaced or made redundant by the addition of galvanised steel stringers. When original stringers are present (see Figures 73, 75, 78), they appear to generally be in moderate to poor condition with early stages of decay and the condition deteriorating towards the seaward side. The pile capping beams across all bents appear to be hardwoods (likely to be ironbark) and appear to be consistent with the original construction drawings. They are mostly in moderate condition with early signs of decay (Figures 75-76).

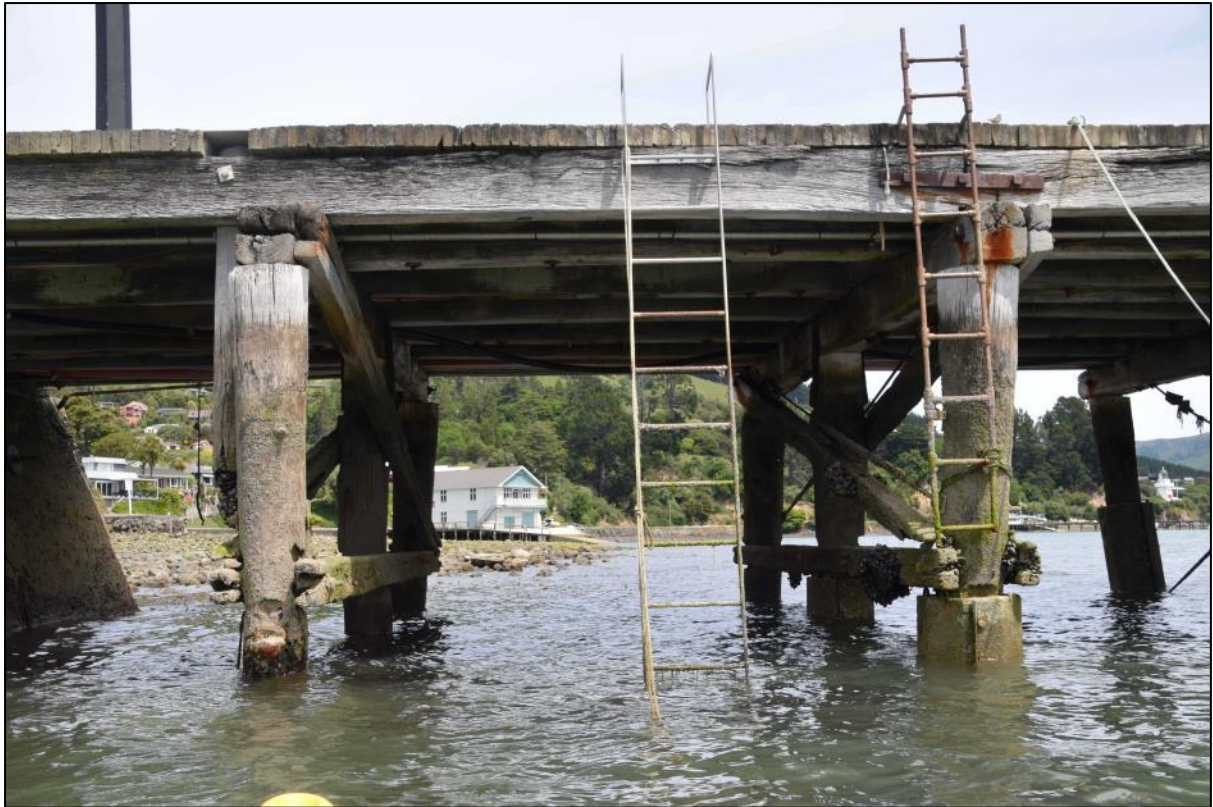
Figure 76. Three pile 'bents' under the eastern end of the wharf close to the abutment. Note the diagonal, timber braces, horizontal timber ties beneath the braces, and later steel rod braces. The original construction can be clearly seen here with timber pile caps (beams) running along the heads of the three piles in each bent and the timber stringers and decking on top. There are no fender piles to this part of the wharf. Ladders are a late 20th century addition (Origin 2021).

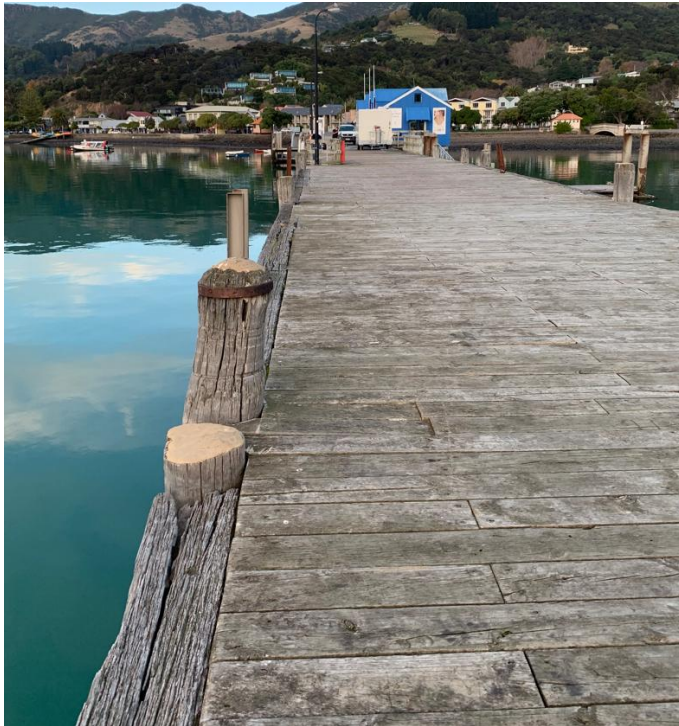
The deck appears to be a mixture of 20th century timber and concrete. The sources consulted indicate that the decking was a major item of replacement in the 20th century. However, there is a possibility that original decking survives in places where concrete surface was installed over it. The decking is framed by timber deck kerbs varying from poor to moderate condition (Figure 79). Some of these kerbs may be original and survived deck replacement in the 20th century.

Figure 79. Timber deck kerb on outer edge of the deck planks. Source: South Island Archaeology 2024.

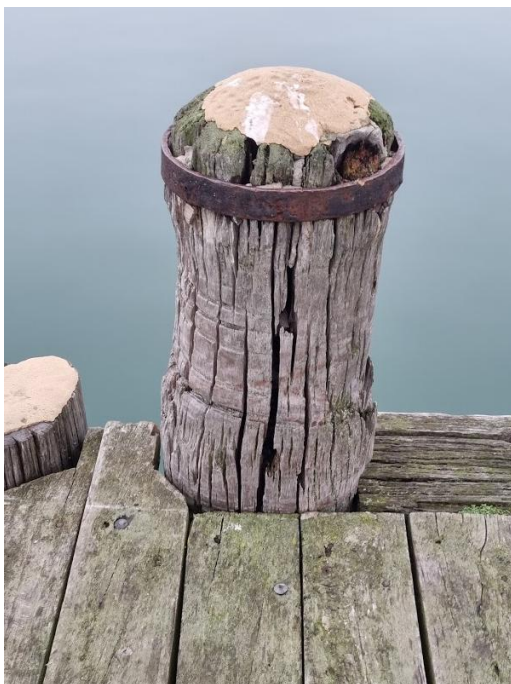
The original drawings and a 1907 photograph of the Akaroa Main wharf showed that every third pile of the wharf also served as a mooring post or 'bollard' that was finished with a metal, likely wrought iron, band (Figure 26). These mooring bollards had a slight hour-glass shape so that they had a wider diameter at the top; this was done to reduce the likelihood of mooring warps ('dock lines'), from working loose from the bollard. One possible 19th century mooring bollard survives on the east side of the wharf's timber deck (Figure 79-80).

Figure 80. Mooring pile with iron band. Source: South Island Archaeology 2024.

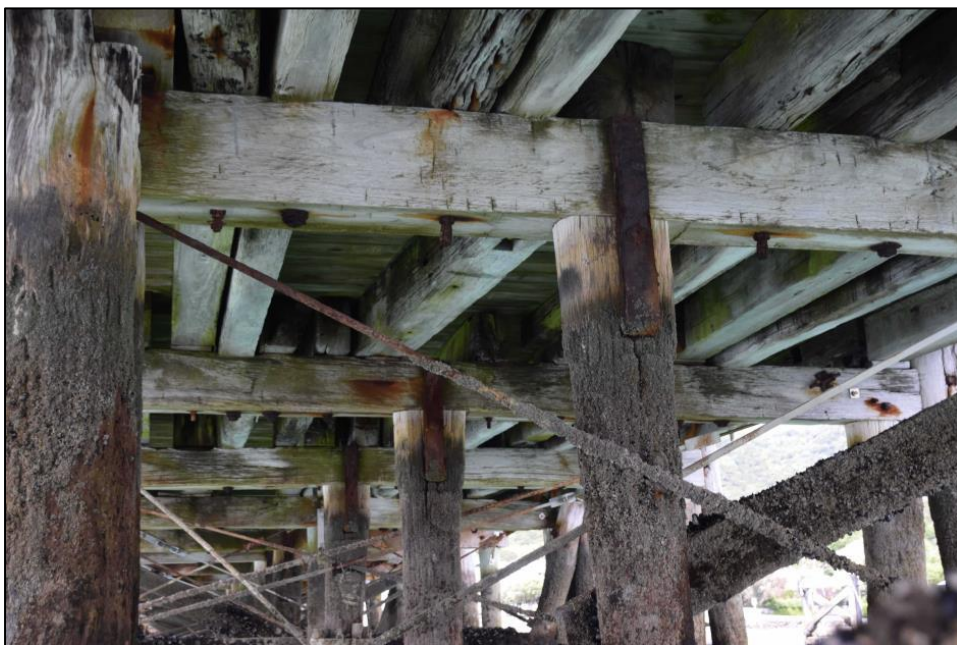
The sources indicate that the original wharf ironwork for fixings and fittings was imported from England. Some pre-1900 elements are evident in some potential surviving wrought iron strap connections that tie the pile caps to the piles, although they are showing signs of corrosion and decay (Figure 81). There is also evidence that original iron bolts and iron bands are present throughout the structure (Figure 82-83). In addition to this there is evidence for the use of joinery techniques on some of the original timbers including presence of mortise and tenon joints (Figure 84).

Figure 82. Original wrought iron strap connections between the central piles and their pile cap. The joints also have a mortise and tenon (Origin 2021).

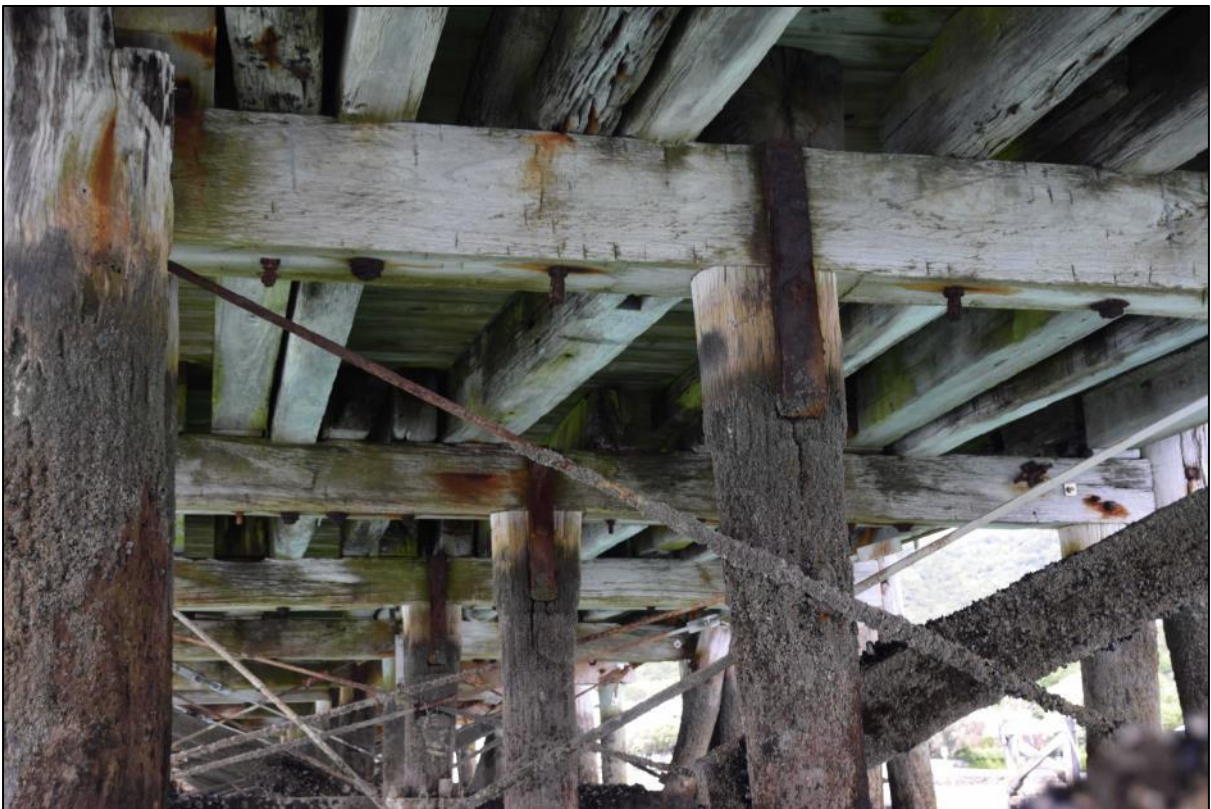
Figure 84. Original wrought iron strap connections between the central piles and their pile cap. The joints also have a mortise and tenon (Origin 2021).

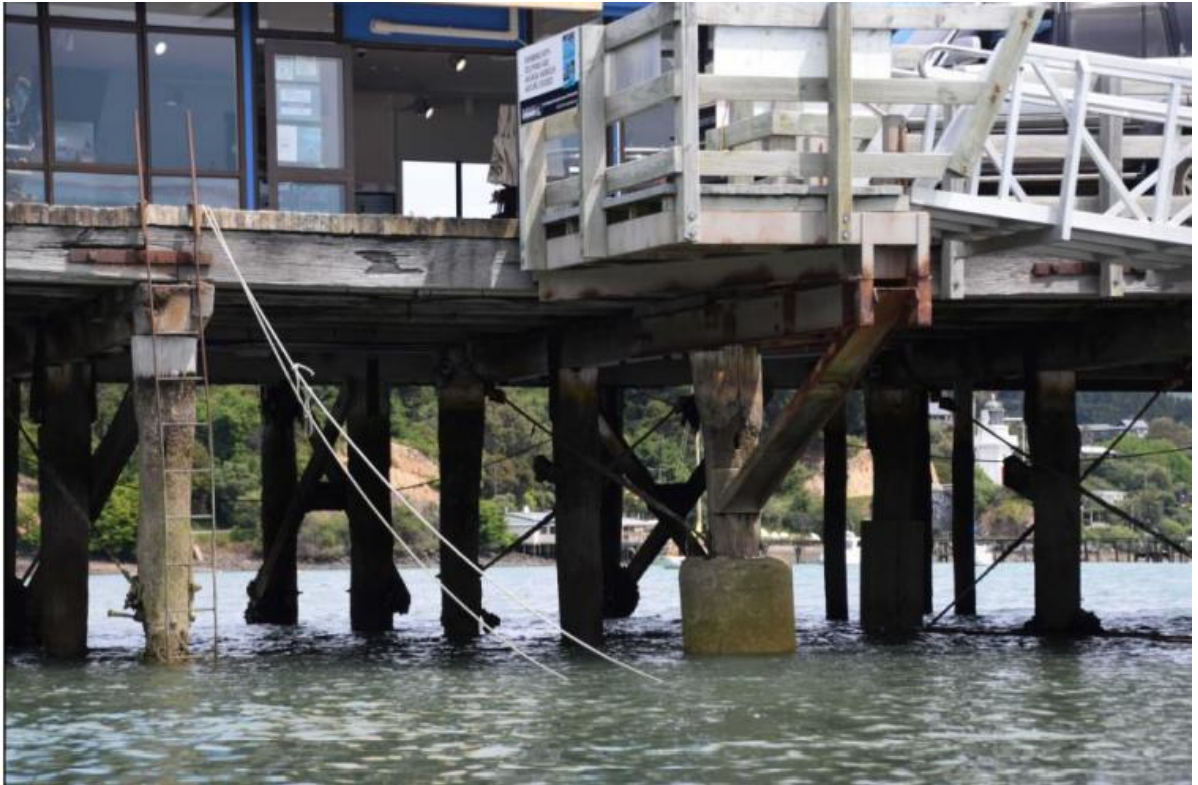
Figure 86. Alterations on the north side of the wharf with steel added to support the gantry to the floating pontoon and concrete cast to the base of the pile supporting the steel framing (Origin 2021).

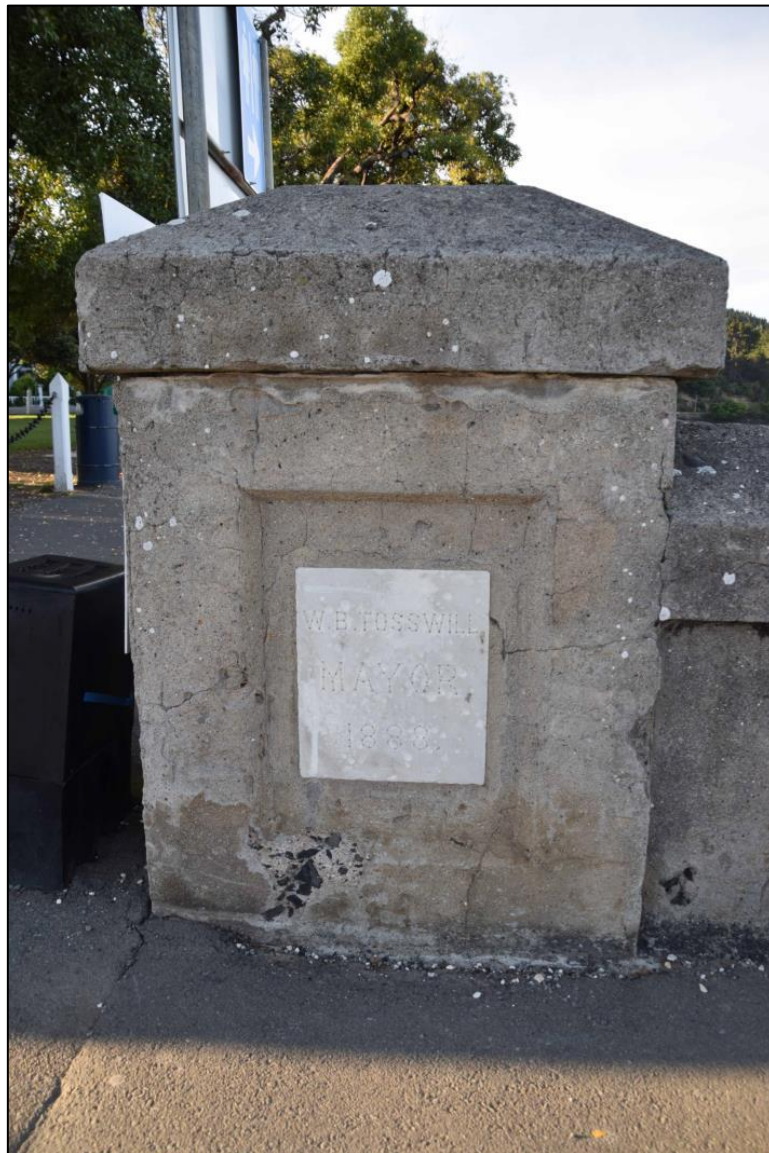
Photo 1 The marble date plaque with the name of the Mayor, W. B. Tosswill. The incised letters and small drill holes indicate that the plaque should have lead lettering and this has either fallen out or been removed.

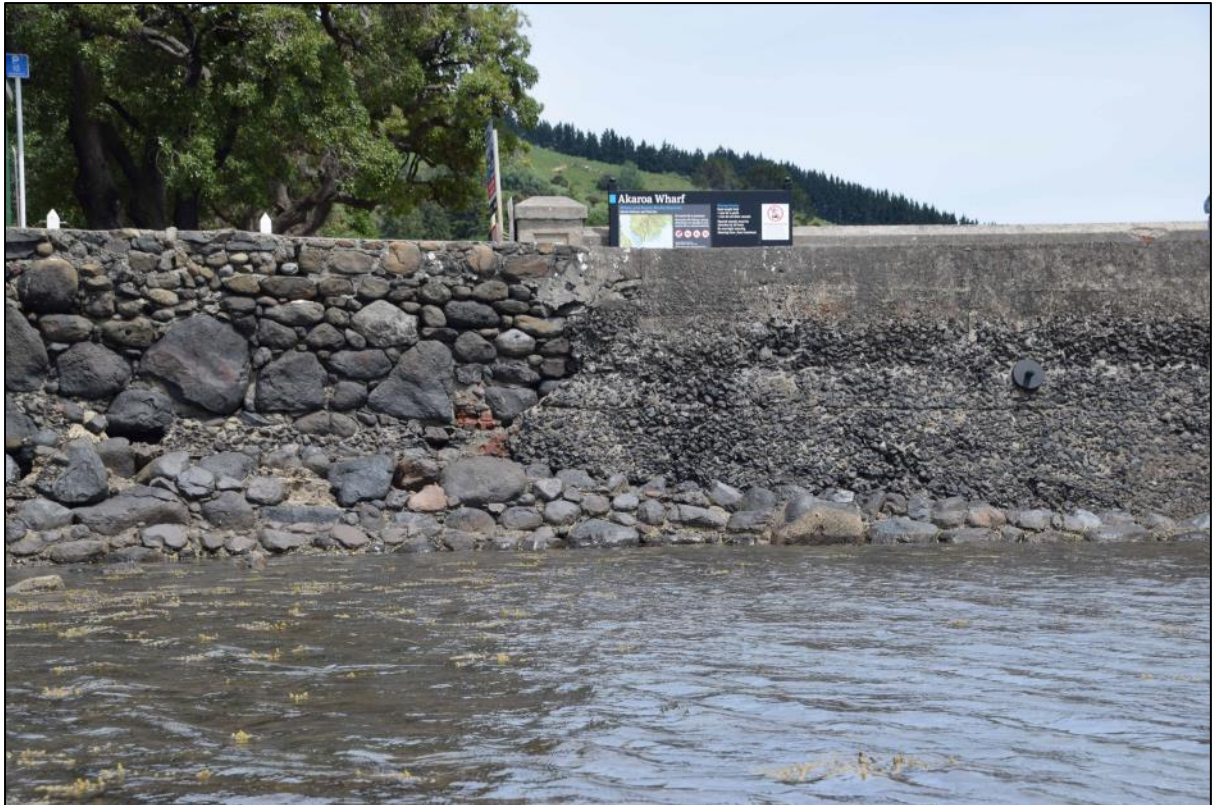
Photo 2 The north face of the seawall at the junction of the abutment and Reserve.

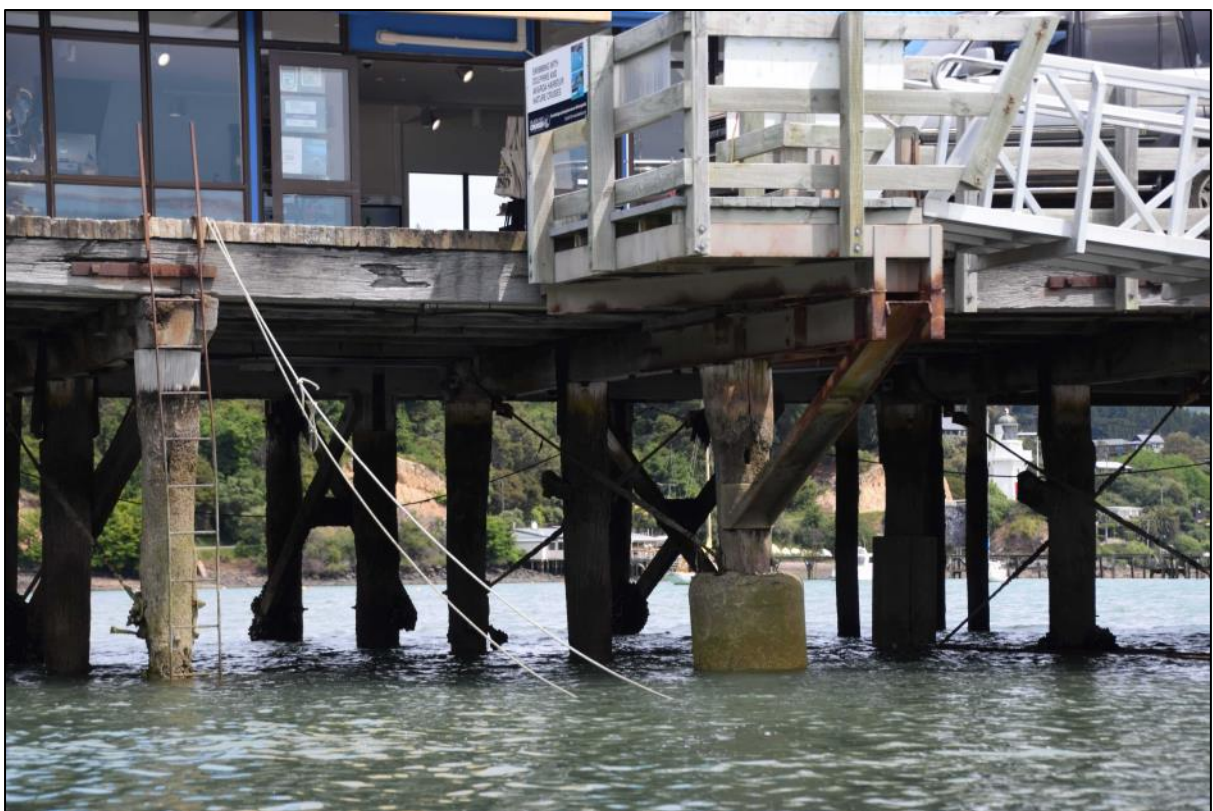
Photo 7 Further alterations on the north side of the wharf with steel added to support the gantry to the floating pontoon and concrete cast to the base of the pile supporting the steel framing.

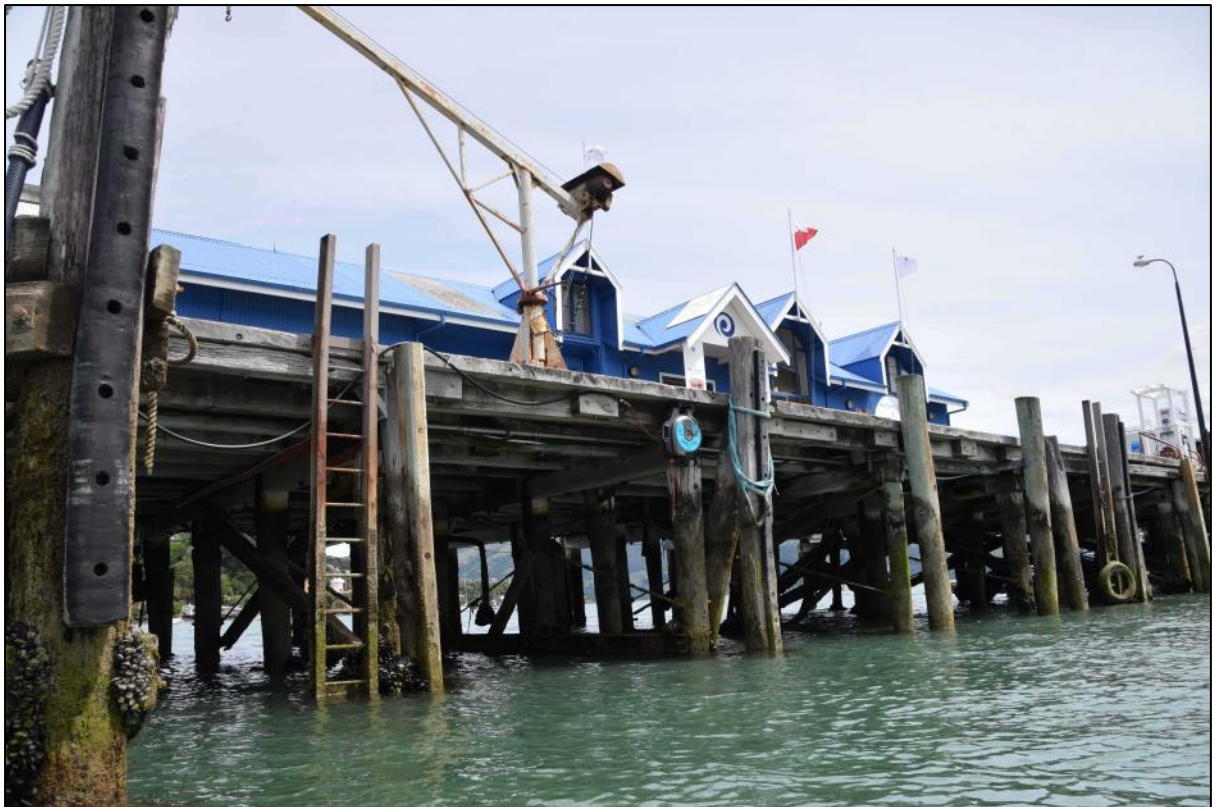
Photo 8 The north side of the wharf beyond the floating pontoon with modern ladders and replacement tanalised fender piles. The width of the wharf has substantially widened to accommodate the late 20th century sheds. Refer to Photo 9 below regarding the pile in the foreground on the left of the image.

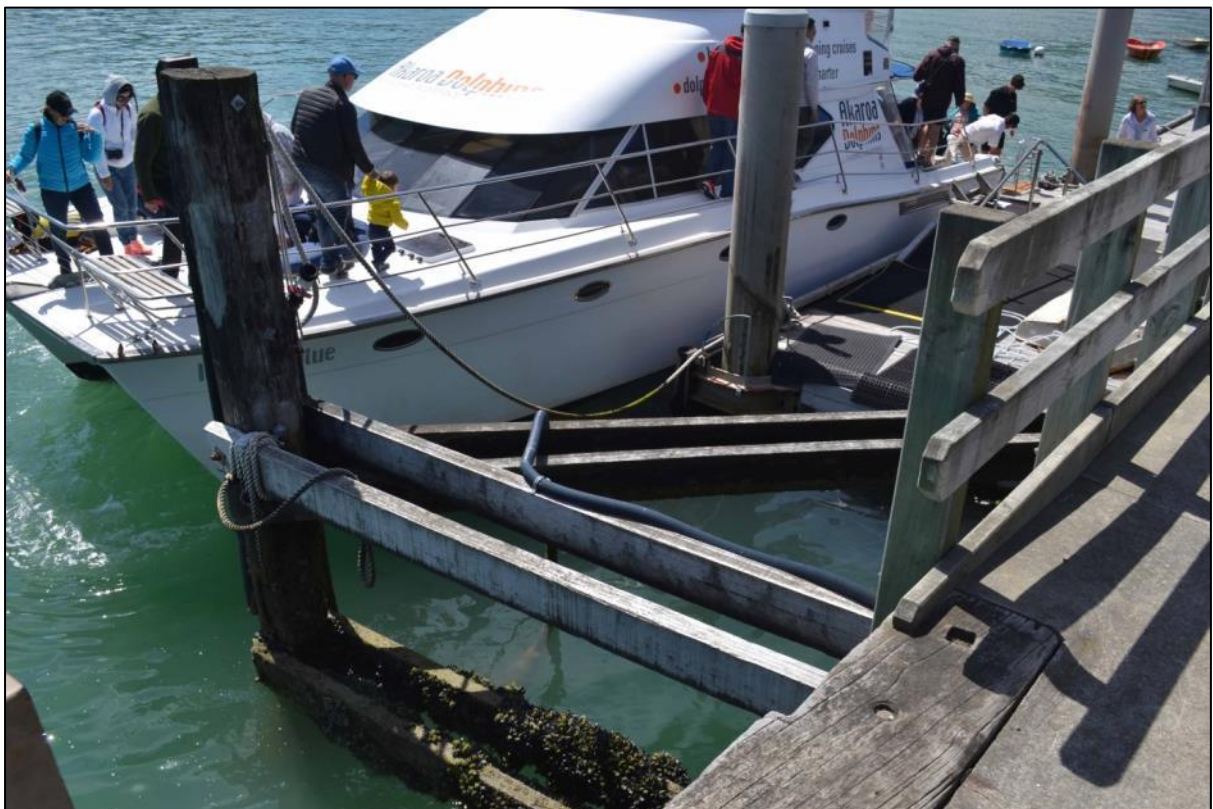
Photo 9 This older pile on the left appears to relate to the former projecting platform and main steps to water level that previously existed on the north side of the wharf.

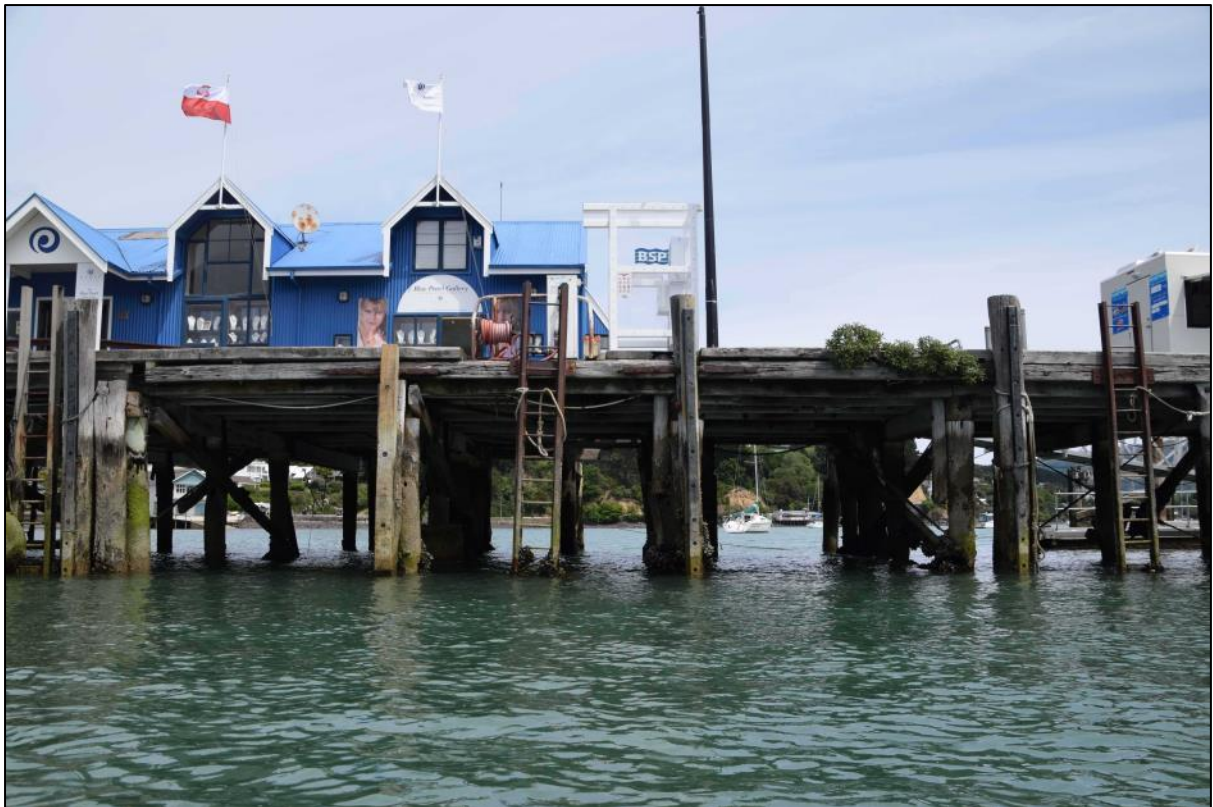
Photo 10 The end of the shed and the BSP fuel station. On the far right is a tethered caravan selling fresh fish. The outer piles here have had modern fenders added.

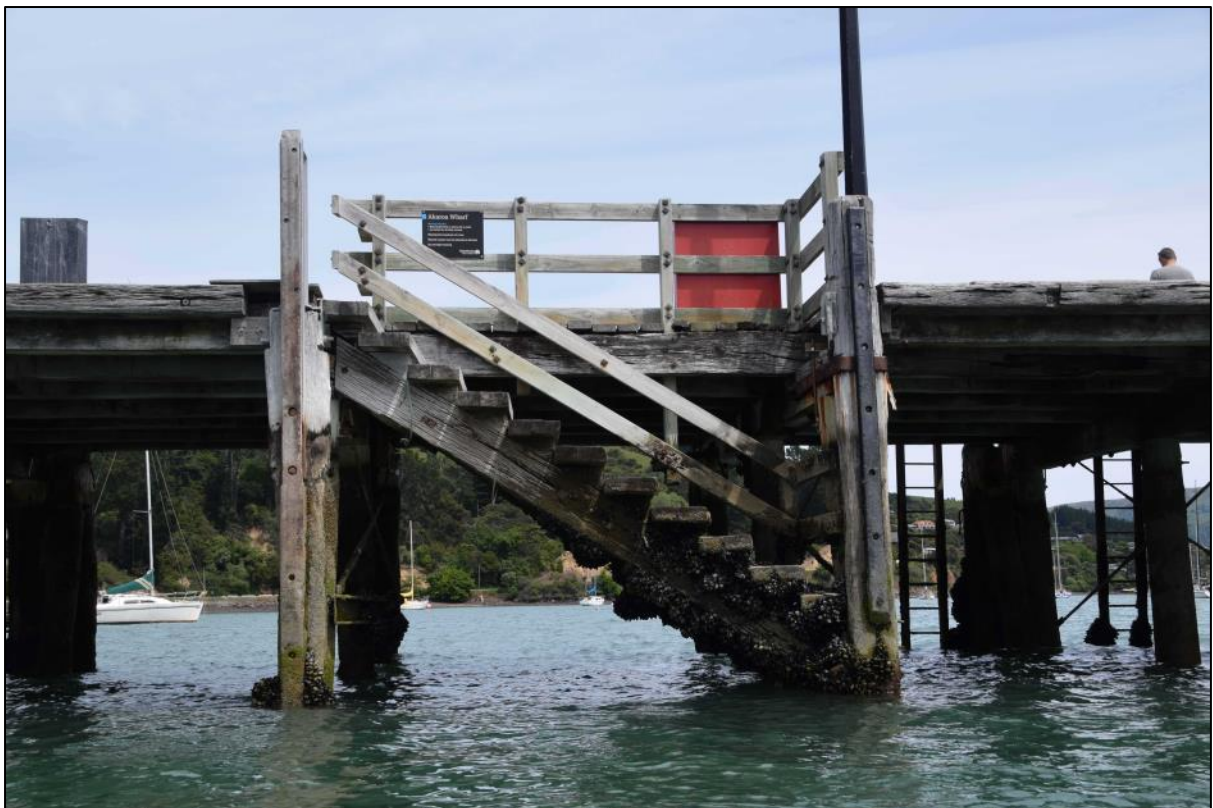
Photo 11 The location of these steps does not relate to the original design of the wharf. They are thought to be a post-1973 alteration. The steps have a tanalised bare timber barrier and handrails (there are similar elsewhere on the wharf).

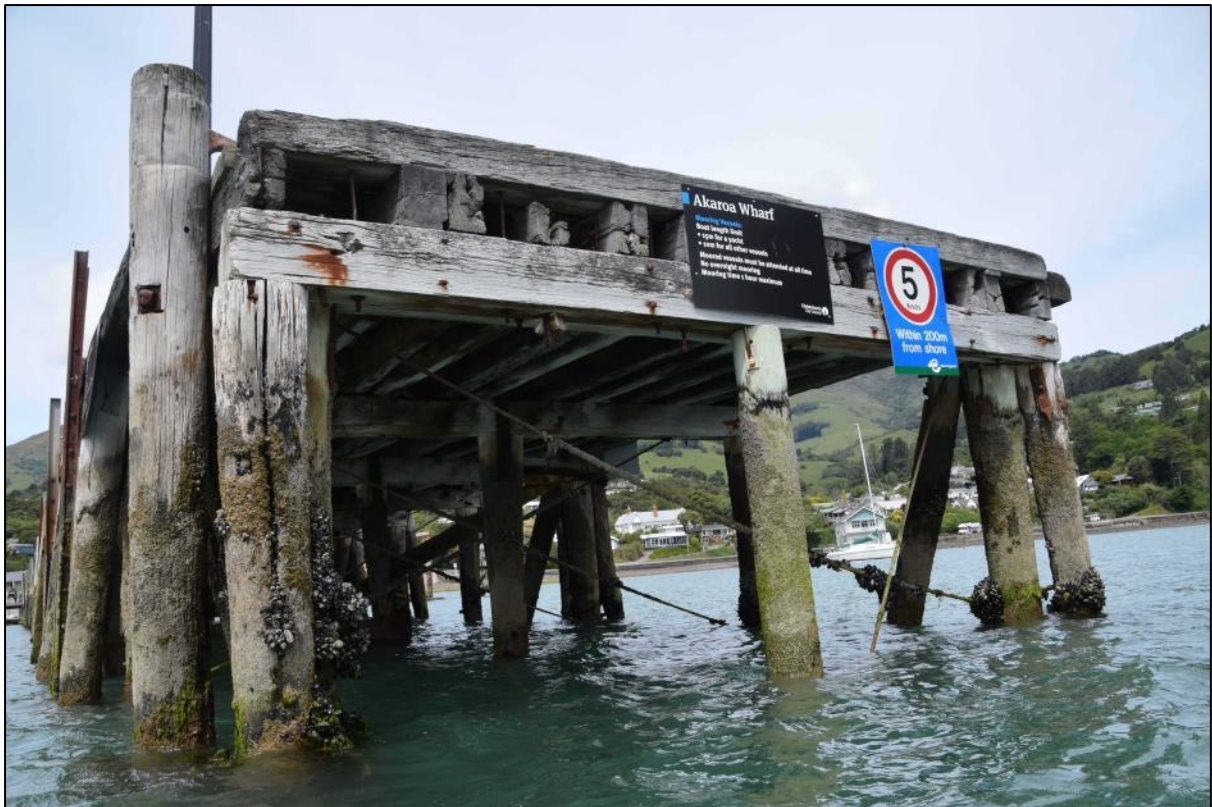
Photo 12 The outer/west end of the wharf clearly showing the original construction, although with some replacement tanalised piles. Along the top of the piles is the timber pile cap (beam). On top of that are the stringers and running parallel to the cap is the timber kerb with the timber decking behind it. On the far left and far right are fender piles and each corner has an inner bracing pile.

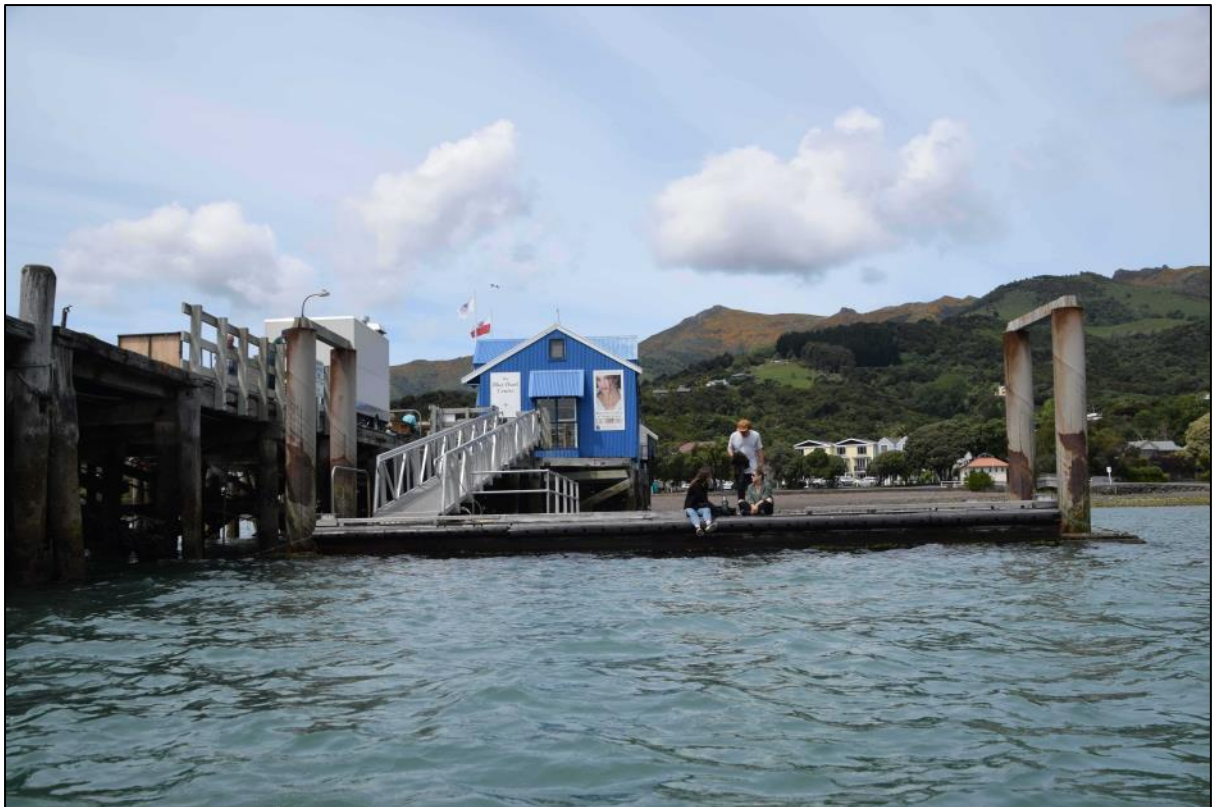
Photo 14 The floating pontoon on the south side of the wharf.

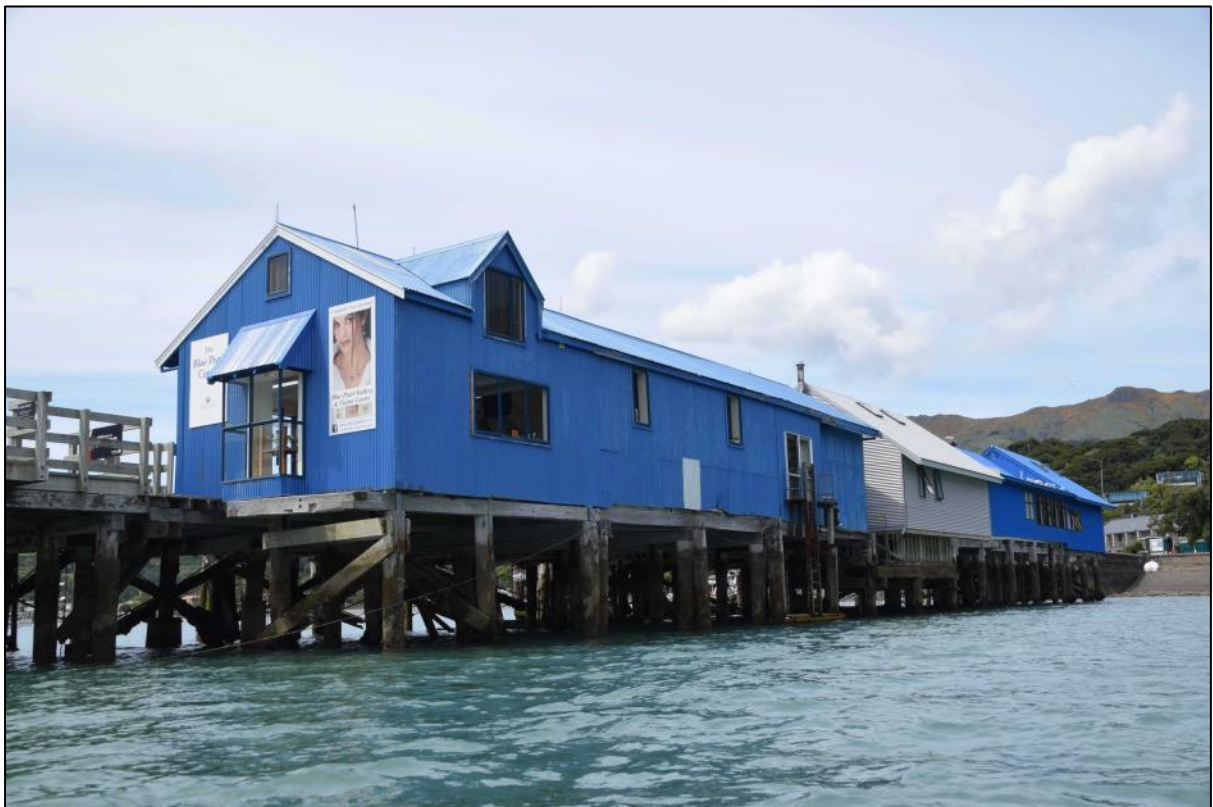
Photo 15 The line of modern sheds on the south side of the wharf running from the 6th bent from the abutment to the 21st and enveloping and extending the original sheds' footprint which ran from the 15th to 20th.
