Akaroa Main Wharf Replacement, Akaroa Archaeological Assessment

Prepared for Christchurch City Council

Status: Final

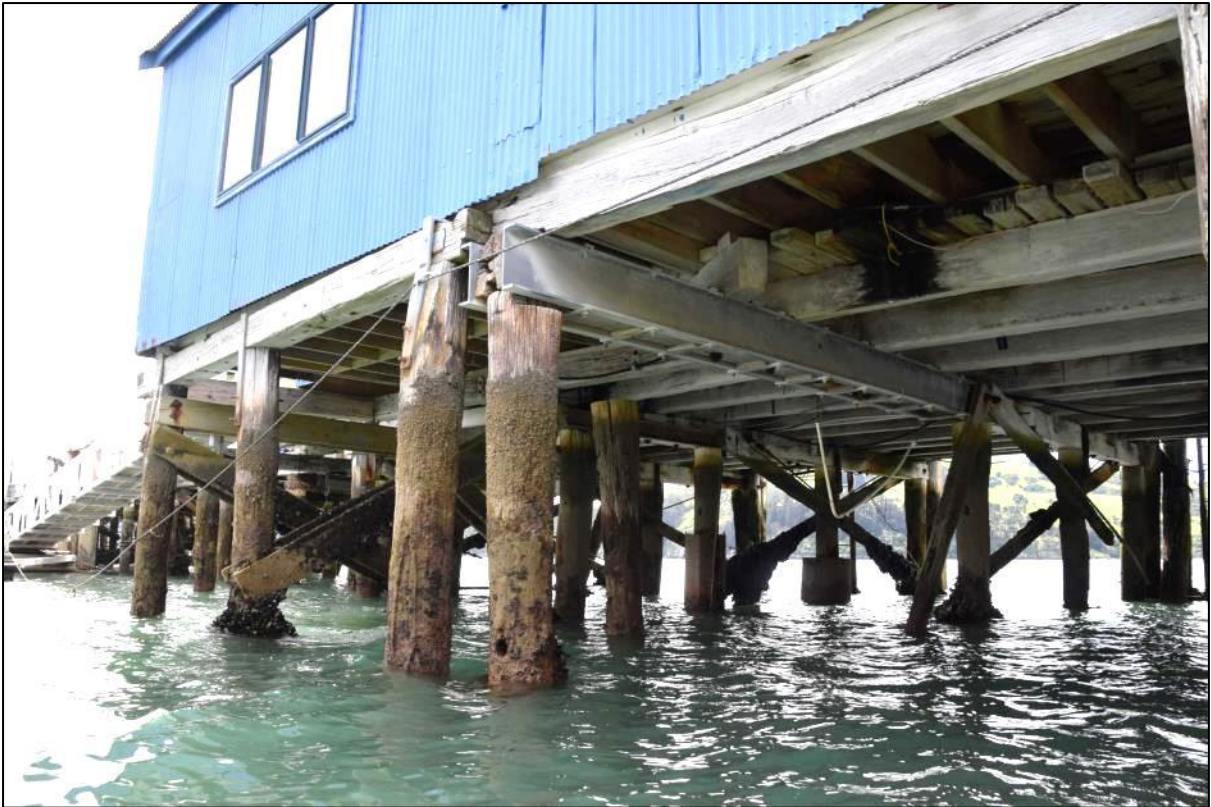
Photo 20 Steel beams either side of a pile cap. It is possible that the short section of diagonally-laid timber beam (cut face towards the camera) on top of the steel strengthening is where the original wharf structure narrowed at the end of the former wharf sheds.

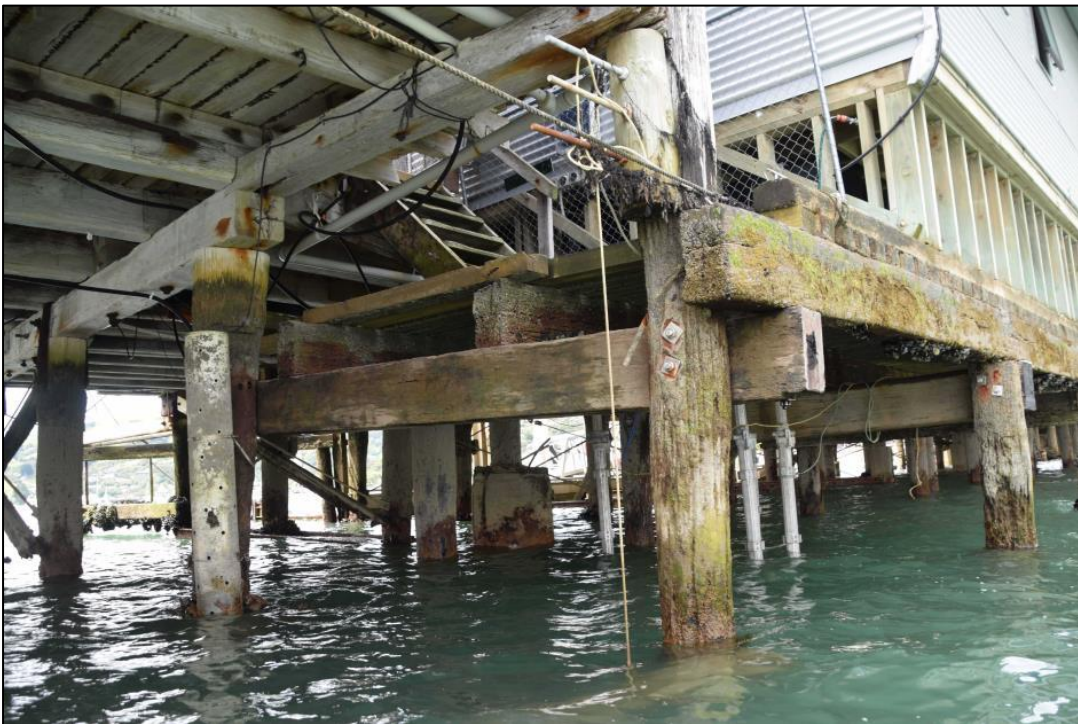
Photo 21 Between about bents 13 and 15 from the abutment, the south side of the wharf has been lowered in the past. None of the historic photographs show this lower and, hence, it seems to have been a 1970s or later alteration. In order to maintain the floor level, the corner of the modern shed (top right) has had to be built up on jack studs (with an area for services and plastic tanks below the floor). Note the steel props under the lowered deck.

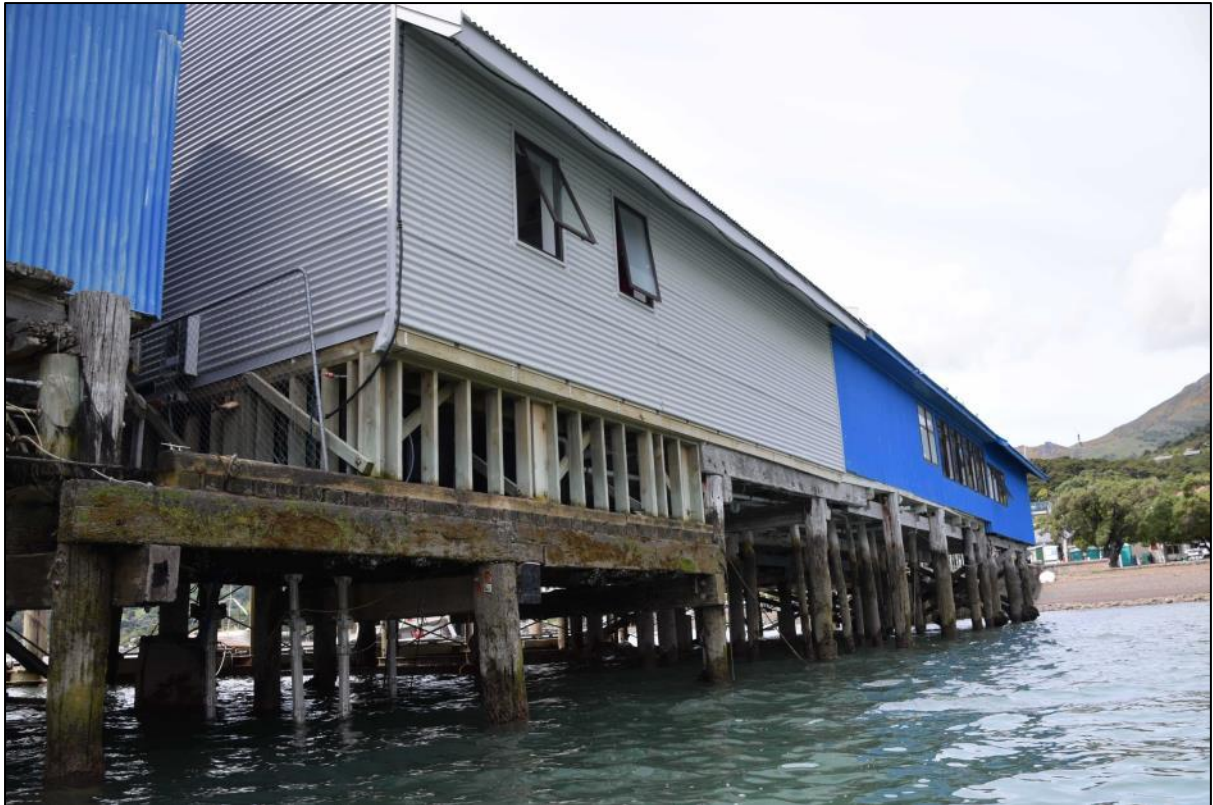
Photo 22 showing the lowered deck area (Photo 21) accessed by timber steps between the two sheds. Note the steel props under the lowered deck.

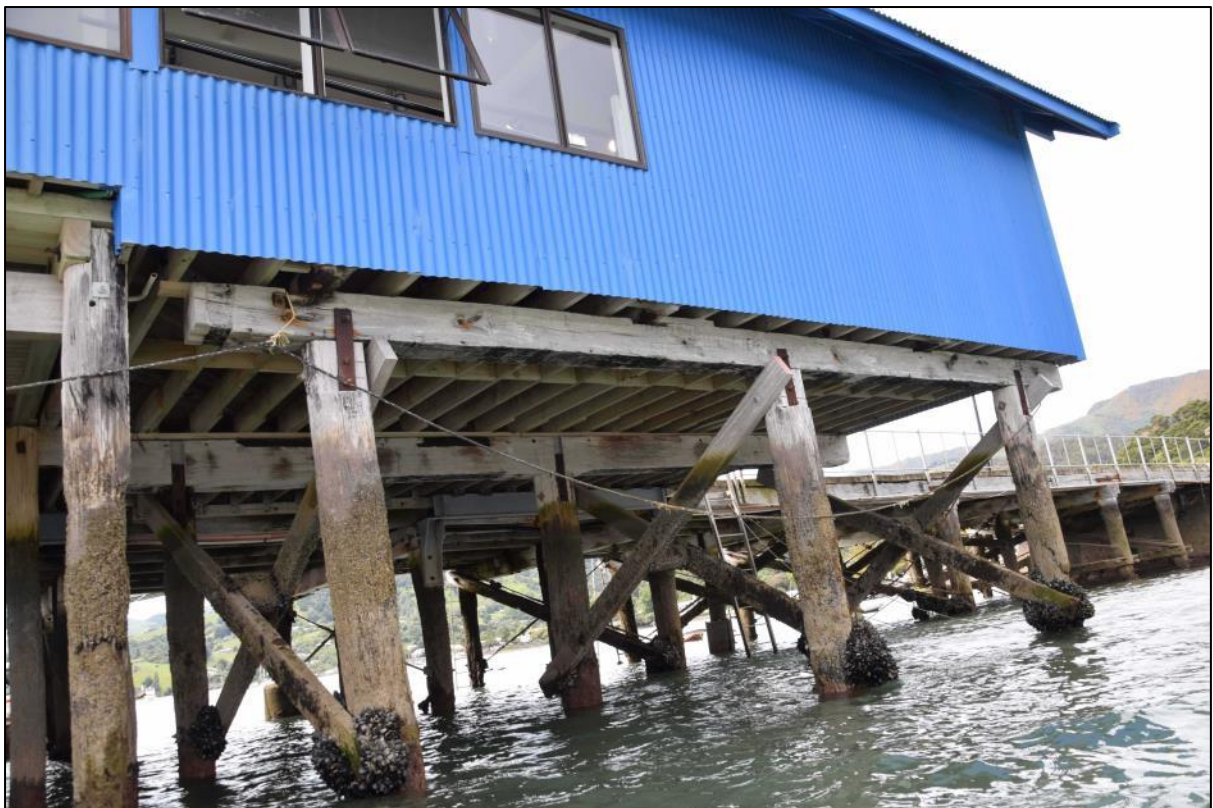
Photo 23 The modern sheds have extended the original sheds' footprint on the south side of the wharf substantially towards the abutment.

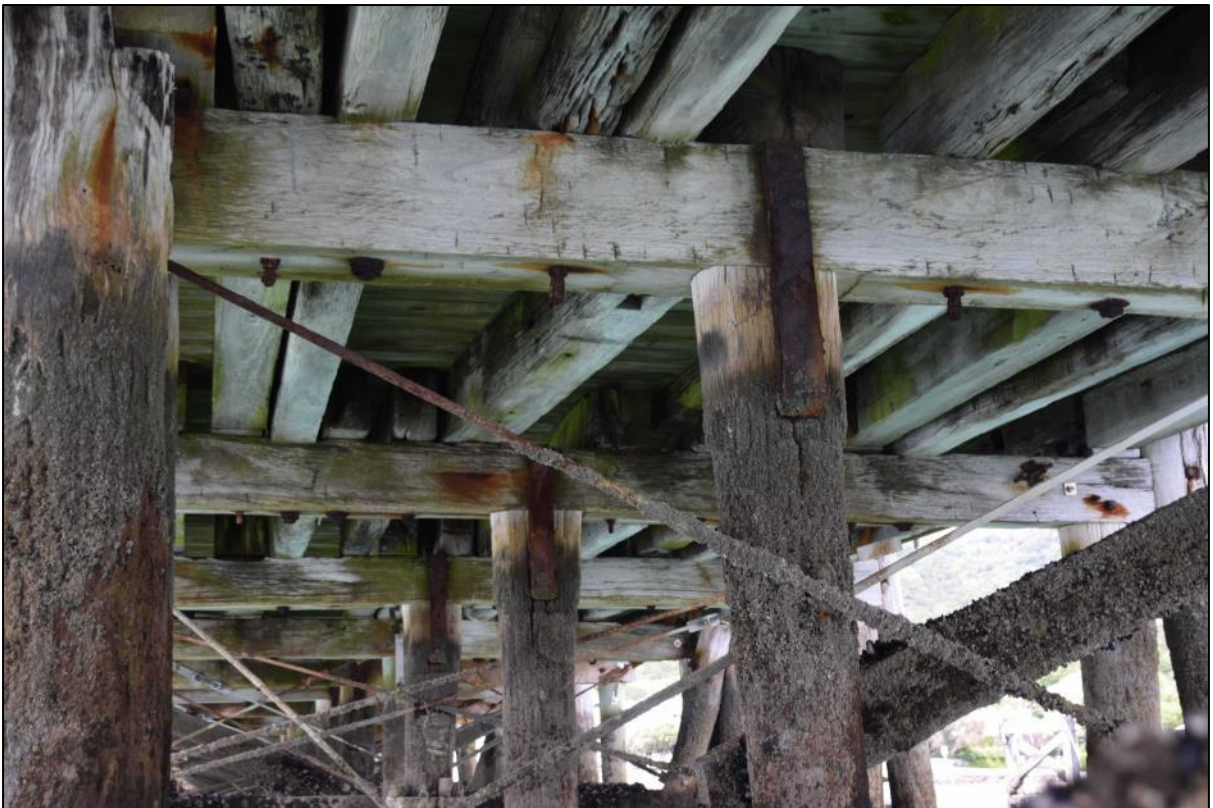
Photo 29 original wrought iron strap connections between the central piles and their pile cap. The joints also have a mortise and tenon.

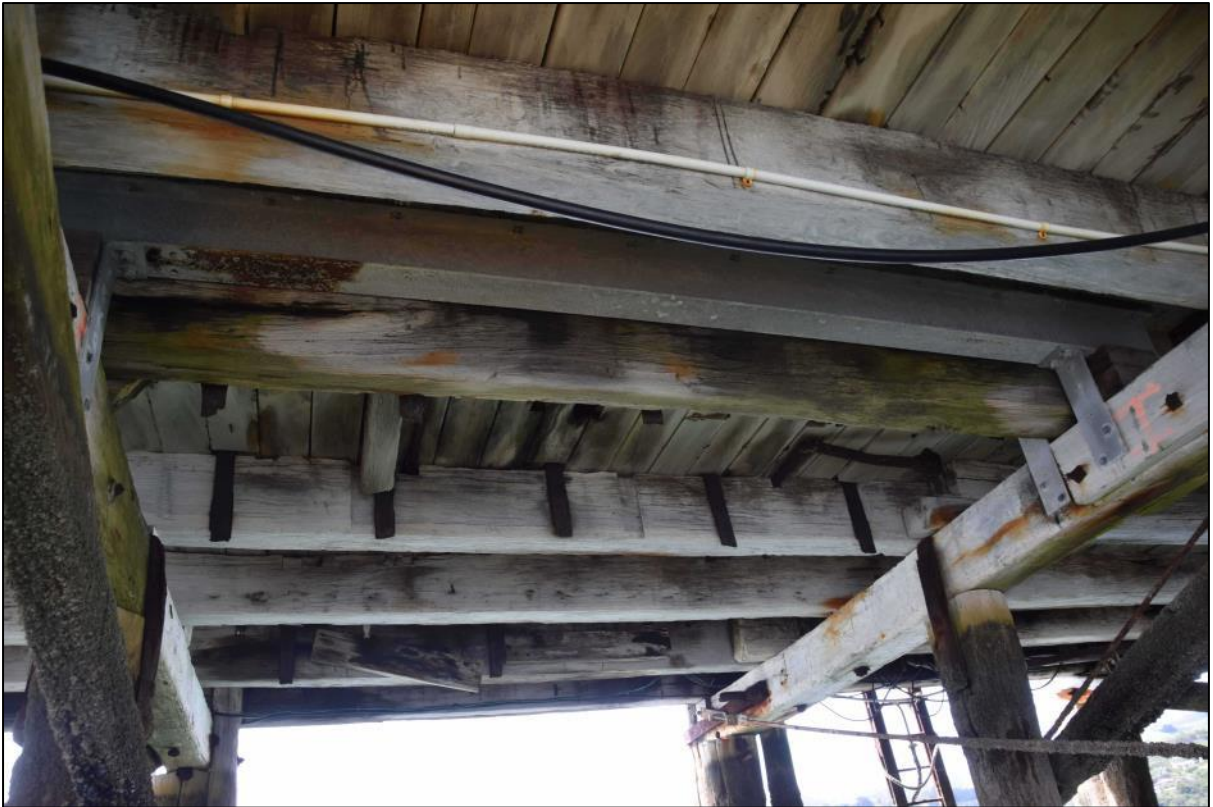
Photo 34 Steel stringer added.

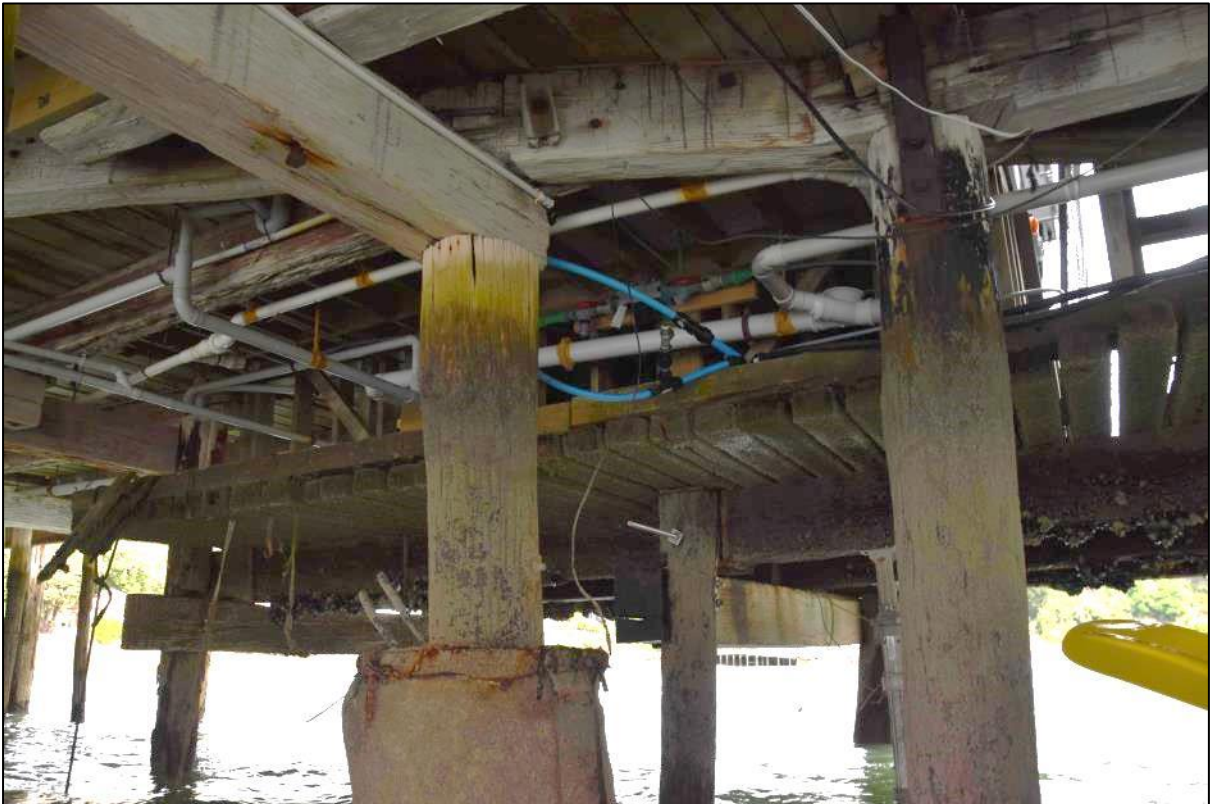
Photo 39 Tanks and modern piping on the lower deck area on the south side of the wharf (refer to Photos 21 & 22).

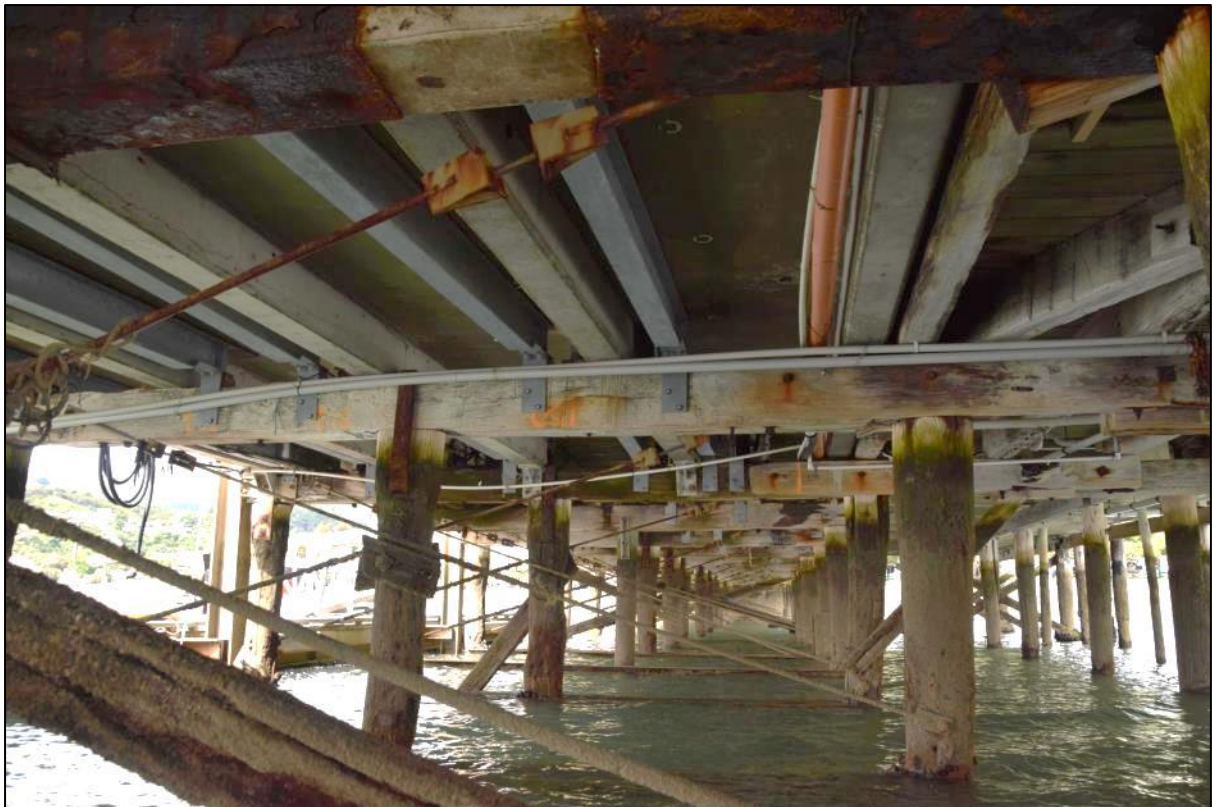
Photo 40 Substantial alterations/repairs with steel and concrete beams below the deck adjacent to the north floating pontoon.

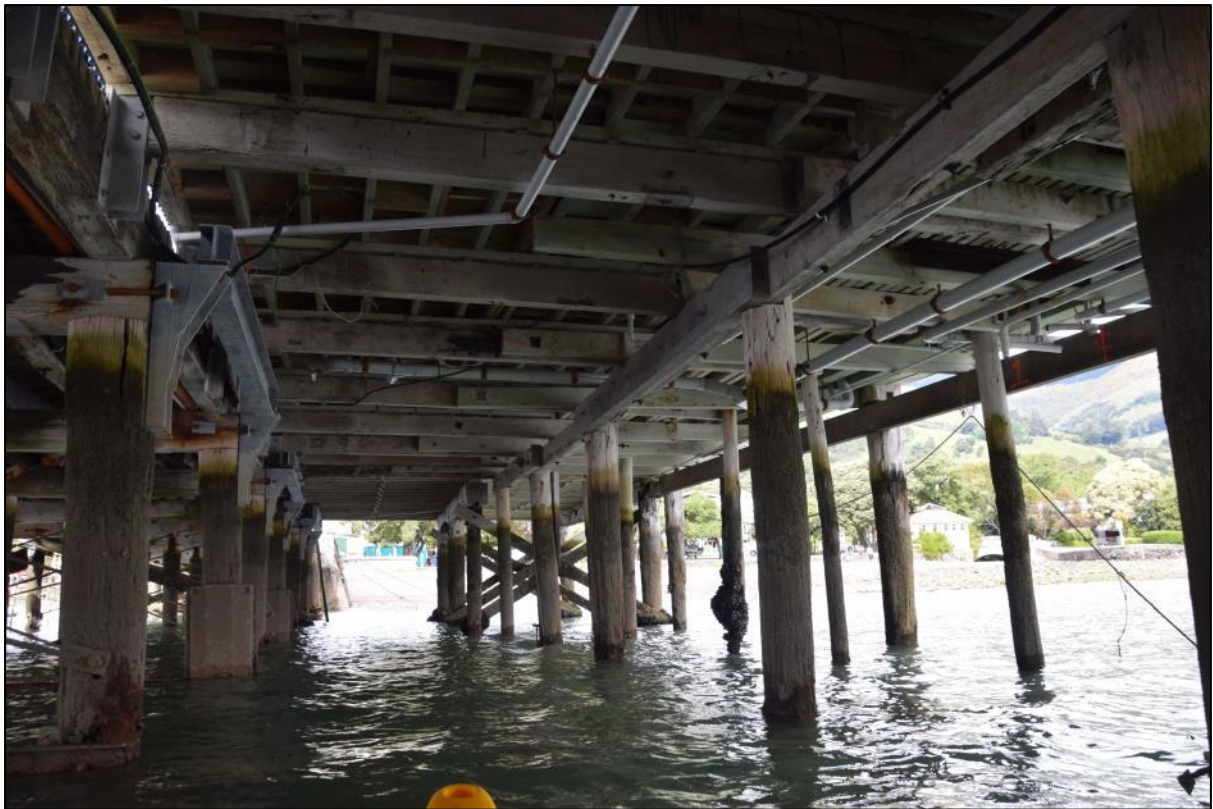
Photo 42 Modern piles, pile caps and floor framing beneath the eastern end of the sheds.

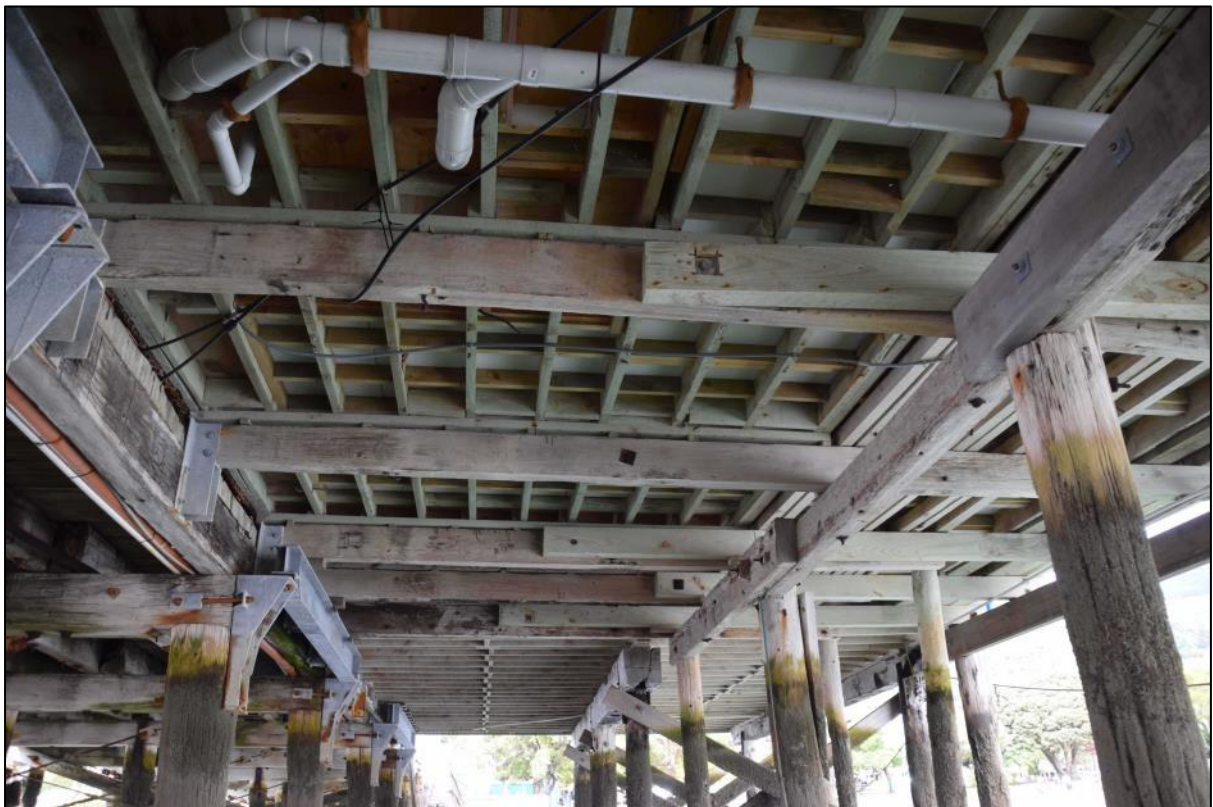
Photo 43 As Photo 42 (looking east), but showing in more detail two different periods of modern floor framing (foreground and distance).

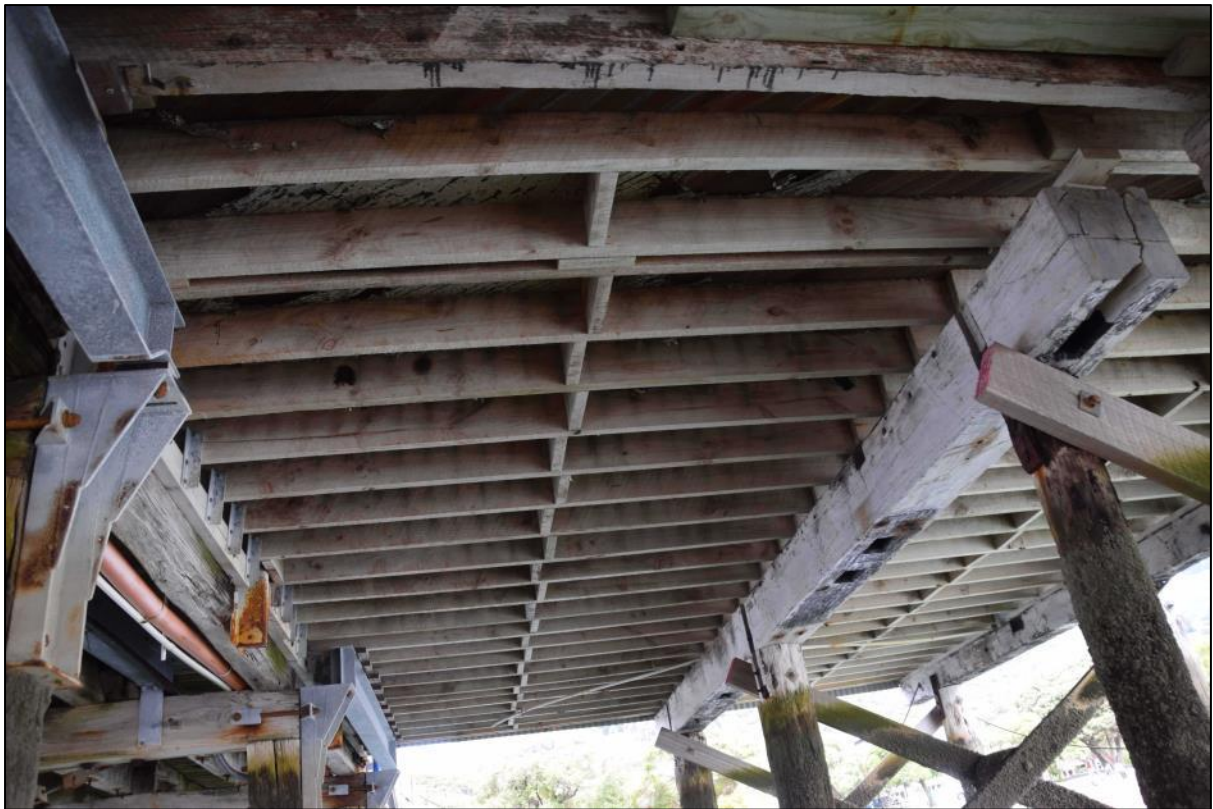
Photo 44 As Photo 43, but showing the more distant floor framing in greater detail.

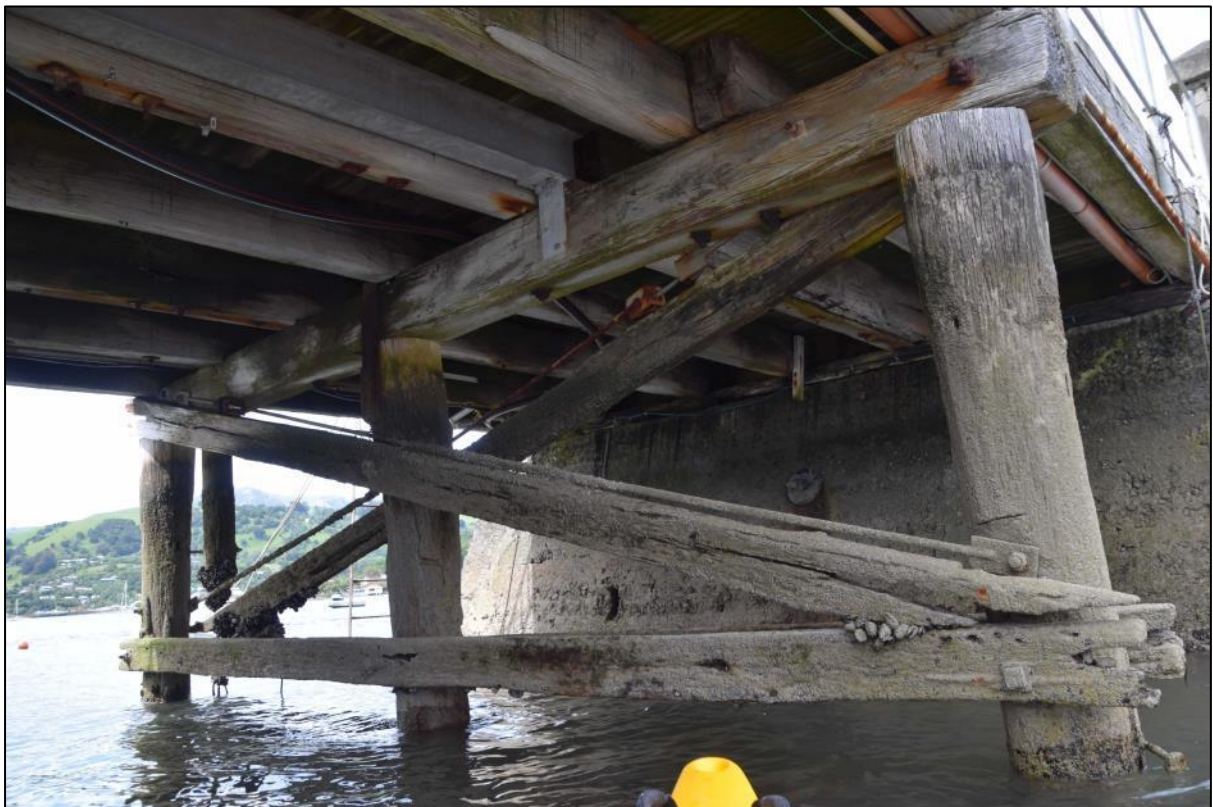
Photo 45 The first bent and the stringer/deck connection to the abutment. This part of the structure contains many original elements, including the pile cap, central pile with wrought iron strap connection to the cap, bracing timbers and horizontal wale between the piles, and timber stringers between the pile cap and modern decking boards.
