Appendix O

Subject: 265 Riccarton Road – Antonio Hall building – Post-fire structural inspection Project Number: 210611

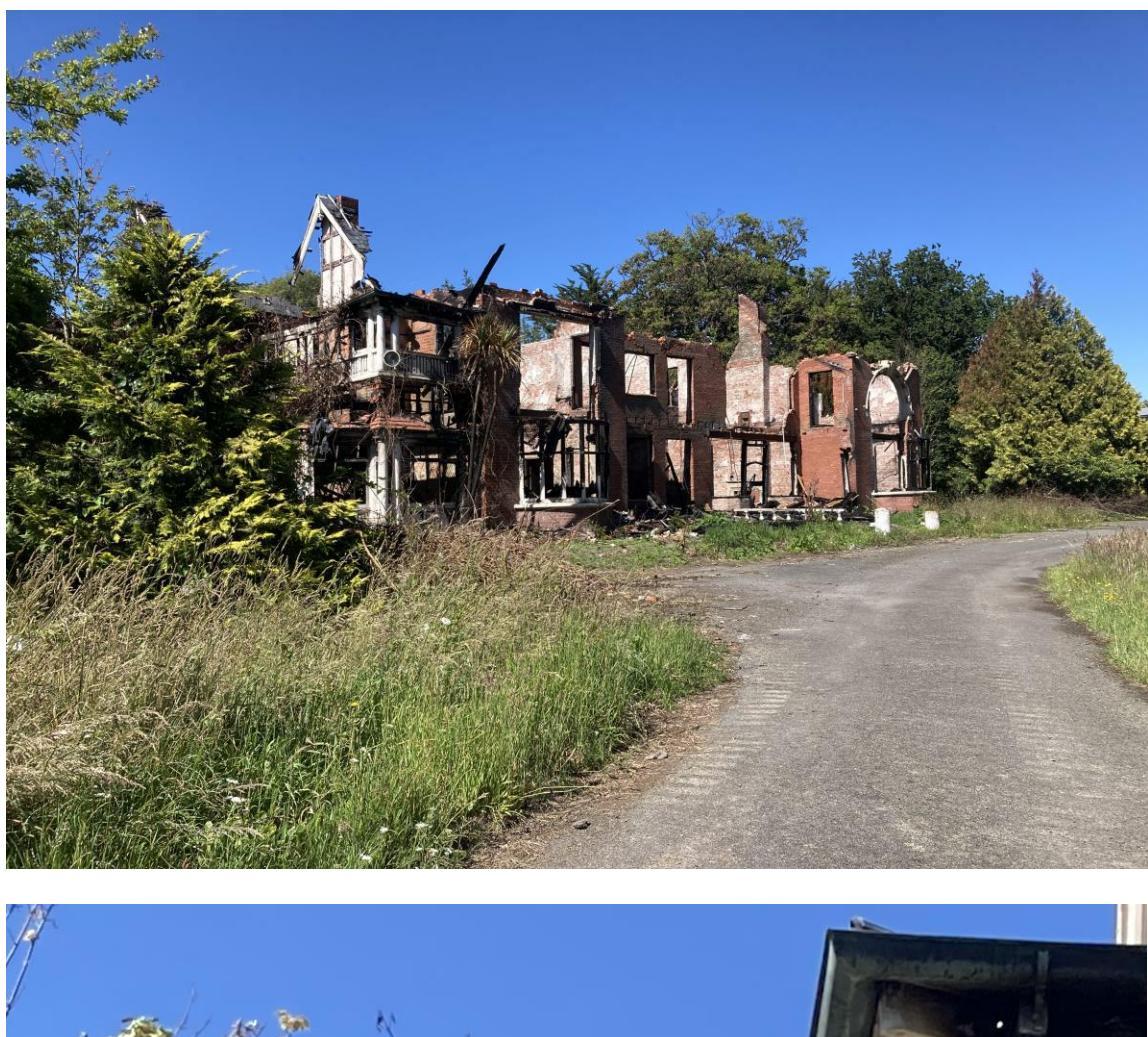
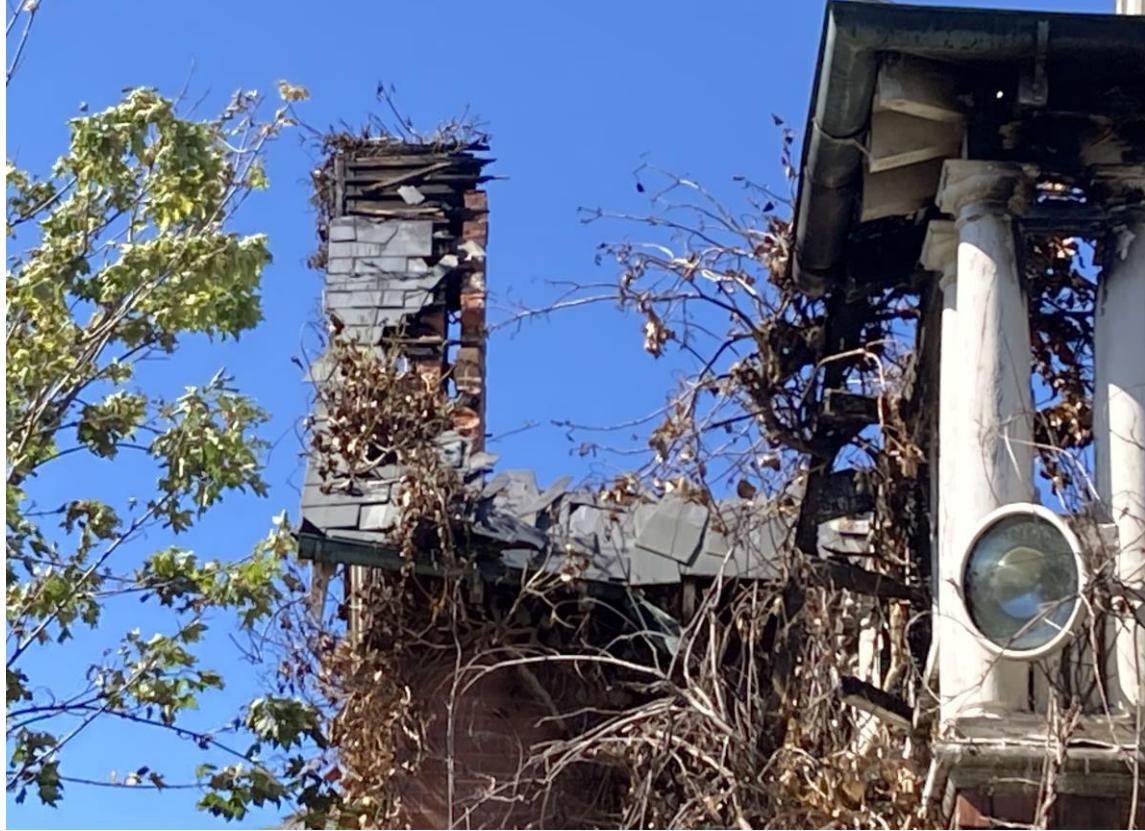
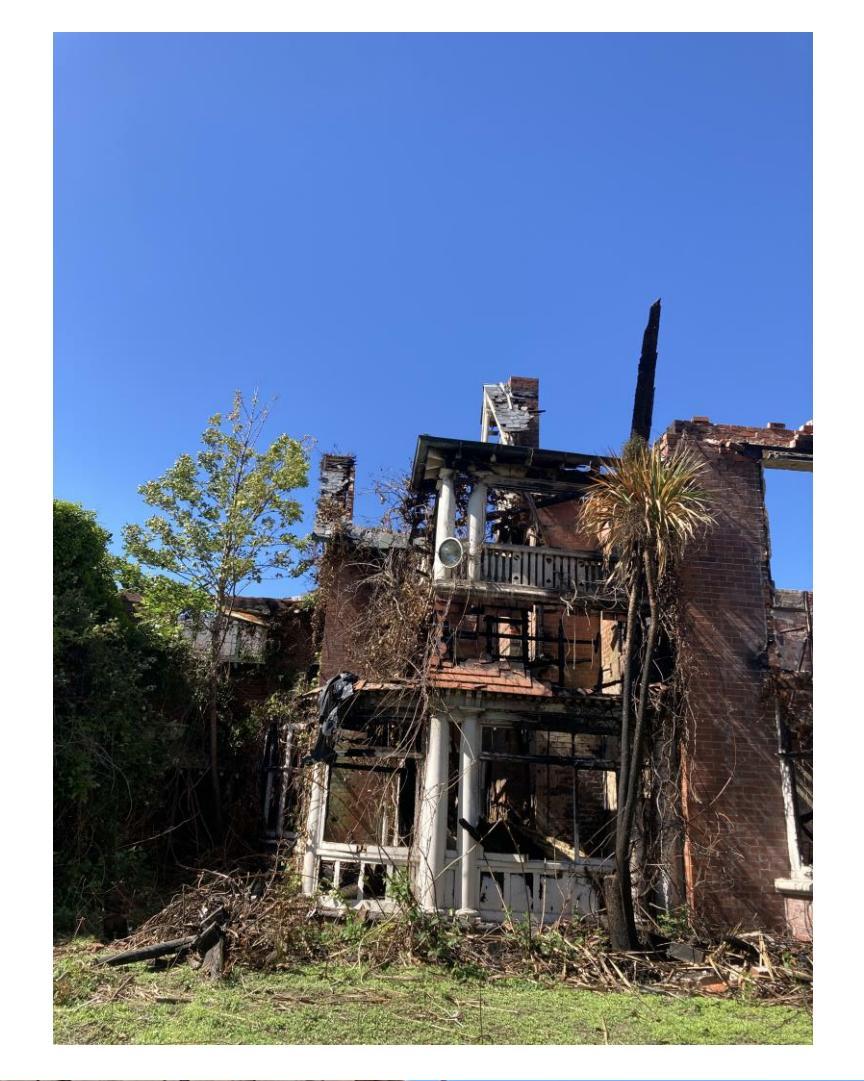
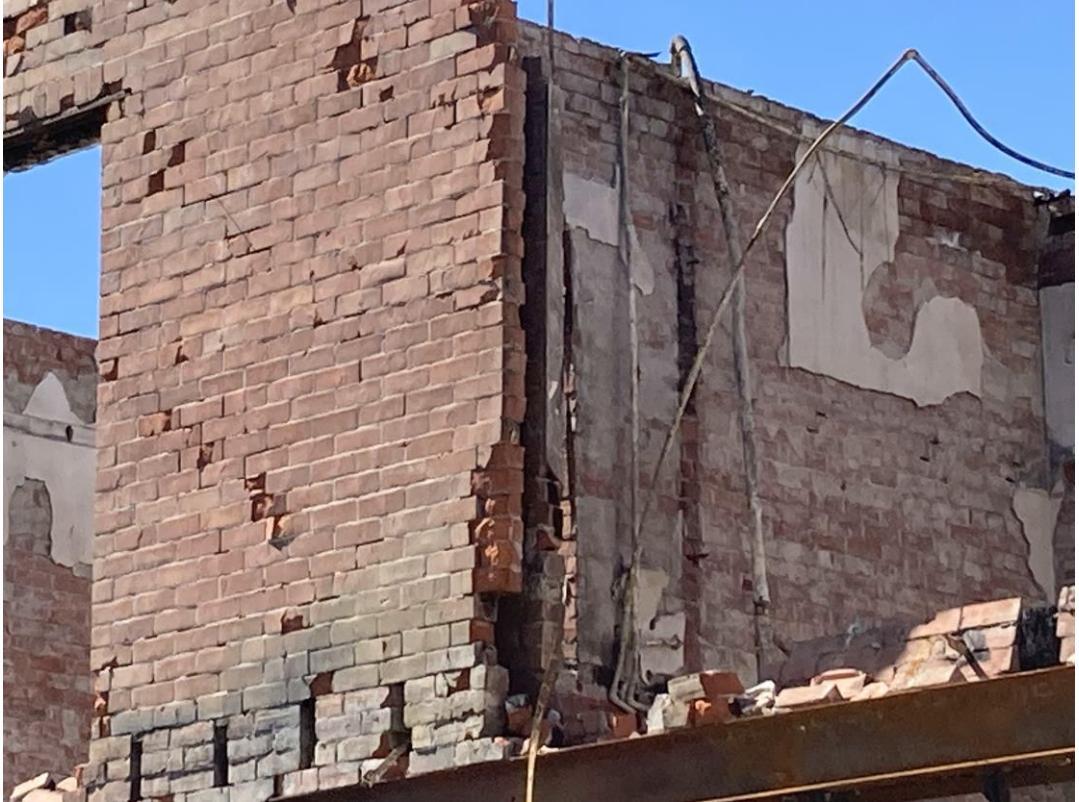
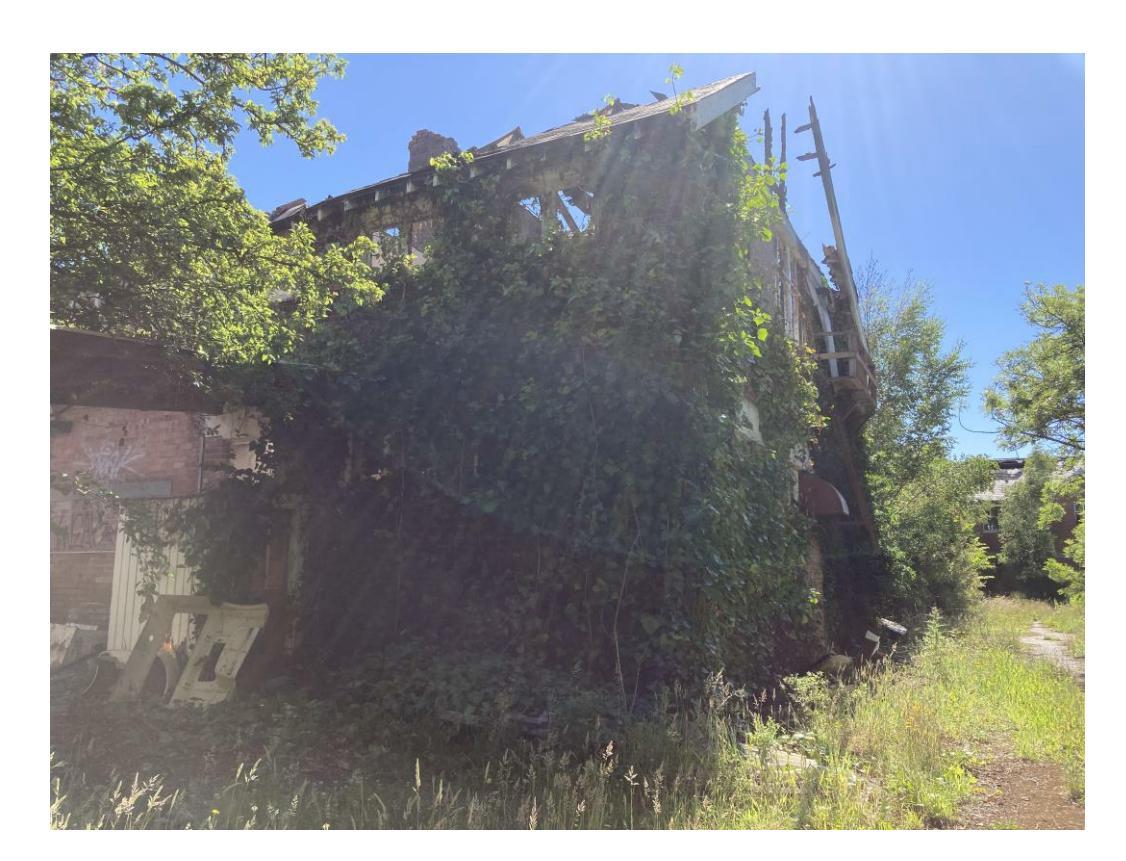
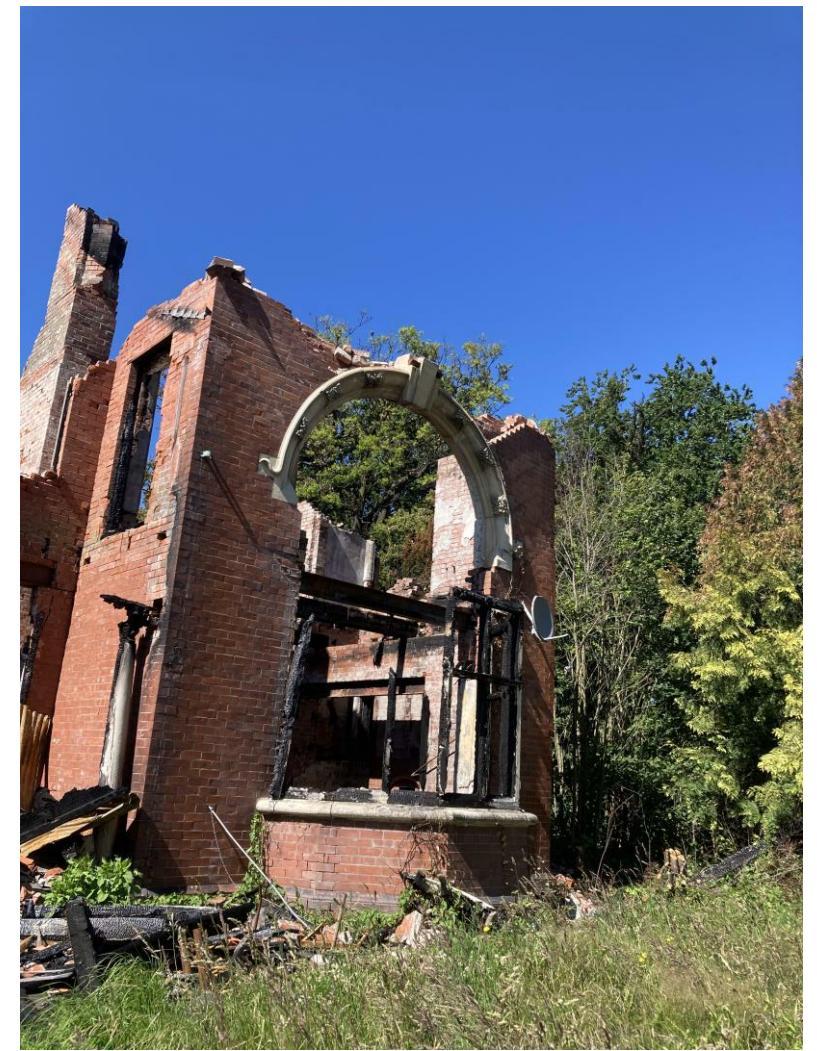
SITE VISIT PHOTOS

The west wing building consists of a two-storey building, L-shape in plan, with the primary structure being double skin brick cavity walls. From the site inspection it is evident that the fire has affected the following elements:

- The fire has burnt through the roof rafters and metal sheeting causing collapse, leaving no roof structure.
- The timber floor joists and flooring of the first floor has been burnt through causing collapse, leaving no first floor.
- The ground floor structure and subfloor was covered in debris from the fire and could not be assessed.

been significantly damaged and has collapsed as a result of the most recent fire. The The majority of wooden structure (roof and first floor flooring) had been significantly damaged and has collapsed as a result of the most recent fire. The existing unreinforced brick walls are currently cantilevered from ground level, with very low out-of-plane capacity under seismic or wind loading. Out of plane collapse presents a risk to anyone within 8m of the building footprint during an earthquake or a moderate wind event. Loose roof linings and building services (ducting) are compromised and at risk of falling or becoming airborne in a moderate wind event.

- 3. Debris on the ground which poses a trip hazard, with timber and exposed nails that present a risk of injury to anyone that accesses the area of debris.
- 4. Remaining burnt out timber elements risk collapse if disturbed.
- 5. The damage to the ground floor structure is unknown and may also present a risk of collapse and entrapment.
- 6. The remaining brick walls have the following damage:
 - Partial collapse of brickwork from loss of lateral support due to collapse of roof and first floor.
 - o Spalling to several areas of brickwork from heat effects of the fire
 - Substantial cracking from earthquake in 'hourglass' formation consistent with inplane shear failure.

- 1. Prevent access to the damaged area of the building by installation of suitable hoarding and/or fencing at least 8m away from the perimeter of the building.
- 2. Remove loose roof linings, building services, etc, where safe to do so.
- 3. Demolish the fire affected internal partition walls and clean up debris from the ground floor.

For the reasons noted above, it is recommended that the remaining elements of the west wing is demolished and the materials that are at risk of becoming airborne (e.g. sheet roofing or lightweight fibres) be secured or disposed of.
