CHRISTCHURCH CITY COUNCIL
PRK_1108_BLDG_001 EQ2
Addington Park – Pavilion and Toilets
77 & 83 Jerrold St, Addington

QUALITATIVE ASSESSMENT REPORT

FINAL

- Rev B
- 23 May 2013

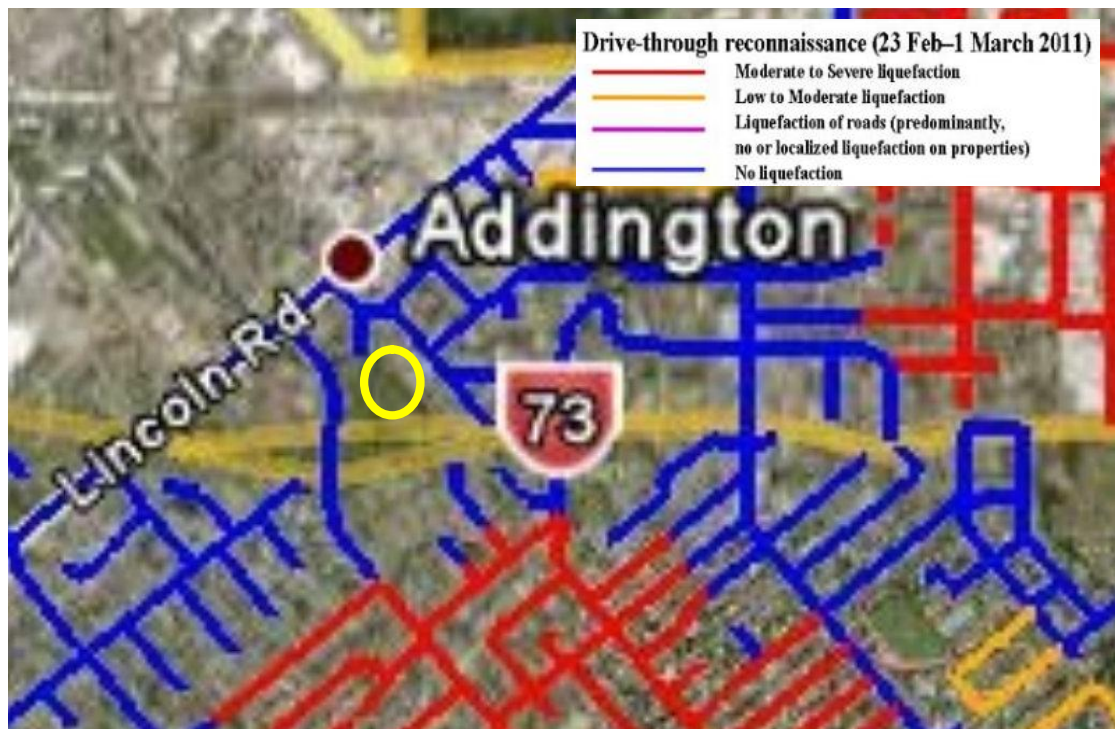
■ **Figure 4 – Liquefaction map (Cubrinovski & Taylor, 2011). Site marked in yellow.**

Following the 22 February 2011 event drive through reconnaissance was undertaken from 23 February until 1 March by M Cubrinovski and M Taylor of Canterbury University. Their findings show there was no liquefaction in the roads around the site.

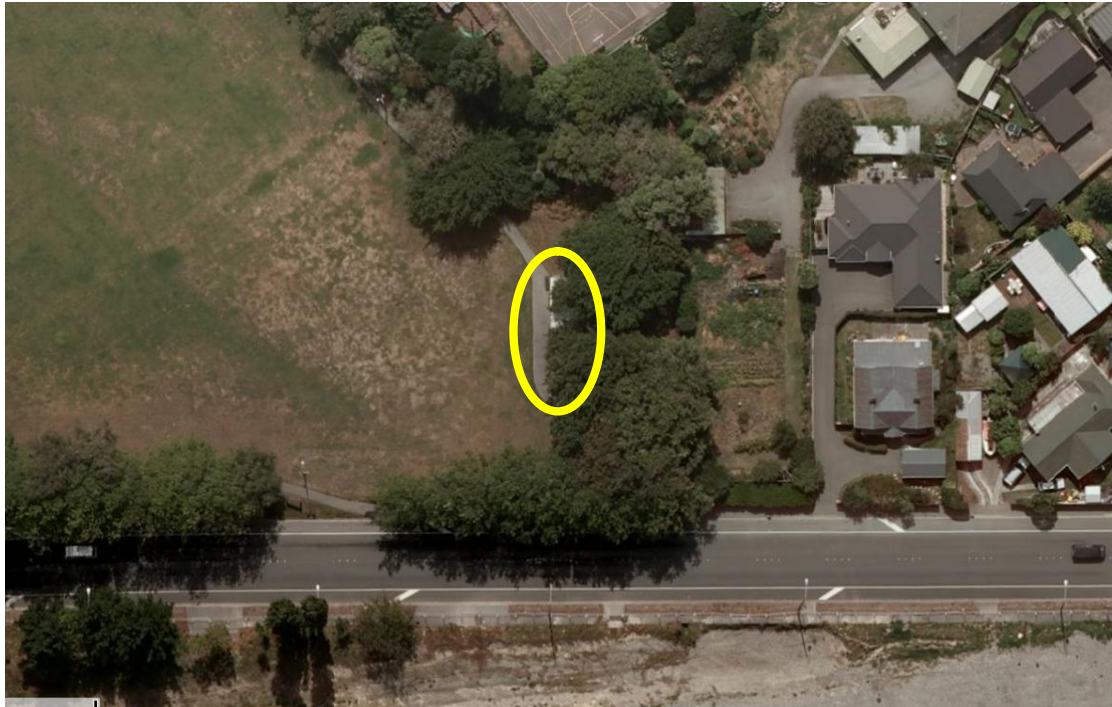
- **Figure 5 – Aerial photography from 24 Feb 2011 (<http://viewers.geospatial.govt.nz/>)**

Aerial photography shows no evidence of liquefaction after the 22 Feb 2011 event.

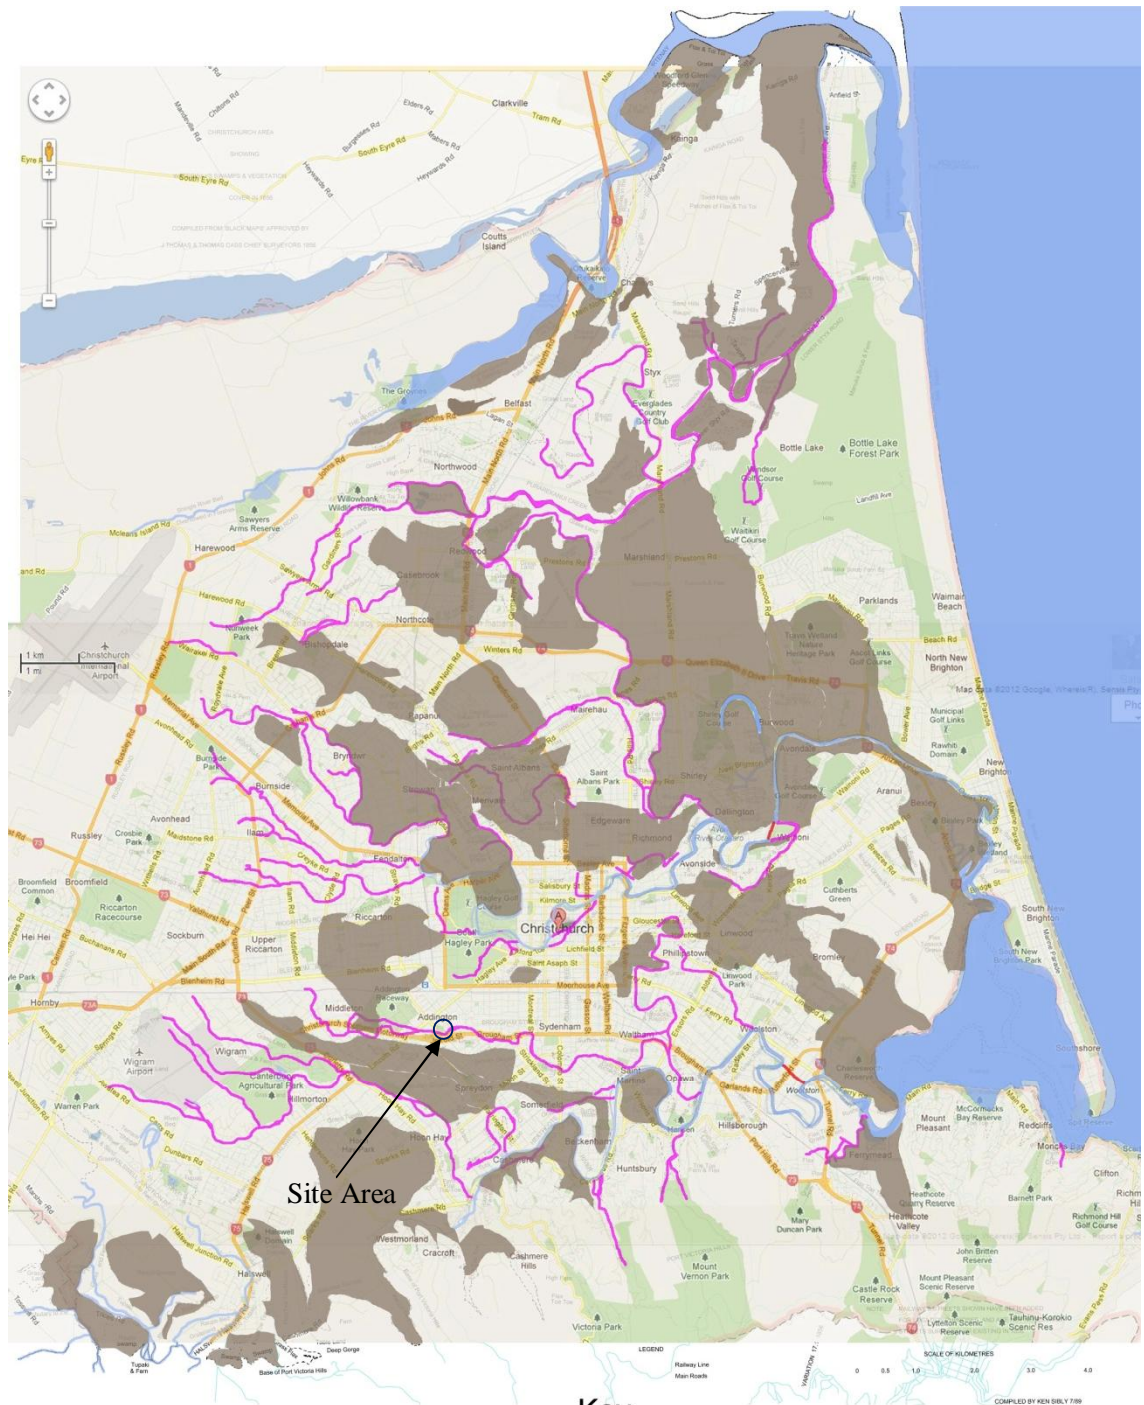
Appendix A – Christchurch 1856 land use

Reference to historical documents (e.g. Appendix A) indicates the site lies on the land that was recorded as previous creeks and river in 1856 and the land approximately 200 m to the south of site was recorded as marshland or swamp in 1856. It is therefore possible that soft or liquefiable ground would be present near the site but no evidence of liquefaction observed from the aerial photography and the site walkover.

The swamps and previous creeks/ivers from 1856 have been overlaid onto a map of Christchurch in 2012
