Allison Courts  
Quantative Engineering Evaluation

Functional Location ID: BU 1113 EQ2  
Address: 40 Brougham Street

**Reference:** 233414  
**Prepared for:**  
Christchurch City Council  
**Revision:** 1  
**Date:** 27 November 2015

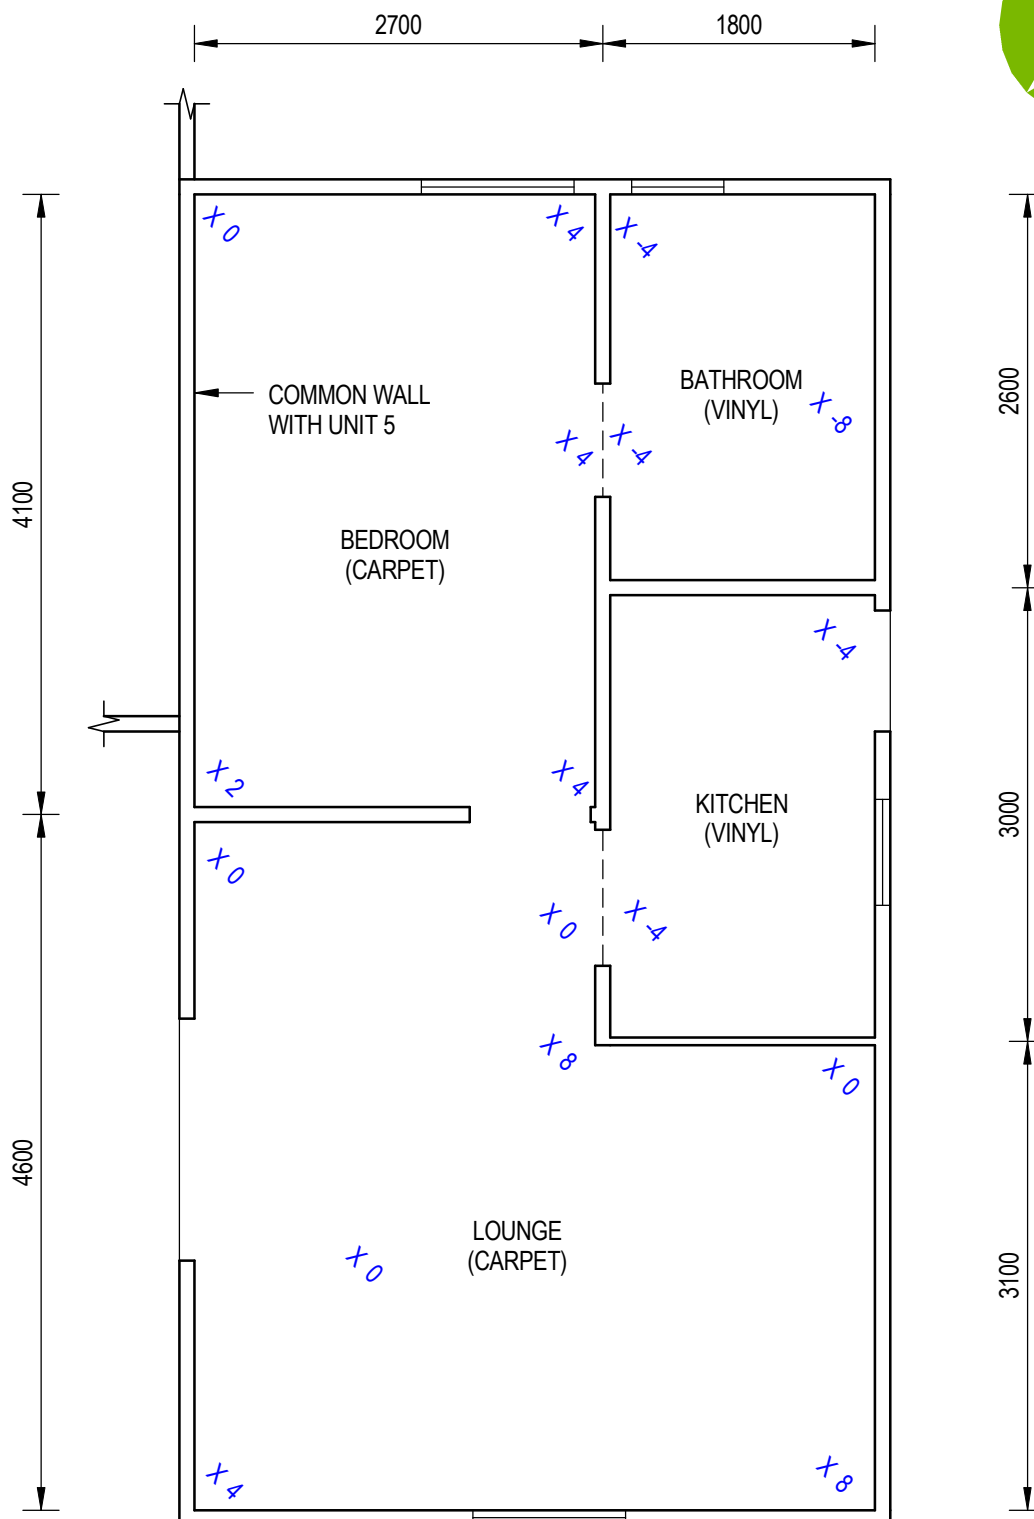
PRELIMINARY NOT FOR CONSTRUCTION	
PROJECT No.	233414
SCALE	1:50
SIZE	A4
DRAWING No.	SK-01-03
REV

PROJECT
ALLISON COURTS 40 BROUGHAM STREET
TITLE
LEVEL SURVEY UNIT 3

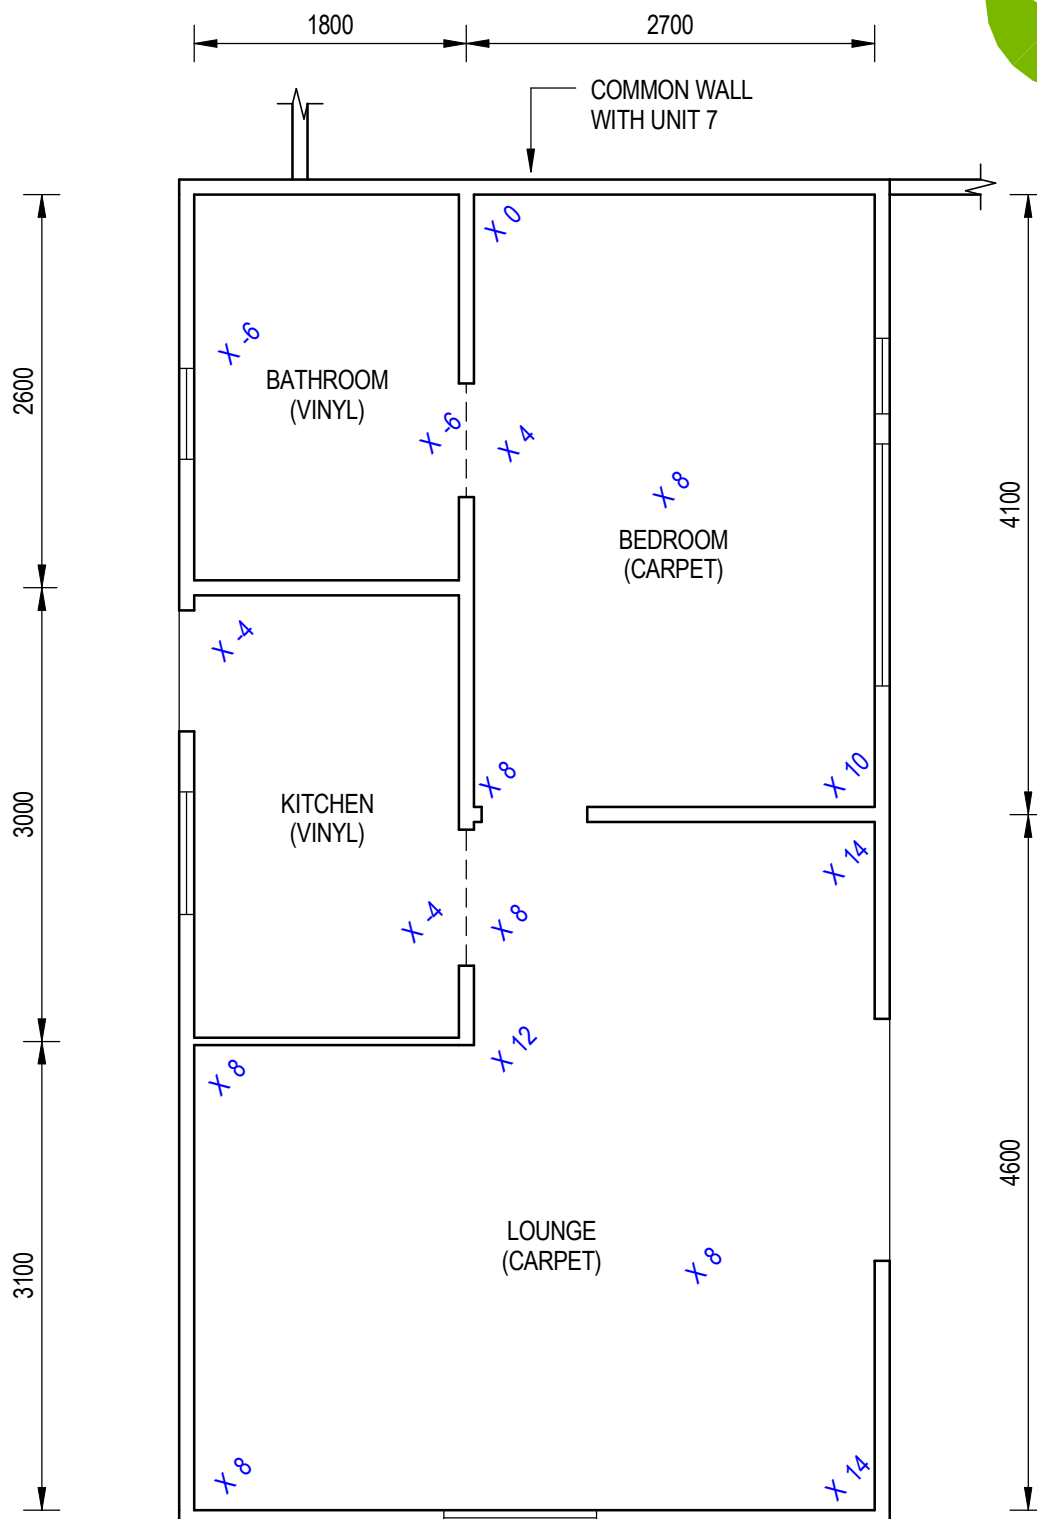
PRELIMINARY NOT FOR CONSTRUCTION	
PROJECT No. 233414	
SCALE 1:50	SIZE A4
DRAWING No. SK-01-08	REV

PROJECT  
**ALLISON COURTS**  
40 BROUGHAM STREET  
TITLE  
**LEVEL SURVEY**  
UNIT 8
