**Barrington Park Cricket Club Shed
PRK 1125 BLDG 003**

Detailed Engineering Evaluation
Quantitative Report
Version FINAL

270 Barrington Street, Spreydon,
Christchurch

Christchurch City Council

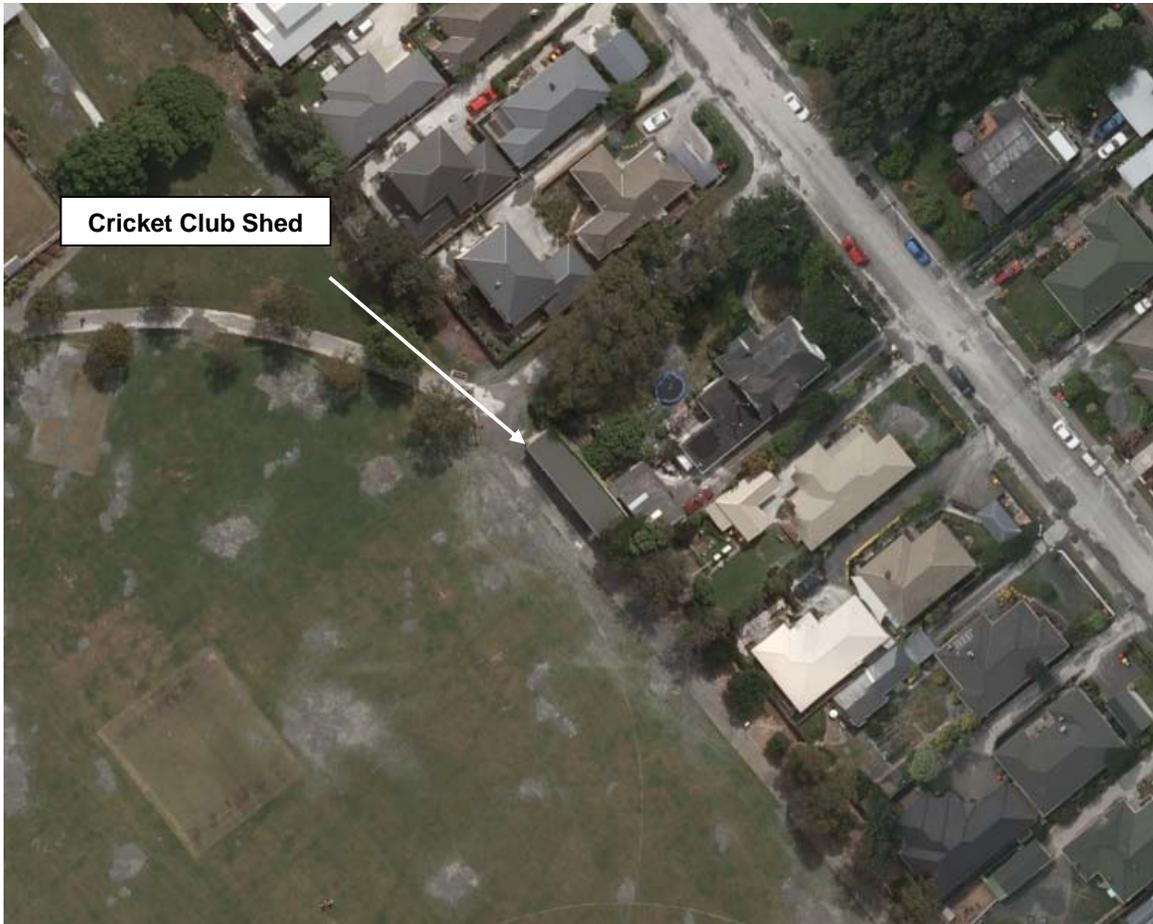
Figure 3 Post February 2011 Earthquake Aerial Photography

Aerial photography⁷ taken following the 22 February 2011 earthquake shows significant liquefaction in the form of sand boils on Barrington Park, as well as moderate liquefaction on Sugden St, as shown in Figure 3. Aerial photography taken following the 13 June 2011 earthquake shows moderate signs of liquefaction on Sugden St and Barrington Park. Aerial photography taken following the 23 December 2011 earthquake shows no further signs of liquefaction in the area. No coverage was taken following the 4 September 2010 earthquake.
