**Botanic Gardens Information Kiosk**  
**PRK 1566 BLDG 002 EQ2**  
Detailed Engineering Evaluation  
Quantitative Report  
Version FINAL

7 Rolleston Avenue, Christchurch  
Central

Christchurch City Council

**Date**  
27/2/13

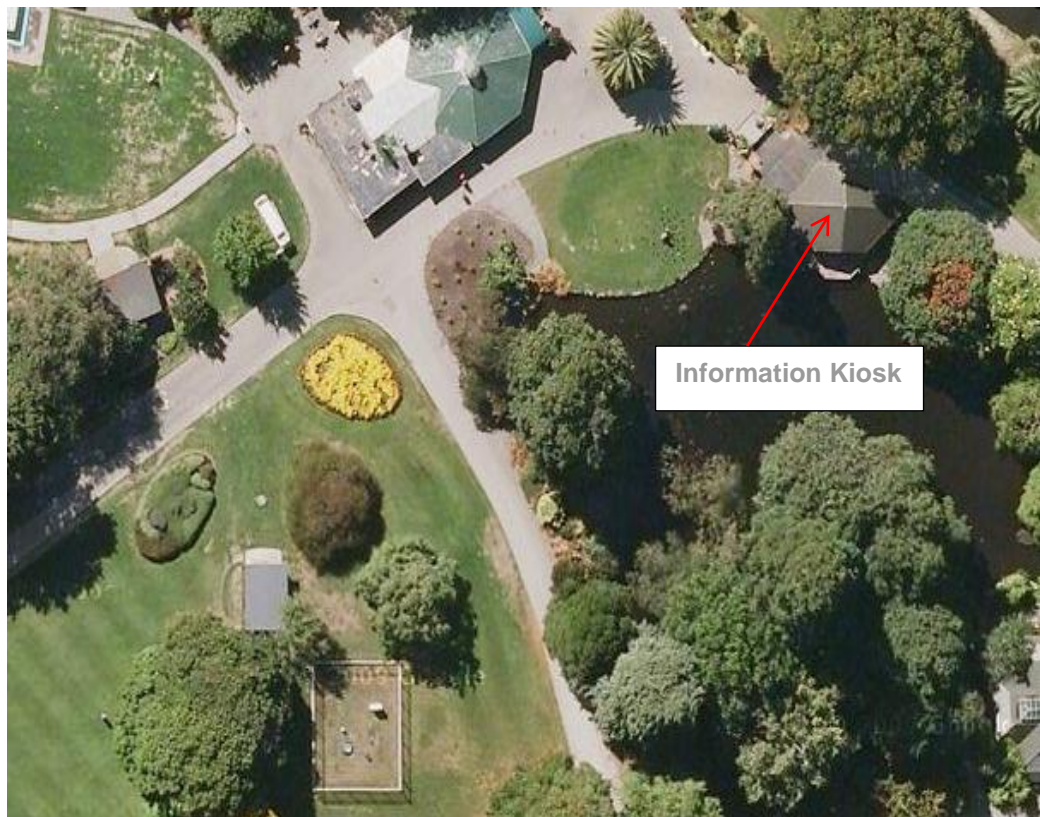
**Photograph 8: Building location on site**

The Information Kiosk is located in the Botanic Gardens at 7 Rolleston Avenue, Christchurch Central. The structure was constructed in 1986 with extensions added to the western and eastern sides of the building in 2000. The site is surrounded by park land with the south side of the structure over-looking a lake. See Photograph 8 for building location on site.

The Information Kiosk is located in the Botanic Gardens and is surrounded by park land and walkways. It abuts a lake with no properties immediately adjacent to the structure. The nearest building is the Tea Kiosk located approximately 30m to the north-west. During the inspection, some minor damage was observed to this structure notably some internal wall lining cracking. See Photograph 8 for the building location.
