Christchurch City Council

Boyd Cottages Housing Complex PRO 3517

Detailed Engineering Evaluation

**Quantitative Assessment Report –
Following Structural Strengthening
2015**

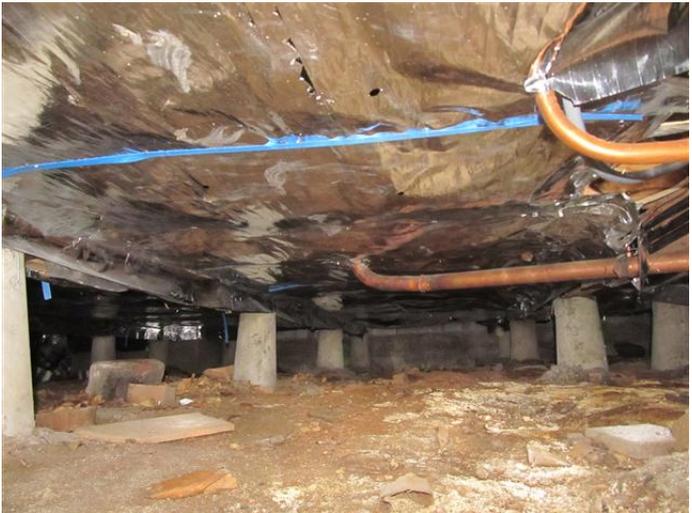
2	Unit 1-4 foundations

The render finish to the ring foundation of unit 4 has spalled off in the corner. Refer photo 9 in Appendix A. The render finish was repaired as part of the repairs completed in January 2015.
