**Briggs Row
Housing Complex
PRO 3519**

**Detailed Engineering Evaluation
Quantitative Assessment Report**

Briggs Row Housing Complex

31 Winchester Street, Lyttelton,

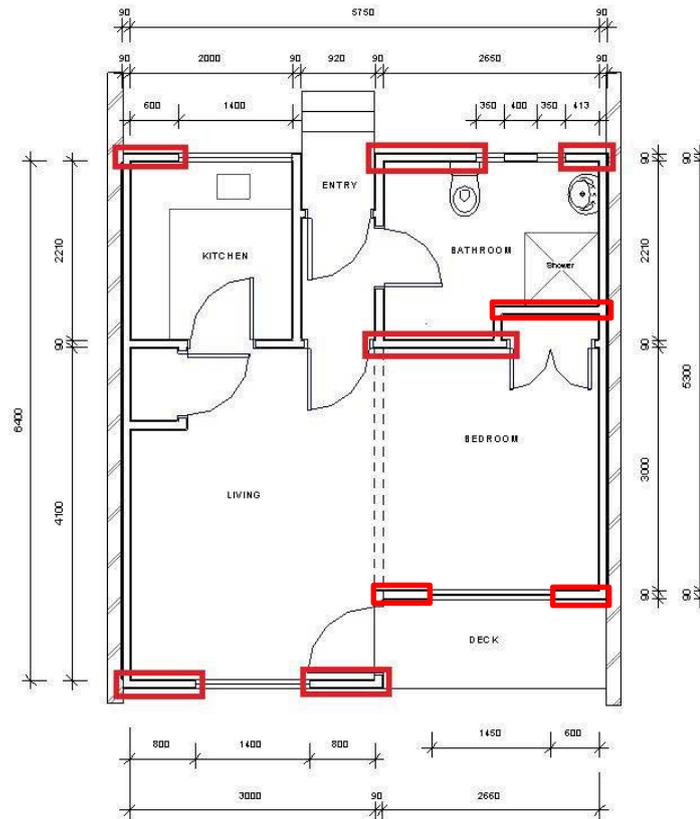
Figure 7: Walls used for bracing in the longitudinal direction.

There is minimal longitudinal subfloor bracing in the units. The plywood which currently forms the barrier to the subfloor is not properly framed and does not adequately transfer loads to the foundations. There is currently no strip footing for the loads to transfer to.

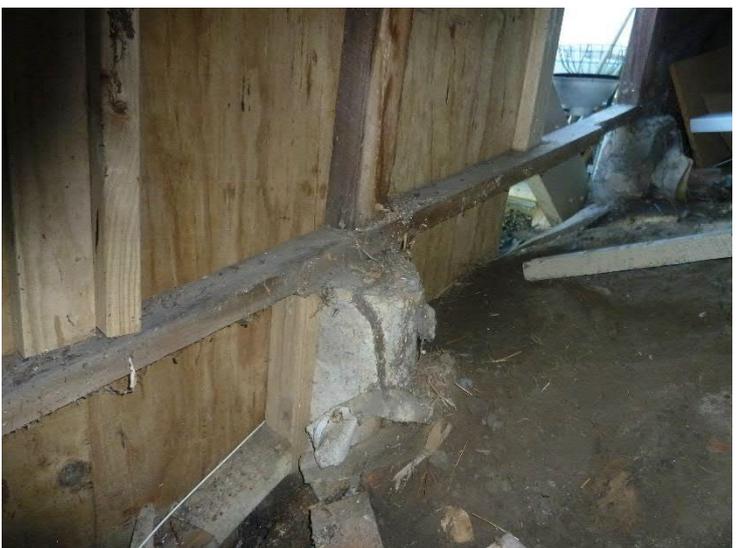
<p>14.</p>	<p>Typical subfloor framing.</p>

During the subfloor inspection it was noted that several members were rotted and cracking. There were large piles of soil, bricks and other construction debris under the units and in some cases these meant the concrete (structural) piles could not be inspected. These piles of material have buried some timber members which will now be more prone to rotting.

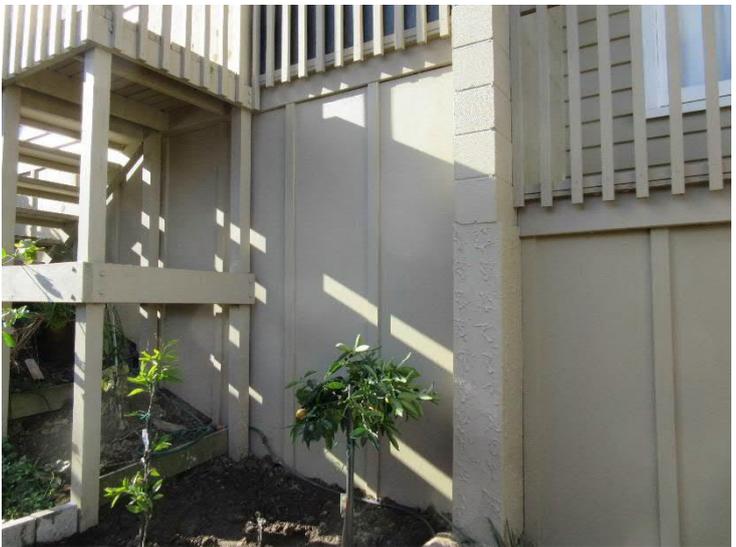
An interior photograph showing a large, light-colored wooden panel, likely a bracing element, installed against a wall. The panel has a natural wood grain and shows some staining. To the right, a white cable runs vertically. The ceiling above shows wooden joists and insulation.
<p>4.</p>	<p>External View of Completed Bracing to Unit 3/4.</p>

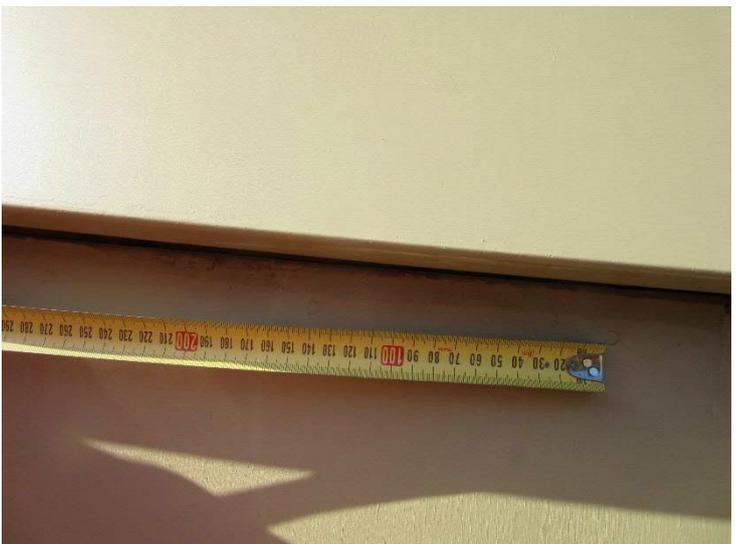
An exterior photograph of a building's corner. A white, vertical bracing element is visible, supporting a balcony or walkway with a white railing. The wall is light-colored with vertical siding. A small tree and some landscaping are in the foreground.
<p>5.</p>	<p>Adequate Nail spacing provided to new bracing elements.</p>
