**Bruce Terrace
Cottages
Housing Complex
PRO 3652**

**Detailed Engineering Evaluation
Quantitative Assessment Report**

20 Bruce Terrace, Akaroa

Date: March 2014
Reference: 6-QC321.00
Status: Final

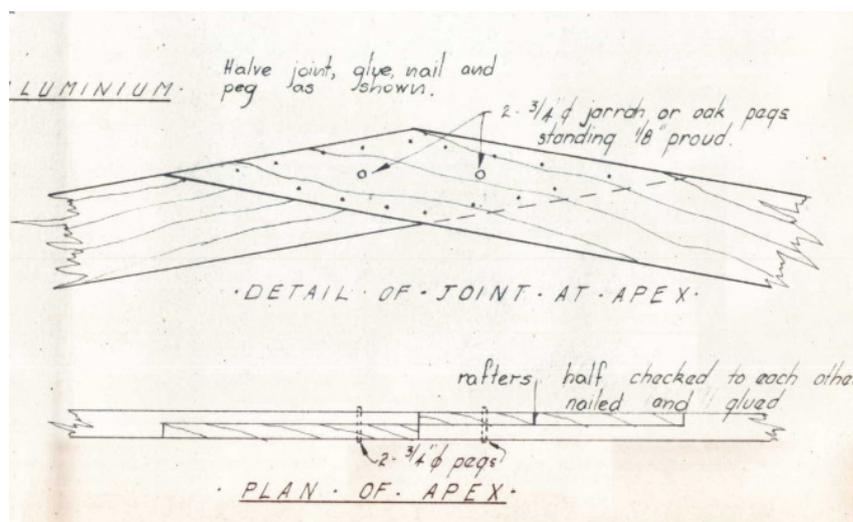
Figure 5: Detail of rafter apex at Bruce Terrace Cottages Housing Complex.

The roof structure comprises of timber rafters which are half checked into each other at the apex, as shown in Figure 5, supporting light-weight metal roofs with rebated timber sarking which is raked to follow the roofline. The timber framed walls are lined with plasterboard.

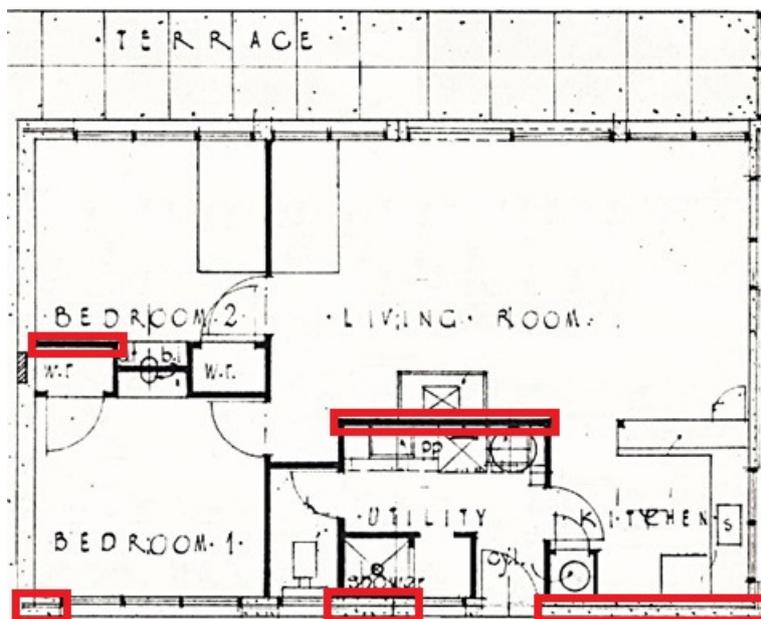
Figure 8: Walls used for bracing in the longitudinal direction.

Hand calculations were performed to determine seismic forces from the current building codes. These forces were applied globally to the structure and the capacities of the walls were calculated and used to estimate the %NBS. The walls, highlighted in Figure 8 and Figure 9, were used for bracing in their respective directions. The frame action along the terrace has been ignored due to its flexibility.

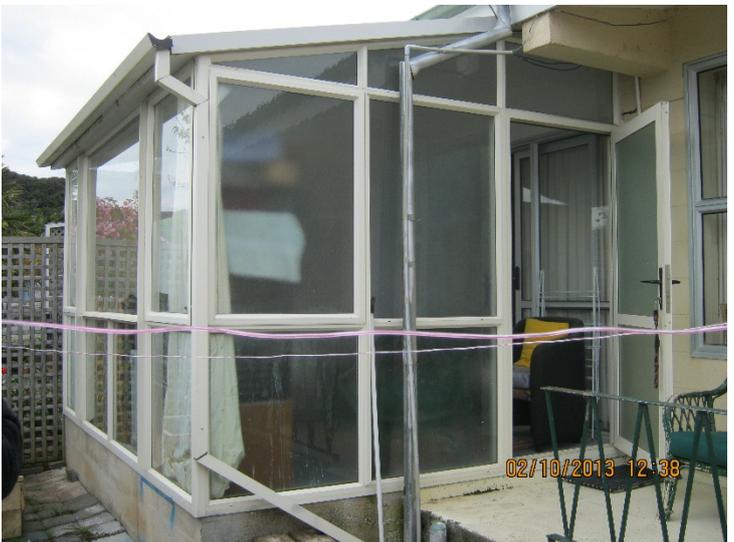
Unit 2 is smaller than the end units as it was converted from the garages of the original 2 units. Unit 2 also has a conservatory extension constructed in 1993.
