# Vehicle Garage Building – Christchurch Wastewater Treatment Plant

## Detailed Engineering Evaluation

### BU 0879-019 EQ2

### Quantitative Report

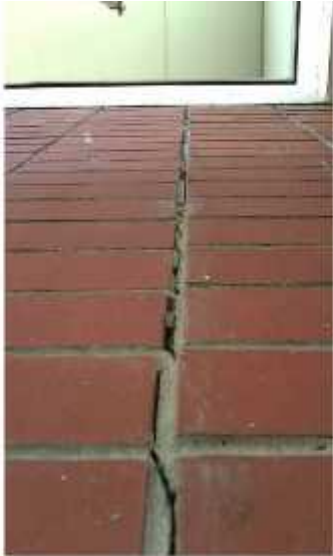
Ref.	Image	Description	Damage Type / Repair
S2.2

Mortar is cracked in brick cladding outside the south-west doorway (view looking upwards towards the eaves).	Type 5.  Remove cracked mortar and repoint masonry.
S2.3

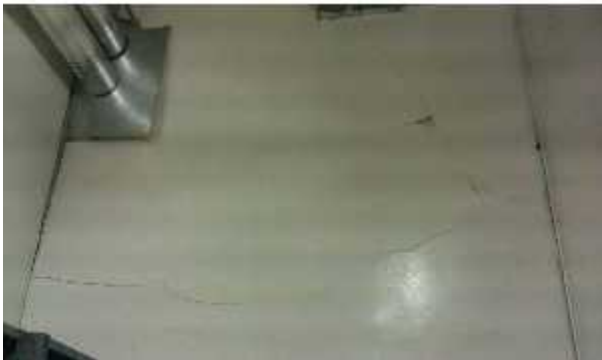
Cracks in walls of storeroom beside PS-A.	<i>Type 2.</i>  Repair with an epoxy or grout injection system

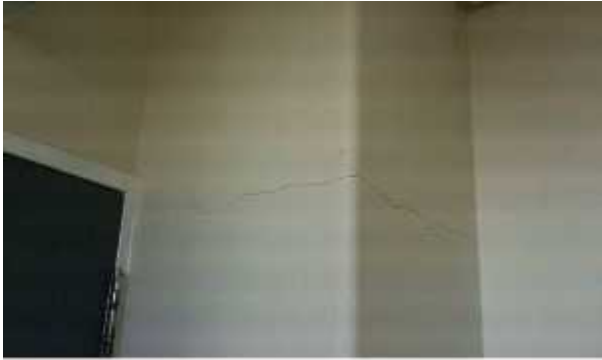
Ref.	Image	Description	Damage Type / Repair
S4.1

Cracking to columns (at two locations).	Type 2.  Repair with an epoxy or grout injection system
S4.2a

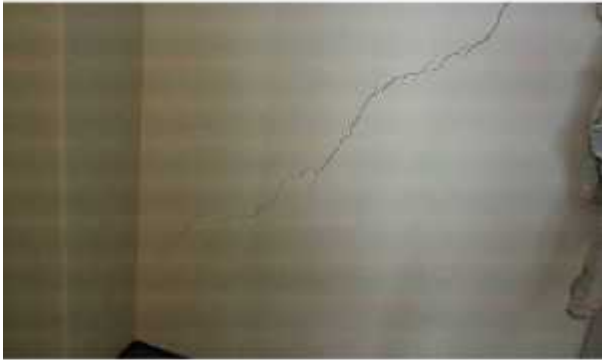
Cracking to walls at entrance to workshop and inside workshop.	Type 2.  Repair with an epoxy or grout injection system
S4.2b

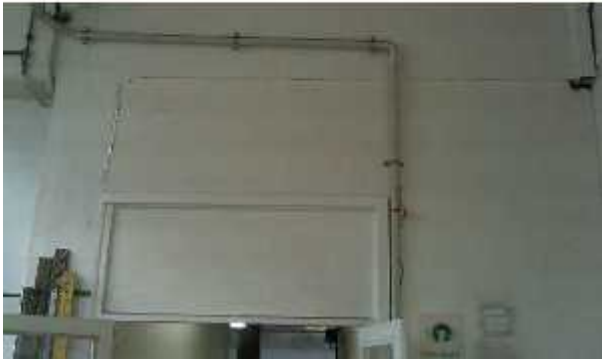
Cracking to walls at entrance to workshop.	Type 2.  Repair with an epoxy or grout injection system

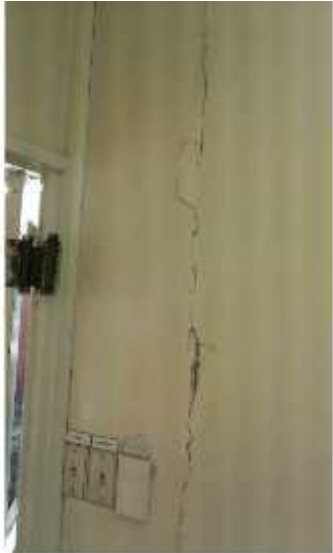
Ref.	Image	Description	Damage Type / Repair
S4.2c

Cracking to walls at entrance to workshop.	<i>Type 2/3.</i>  Repair with an epoxy or grout injection system
S4.2d

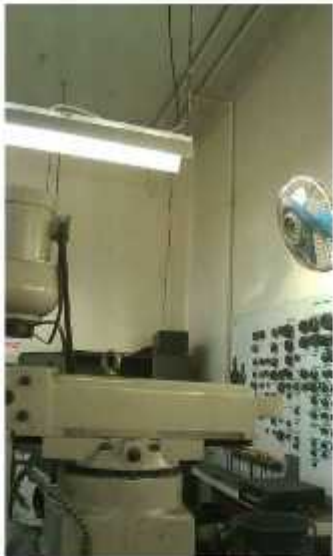
Cracking to walls in workshop.	<i>Type 2.</i>  Repair with an epoxy or grout injection system
S4.3

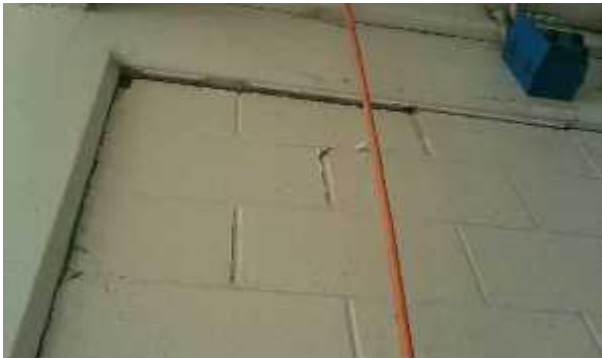
Ref.	Image	Description	Damage Type / Repair
S5.2

Cracked mortar in blockwork on south-west wall.	<i>Type 5.</i>  Remove cracked mortar and repoint masonry
S5.3

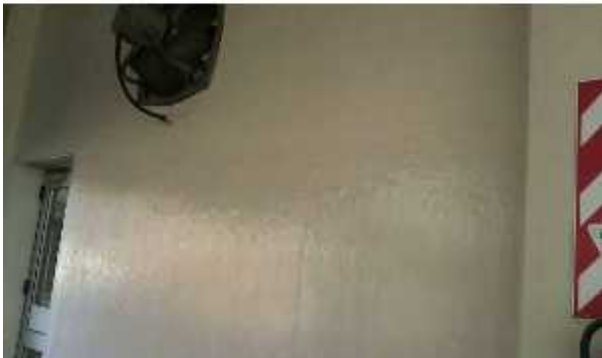
Horizontal cracks in walls (approx 0.3 mm crack width).	<i>Type 2.</i>  Repair with an epoxy or grout injection system

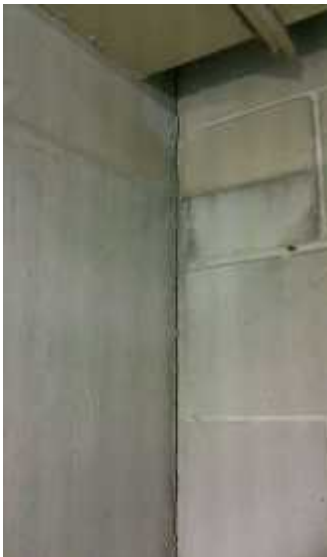
Ref.	Image	Description	Damage Type / Repair
S6.1

In the workshop to the south of the engine room there was cracking in corner join between masonry wall and reinforced concrete columns. This was observed to be typical at all columns.	Type 5.  Remove cracked mortar and repoint masonry.

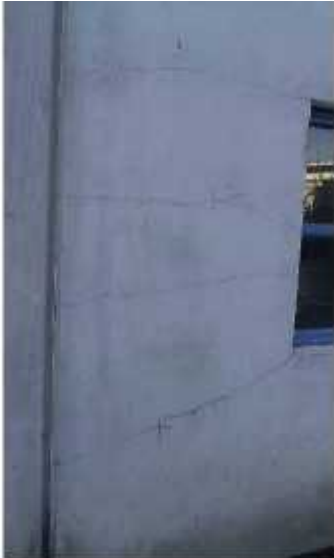
Ref.	Image	Description	Damage Type / Repair
S7.1

Horizontal cracking next to windows on western side of building.	<i>Type 2.</i>  Repair with an epoxy or grout injection system.
S7.2

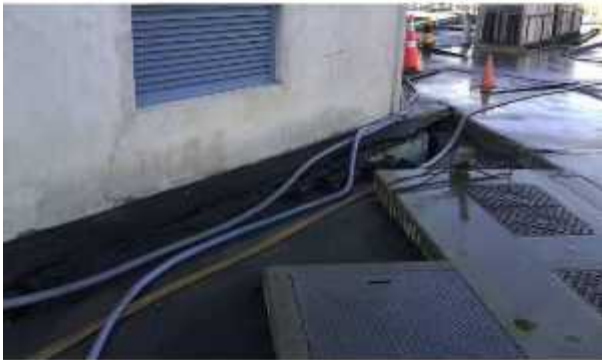
The building does not appear to have suffered significant structural damage as a result of the earthquake. However, the cracked concrete at the pipe may be the result of differential settlement. It is recommended a level survey be carried out to determine the amount of structural differential settlement (if any). If the differential settlement is significant carry out sub-surface investigation to identify if there any voids underneath the structure.

Settlement of the ground at the north-eastern end of the building.	Remove loose soil and broken pavement, backfill, compact and replace pavement.
S7.3

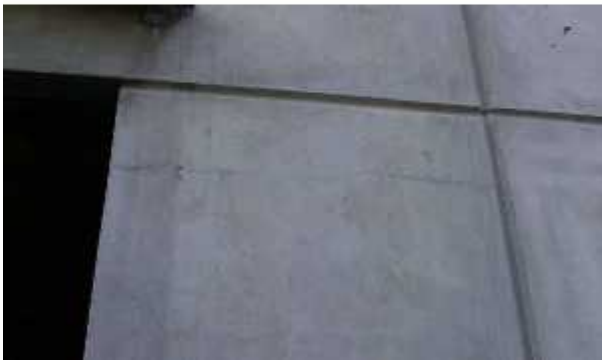
Cracking (approx 0.2 mm crack width) on western wall near door on southern end of building.	<i>Type 1.</i>  Repair with an epoxy or grout injection system

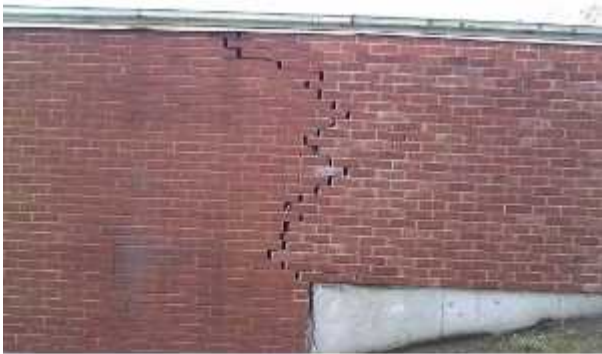
Ref.	Image	Description	Damage Type / Repair
S8.1a

Large cracks / gaps (30 mm) in brickwork on northern wall next to Digester 4. This appears to be the result of slope movement next to Digester No. 4 (as evidenced by tension cracks in the slope).	Investigate stability of slope. Remove and replace brickwork or remove brickwork completely and replace with timber framed wall (or similar).
S8.1b

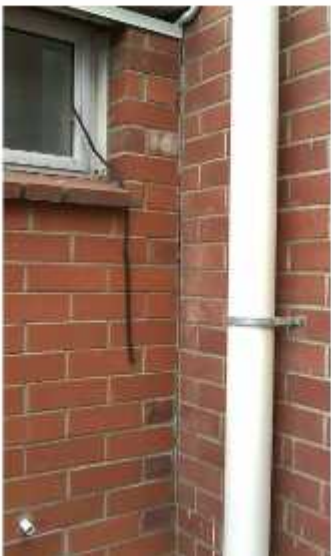
Gaps in brickwork between walls on northern face.	Type 5.  Remove cracked mortar and repoint masonry.

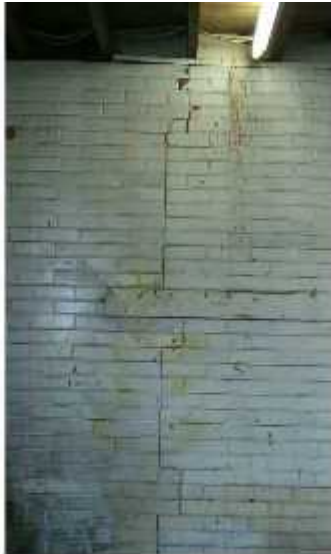
Ref.	Image	Description	Damage Type / Repair
S8.3

Cracks in brickwork mortar in eastern wall.	<i>Type 5.</i>  Remove cracked mortar and repoint masonry.

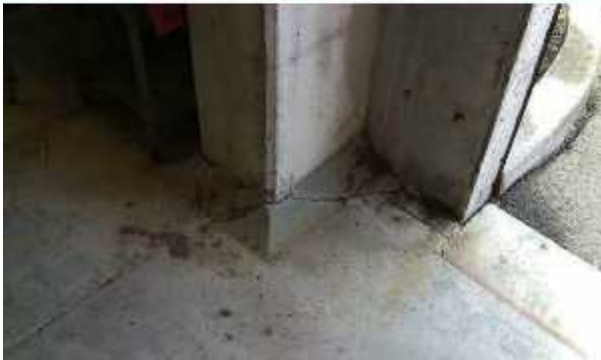
Ref.	Image	Description	Damage Type / Repair
S9.1

Cracking / spalled concrete at base of concrete encased steel I-beam columns.	<i>Type 4.</i>  Break out loose concrete and repair with structural repair mortar system.

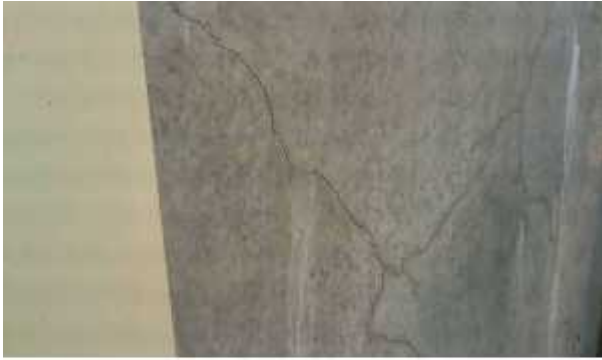
Ref.	Image	Description	Damage Type / Repair
S9.2

Cracking in eastern walls (approx 0.3 mm crack width).	Type 2.  Repair with an epoxy or grout injection system.
S9.3

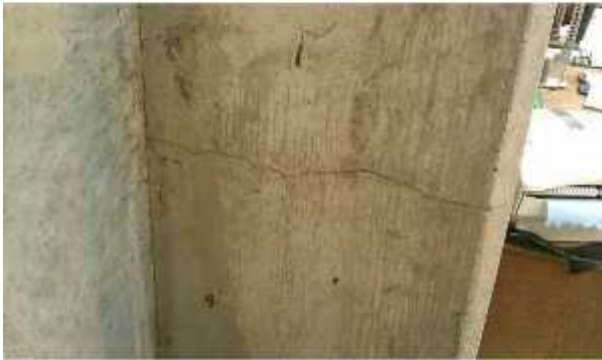
Cracking in columns.	Type 2.  Repair with an epoxy or grout injection system.
S9.4

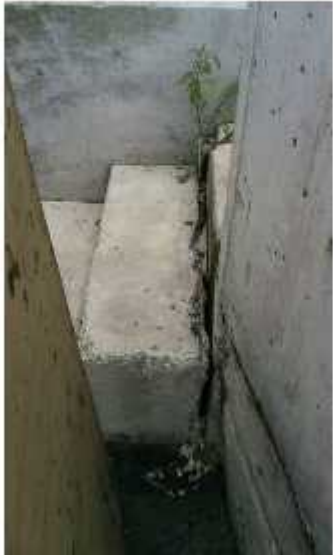
Large gap at steps at south-western corner of building.	Reinstate concrete and provide seal.

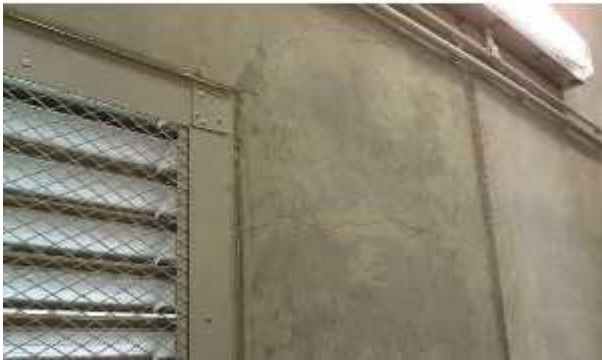
Cracking in walls next to opening on western wall (approx 0.3 mm crack width).	Type 2.  Repair with an epoxy or grout injection system

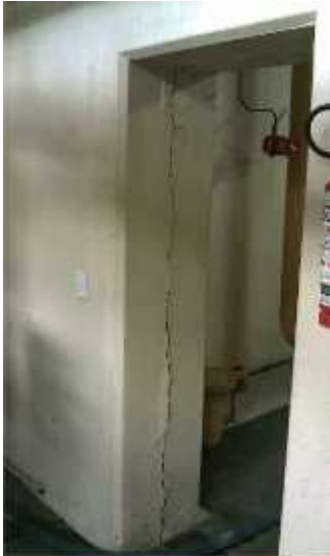
Ref.	Image	Description	Damage Type / Repair
S12.1

Cracking around doorway near digester control room.	Type 2.  Repair with an epoxy or grout injection system
S12.2a

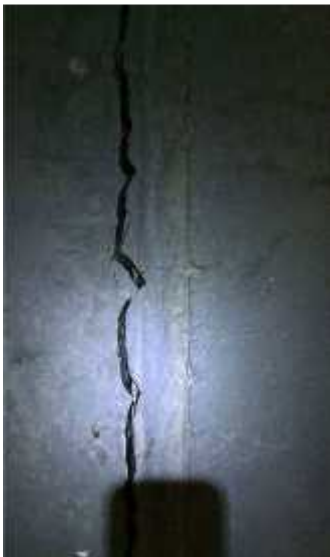
Differential vertical and horizontal movement at control joints up to 20 mm. This type of damage was observed at most of the joints.	Remove seal, remove loose concrete, reinstate concrete and replace seal

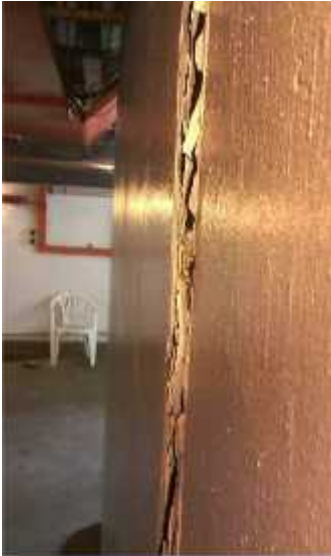
Differential vertical and horizontal movement at control joints.	As above
S12.2c

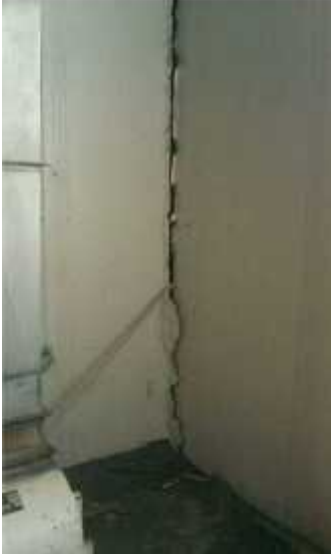
Differential vertical and horizontal movement at control joints.	As above

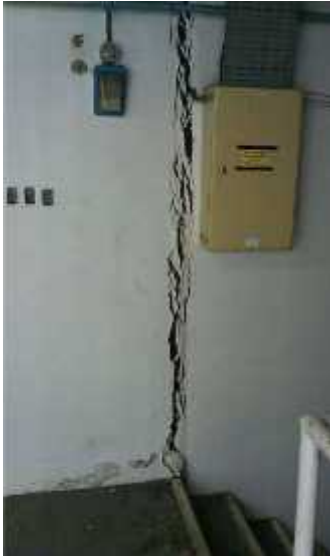
Ref.	Image	Description	Damage Type / Repair
S12.3

Large movement (approx 30 mm) at top of stairs next to Digester Control Room.	Remove seal, remove loose concrete, reinstate concrete or provide a cover plate and replace seal.

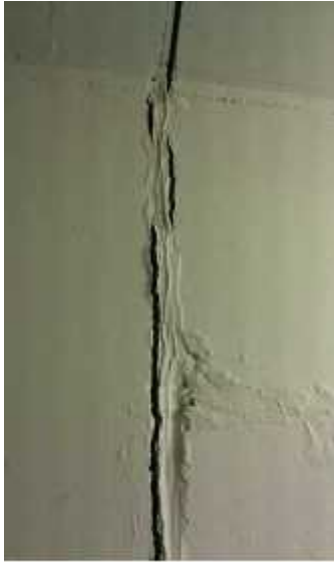
Ref.	Image	Description	Damage Type / Repair
S13.1a

Differential vertical and horizontal movement at control joints up to 20 mm. This type of damage was observed at most of the joints.	Remove seal, remove loose concrete, reinstate concrete and replace seal
S13.1b

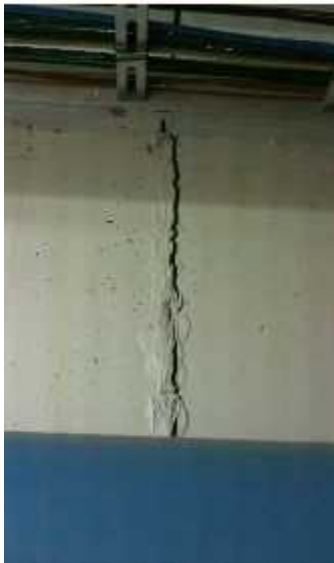
Differential vertical and horizontal movement at control joints.	As above

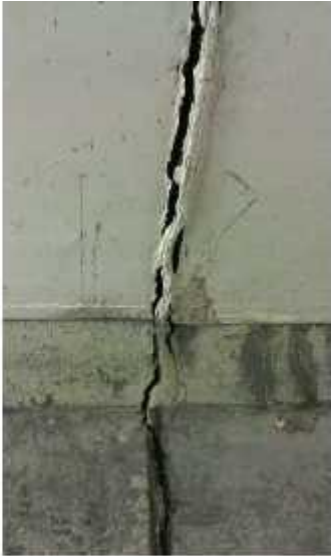
Ref.	Image	Description	Damage Type / Repair
S13.1c

Differential vertical and horizontal movement at control joints.	As above
S13.1d

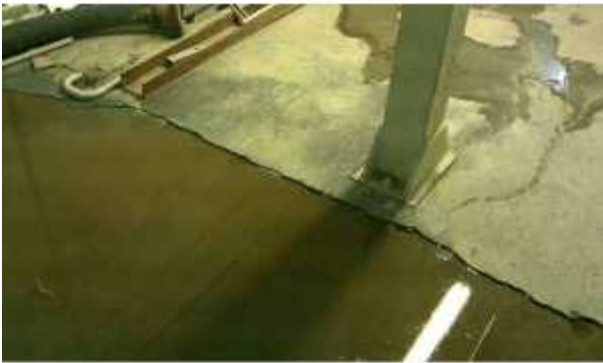
Differential vertical and horizontal movement at control joints.	As above
S13.1e

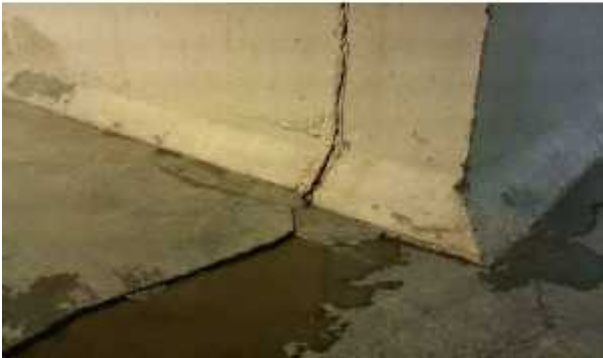
Differential vertical and horizontal movement at control joints.	As above

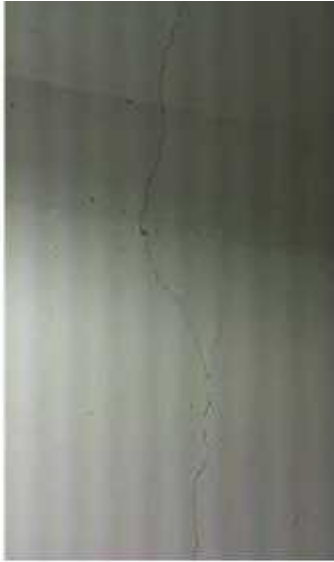
Ref.	Image	Description	Damage Type / Repair
S13.2

Cracking in walls (approx 0.3 mm crack width).	<i>Type 2.</i>  Repair with an epoxy or grout injection system
S13.3a

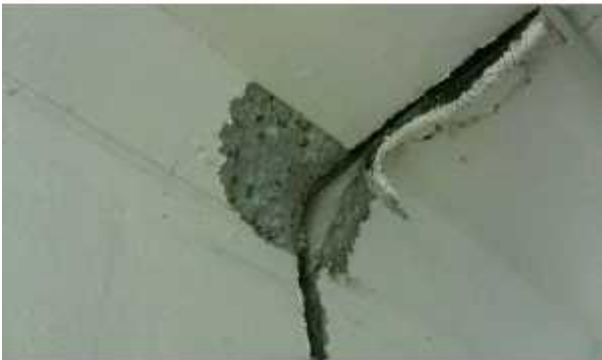
Spalling at top of walls at control joints.	<i>Type 4.</i>  Repair with structural repair mortar system.
S13.3b

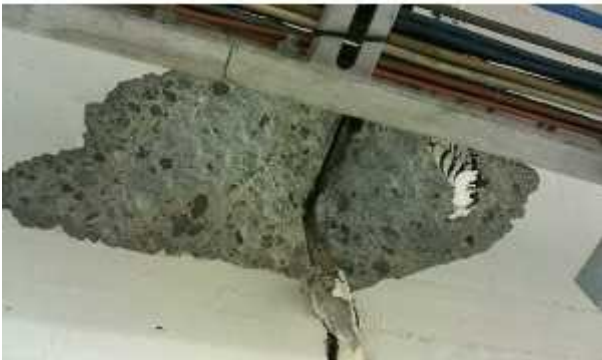
Spalling at top of walls at control joints.	<i>Type 4.</i>  Repair with structural repair mortar system.

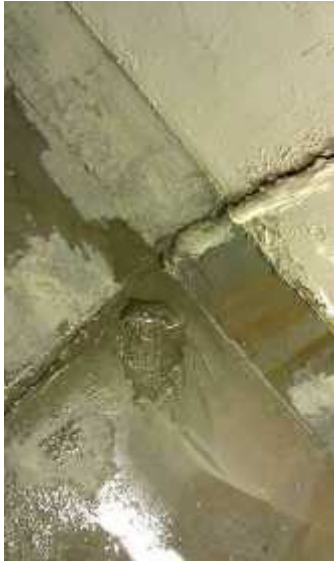
Ref.	Image	Description	Damage Type / Repair
S13.4

Evidence of leakages at joints and sand infiltration.	Remove seal, remove loose concrete, reinstate concrete and replace seal.

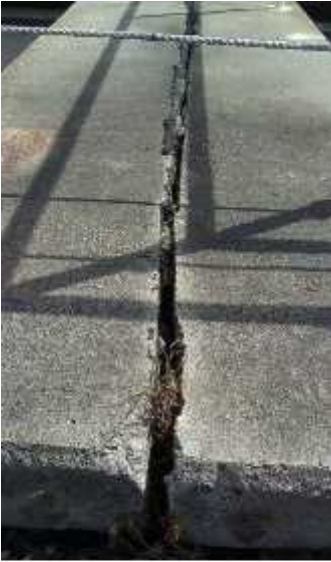
Ref.	Image	Description	Damage Type / Repair
S14.1a

Separation at joints between tanks by up to approx 15 mm.	Remove and reinstate sealing strip.
S14.1b

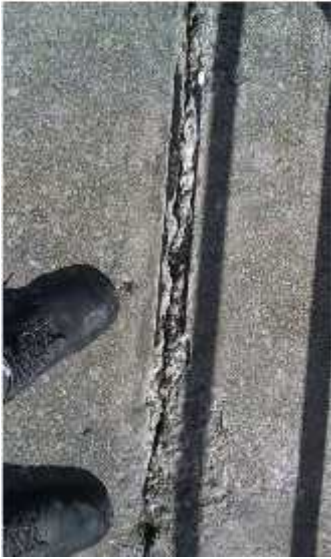
Separation at joints between tanks by up to approx 15 mm.	As above.

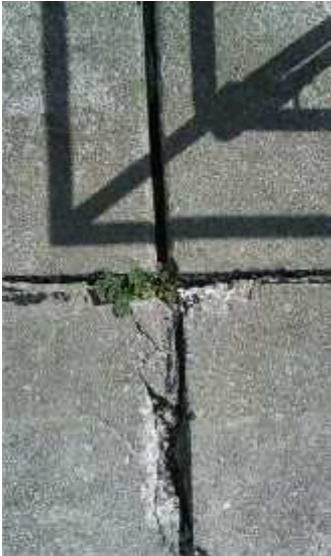
Ref.	Image	Description	Damage Type / Repair
S14.1c

Separation at joints between tanks by up to approx 15 mm.	As above
S14.2

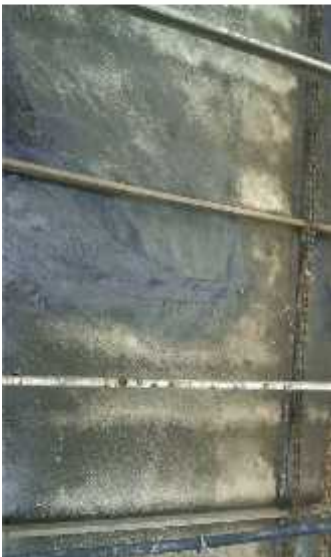
Leakage at bottom of PST1 (northern tank). Possible leakages at other tanks (could not observe most other tanks due to these either being full of wastewater or bottom being obscured).	Breakout and repair cracks / holes. If voids are present under slab fill these with flowable grout.

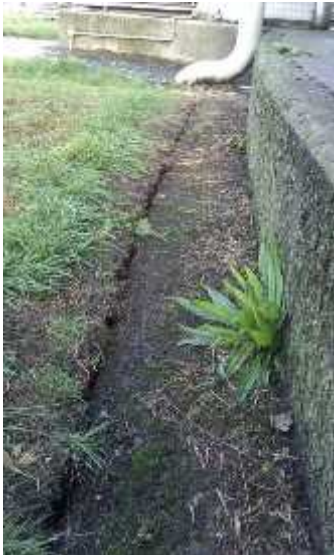
Ref.	Image	Description	Damage Type / Repair
S17.2a

Local heaving of ground or settlement of footing.	Non-structural. However, carry out level survey to confirm if any differential settlement has occurred. Re-grade as necessary.

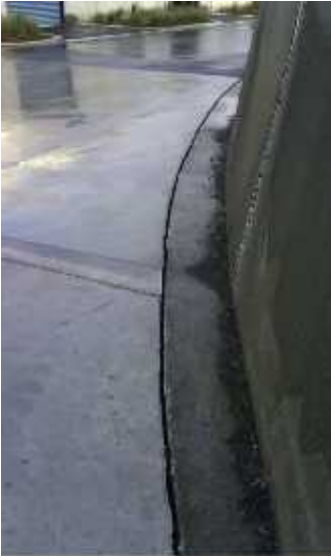
Ref.	Image	Description	Damage Type / Repair
S17.2b

Evidence of movement at base of trickling filters.	Non-structural.
S17.3a

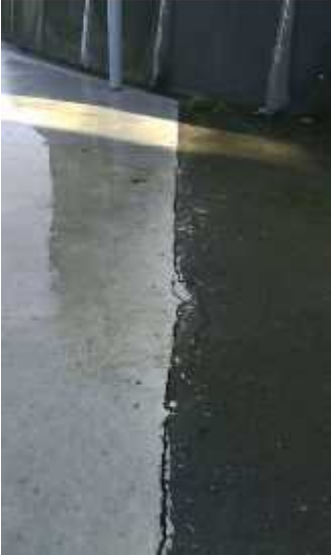
Cracked pavement at perimeter of trickling filters.	Remove damaged areas of pavement and replace.

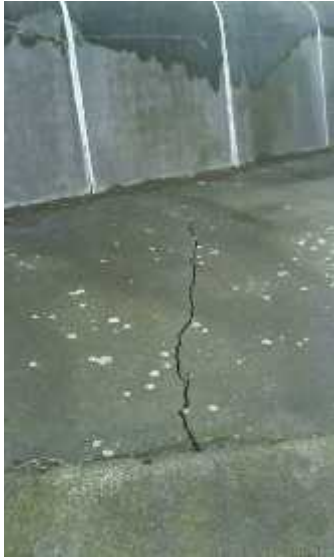
Ref.	Image	Description	Damage Type / Repair
S17.3b

Cracked pavement at perimeter of trickling filters.	Remove damaged areas of pavement and replace.

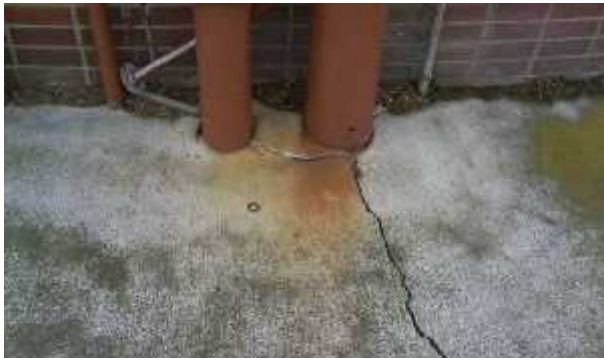
Ref.	Image	Description	Damage Type / Repair
S18.3

Cracked pavement concrete around digester tanks.	Remove and reinstate pavement concrete.
S18.4a

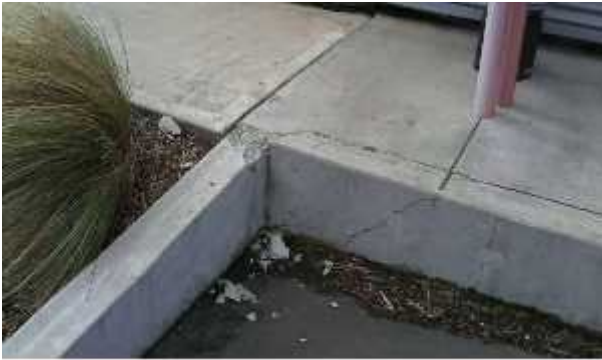
Ref.	Image	Description	Damage Type / Repair
S20.1

Spalled pavement concrete slab around perimeter of tanks.	Type 4.  Breakout loose concrete and repair with structural repair mortar system
S20.2

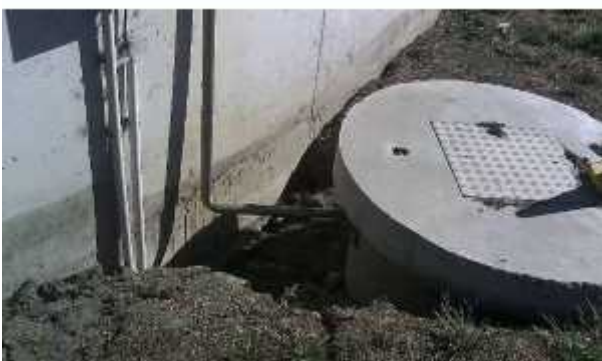
Significant settlement around the manhole structure.	Backfill and re-grade as necessary.

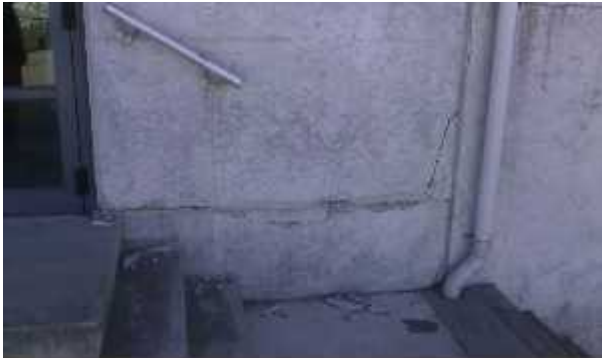
Ref.	Image	Description	Damage Type / Repair
S23.1

Cracking to panel near entry door on western side.	Type 2.  Repair with an epoxy or grout injection system
S23.2	(no image)	Diagonal cracks in wall at corner of east window.	Type 2.  Repair with an epoxy or grout injection system
S23.3

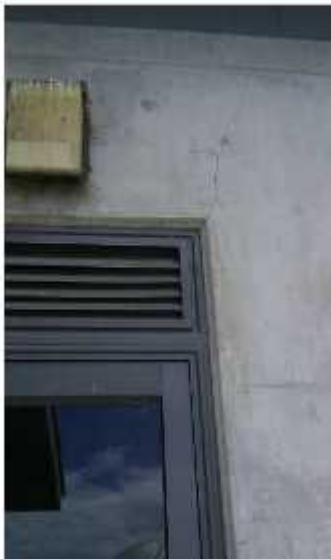
Cracks above door in east side.	Type 2.  Repair with an epoxy or grout injection system

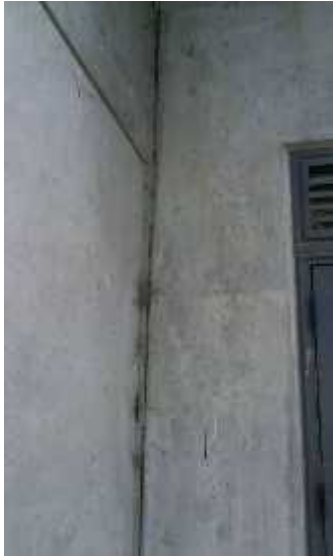
Ref.	Image	Description	Damage Type / Repair
S23.4

Approx 10 mm separation at joint between walls on eastern side.	Remove and replace sealants.
