**Clent Lane  
Housing Complex  
PRO 1091**

**Detailed Engineering Evaluation  
Quantitative Assessment Report**

**32 Cobham Street, Spreydon,**

Date: April 2014

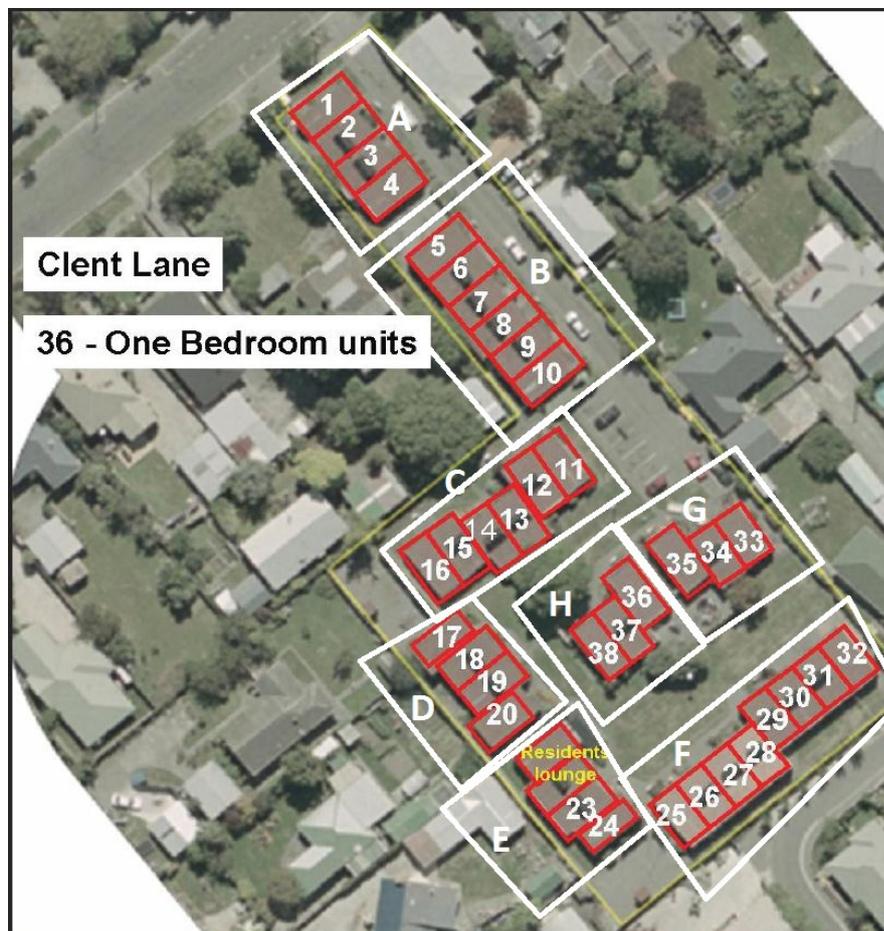
Figure 2: Site plan of Clent Lane Housing Complex.

The site contains 36 residential units which were constructed in 1977 and a resident's lounge which was converted from two residential units. The roofs of all units were replaced and interiors refurbished in 2011. A site plan showing the location of the units, numbered 1 to 38 (residential lounge occupies units 21 and 22), is shown in Figure 2. Figure 3 shows the location of the site in Christchurch City. The units are grouped together to form 7 blocks of three, four, six or eight units.

Unit 18 could not be entered due to fire damage.

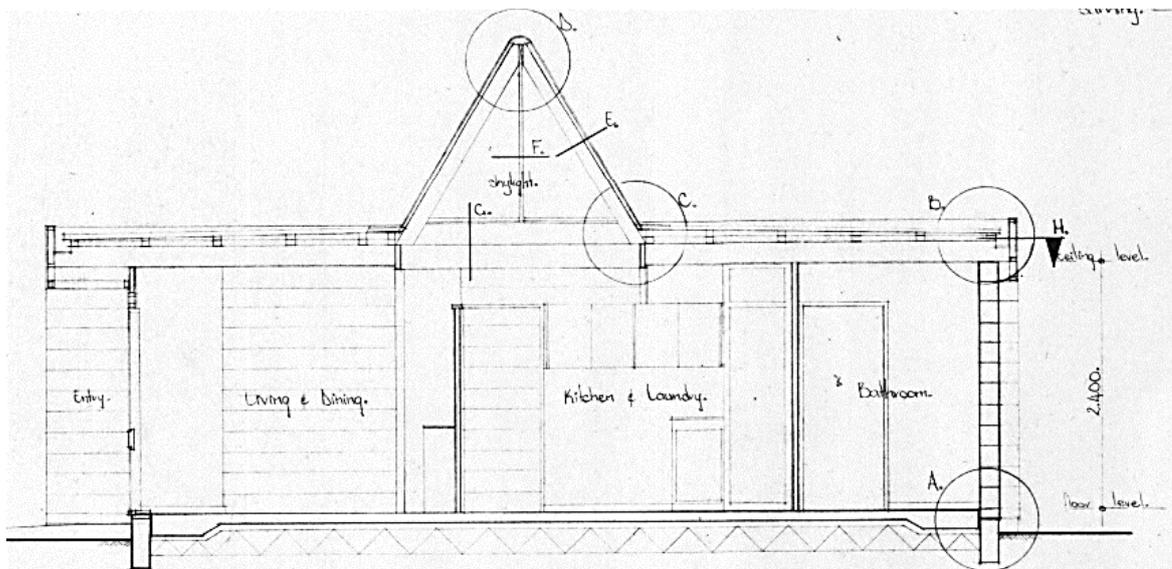
Figure 7: Comparable cross section of Clent Lane (before roof replacement).

Figure 4 and Figure 5 show floor plans of a typical residential unit and the Residents Lounge respectively produced from site measurements by Opus. Figure 7 shows a comparable cross section used in calculations, from Clent Lane prior to the roof replacement.

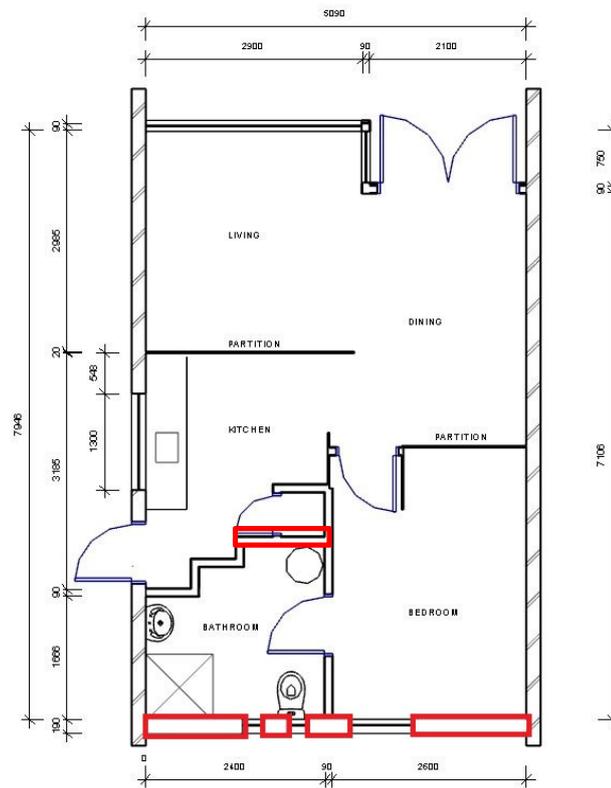
Figure 8: Walls used for bracing in the longitudinal direction residential units.

Hand calculations were performed to determine seismic forces from the current building codes. These forces were applied globally to the structure and the capacities of the walls were calculated and used to estimate the %NBS. The walls, highlighted in Figure 8 through Figure 10, were used for bracing in their respective directions.

Building Description	Critical element	% NBS based on calculated capacity in longitudinal direction	% NBS based on calculated capacity in transverse direction.
Blocks A-D and F-H	Out of plane bending of Fire Wall	41%	-
	In plane shear of bracing walls	27%	100%
Block E	Out of plane bending of Fire Wall A (Figure 10) with temporary propping	55%	-
	In plane shear of bracing walls in residential units	27%	100%

- Strengthening schemes be developed to bring the capacities of the structures to at least 67%NBS.
- Cracking in the concrete bond beam and block firewall be repaired.
- Replace temporary propping with permanent strengthening solution.
- Cosmetic repairs be undertaken as required.

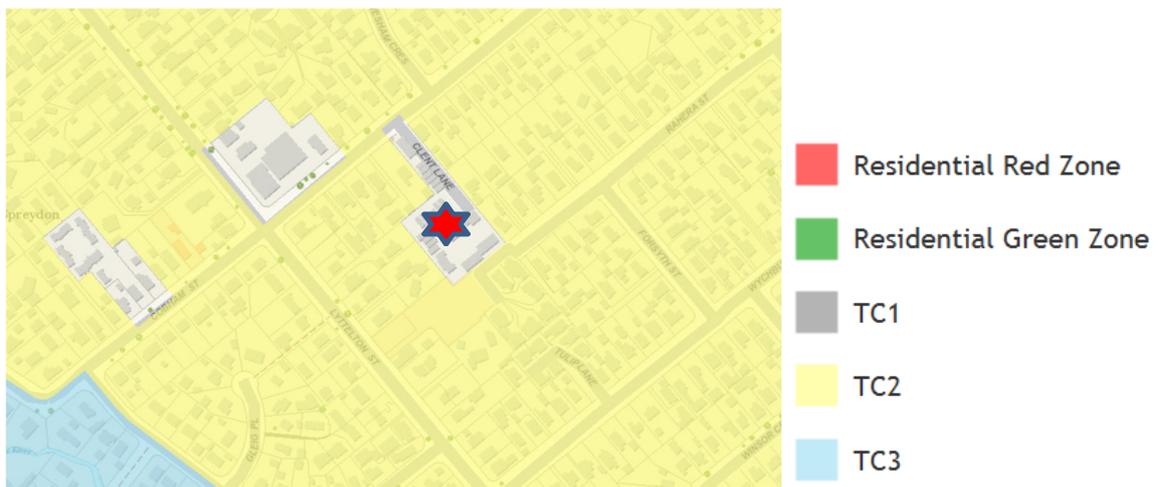
**Figure 12: CERA Technical Categories map (loc. starred).**

CERA indicates that Clent Lane is located in a TC2 zone (as shown in Figure 12). This classification suggests future significant earthquakes will cause minor to moderate land damage due to liquefaction and settlement.

There is no evidence to suggest that further geotechnical investigation is warranted for this site.
