**Coles Place  
Housing Complex  
PRO 0616**

**Detailed Engineering Evaluation  
Quantitative Assessment Report**

**21-49 Coles Place, St Albans, 8014**

Date: January 2014  
Reference: 6-QC332.00  
Status: Final

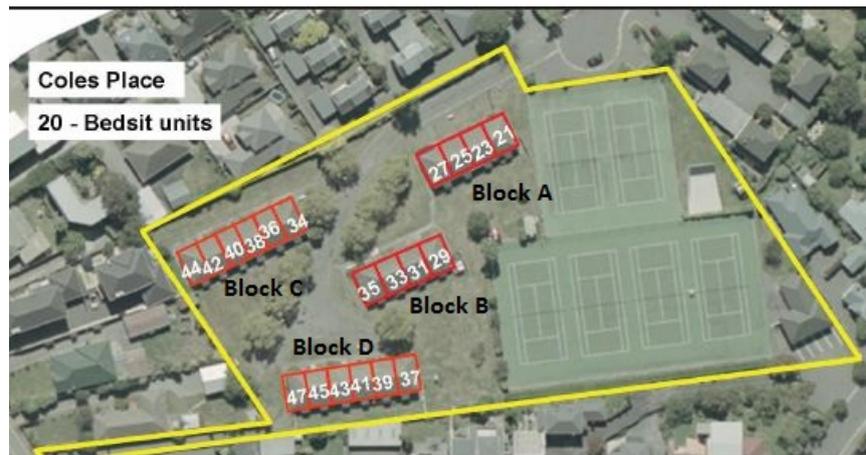
Figure 2: Site plan of Coles Place Housing Complex.

The site contains 20 residential units which were constructed in 1953. A site plan showing the location of the units, numbered 21 to 47 (odd numbers only) and 34 to 44 (even numbers only), is shown in Figure 2. Figure 3 shows the location of the site in Christchurch City. The units are grouped together to form blocks of either four or six units.

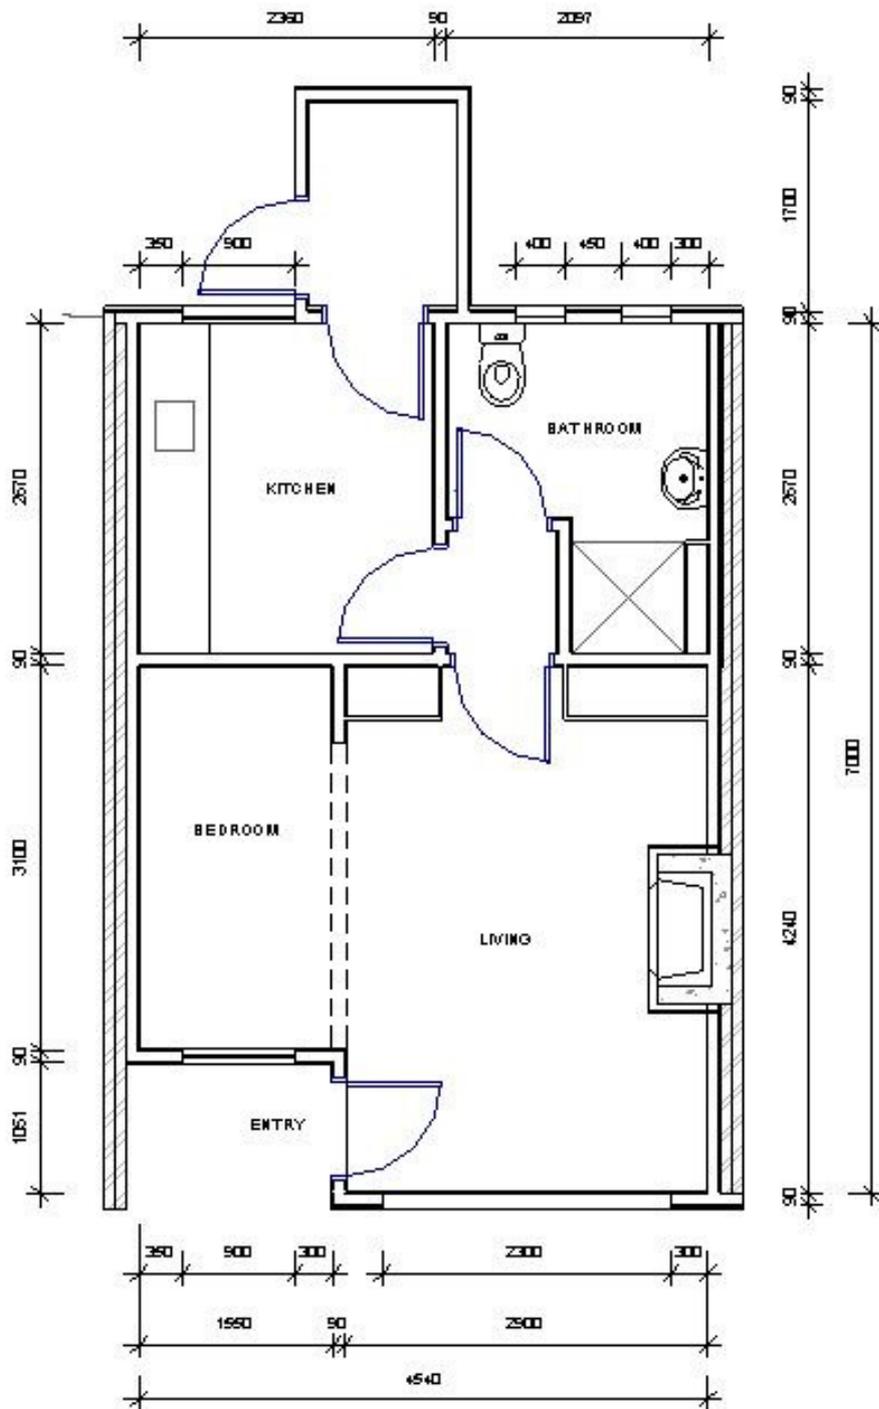
Figure 4: Typical partial floor plan of a residential unit.

Figure 4 shows a typical floor plan of a residential unit produced from site measurements by Opus. Figure 5 shows a comparable cross section used in calculations, from Barnett Avenue.

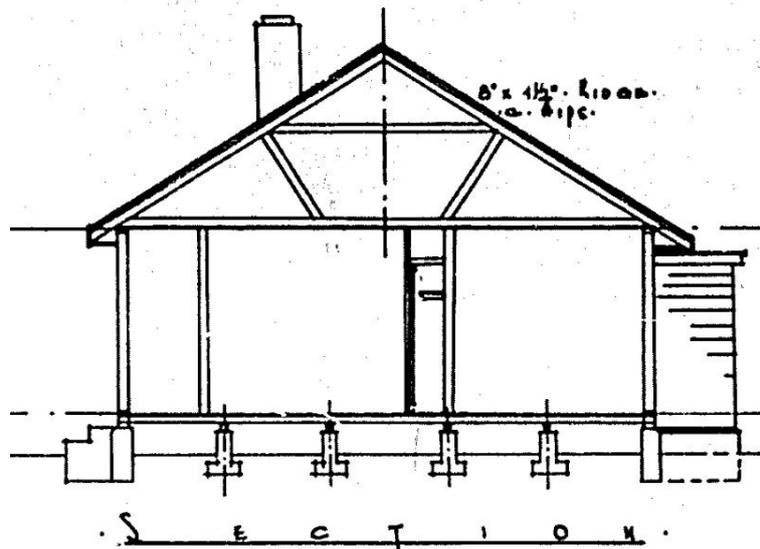
Figure 5: Comparable cross section, from Barnett Ave (chimneys removed).

The residential units are timber-framed buildings with diagonal timber braces. The roof structure comprises of timber roof framing supporting heavy, concrete tile roofs. The walls and ceilings are lined with lathe and plaster. External walls are clad with light timber weatherboards. Foundations consist of a concrete perimeter foundation with concrete piles supporting timber floors.

The units are separated by a 260mm thick double brick fire wall with every fourth course used as a header course (based on information available for other similar blocks of the same era).

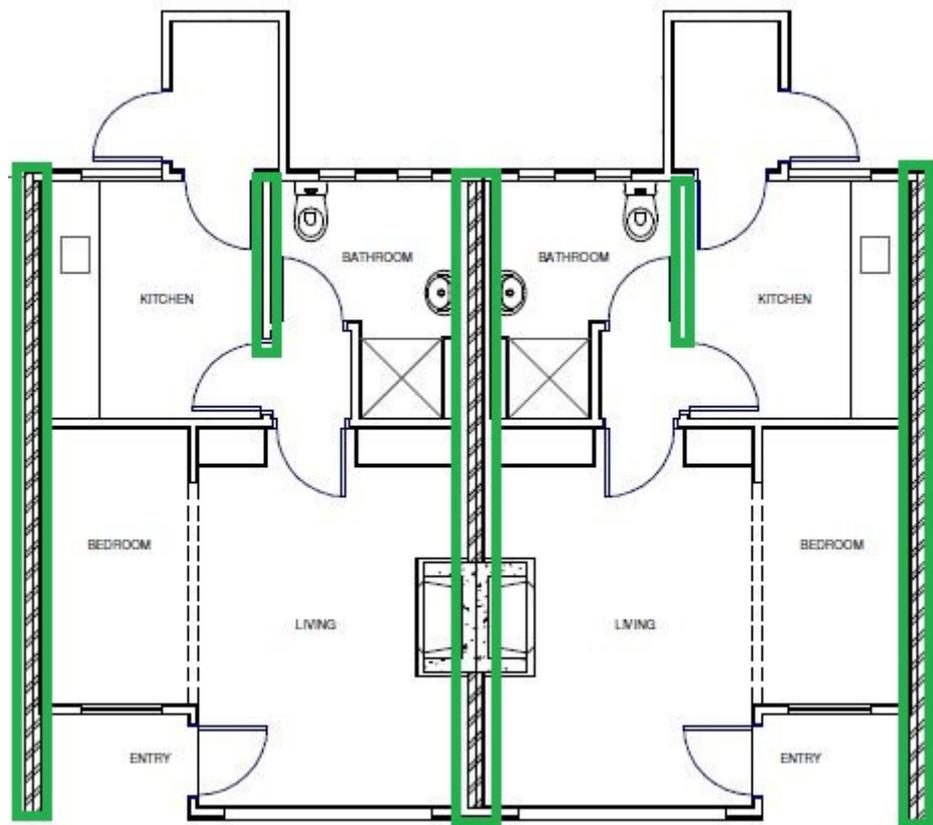
Figure 7: Walls used for bracing in the transverse direction.

Hand calculations were performed to determine seismic forces from the current building codes. These forces were applied globally to the structure and the capacities of the walls were calculated and used to estimate the %NBS. The walls, highlighted in Figure 6 and Figure 7, were used for bracing in their respective directions.

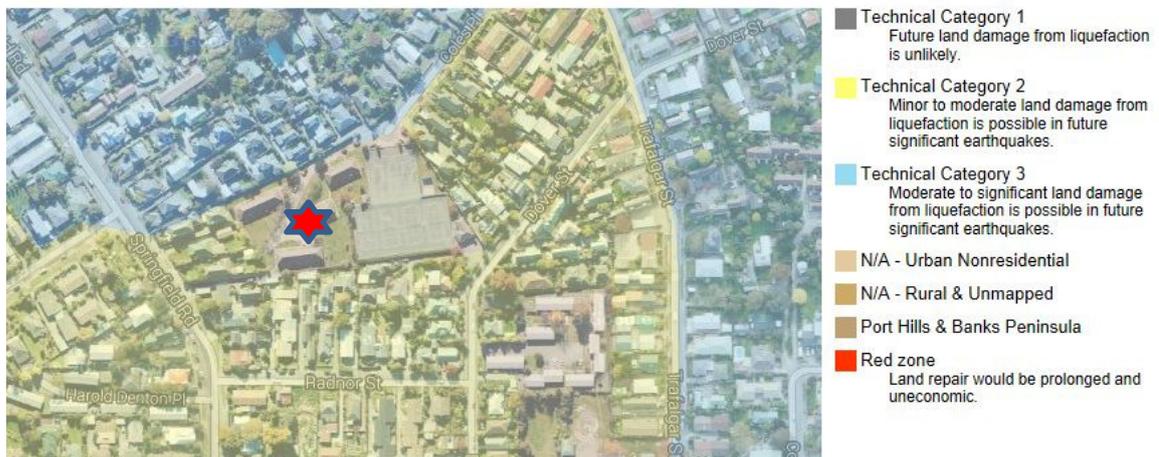
**Figure 8: CERA Technical Categories map (loc. starred).**

CERA indicates that Coles Place is located in a TC2 zone (as shown in Figure 8). This classification suggests future significant earthquakes will cause minor to moderate land damage due to liquefaction and settlement.

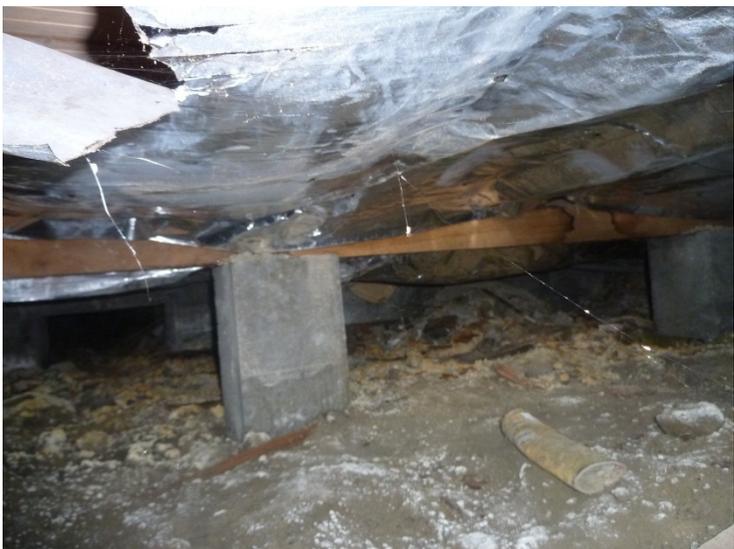
It is noticeable that none of the residential unit blocks, and individual units, have suffered any significant earthquake damage. It is noted that units 29, 37, 42 have areas where rotten floor boards are present.

| <p>8.</p> | <p>Typical floor void</p> | |

- The concrete perimeter footings be repaired on blocks where cracking occurs.
- A site specific geotechnical site investigation be carried out to determine the liquefaction potential of the site and the shallow bearing capacities of the soils if this information is required for future construction on the site.
- Cosmetic repairs be undertaken as required.
- Veneer at height (gable ends) have their veneer ties checked.
- All buildings be strengthened to at least 67% NBS.
- Repairs be undertaken to replace rotten floor boards.
