Cowles Stadium, Wainoni, Christchurch

QUANTITATIVE ASSESSMENT OF STRUCTURE

- Report 3
- 20 December 2011

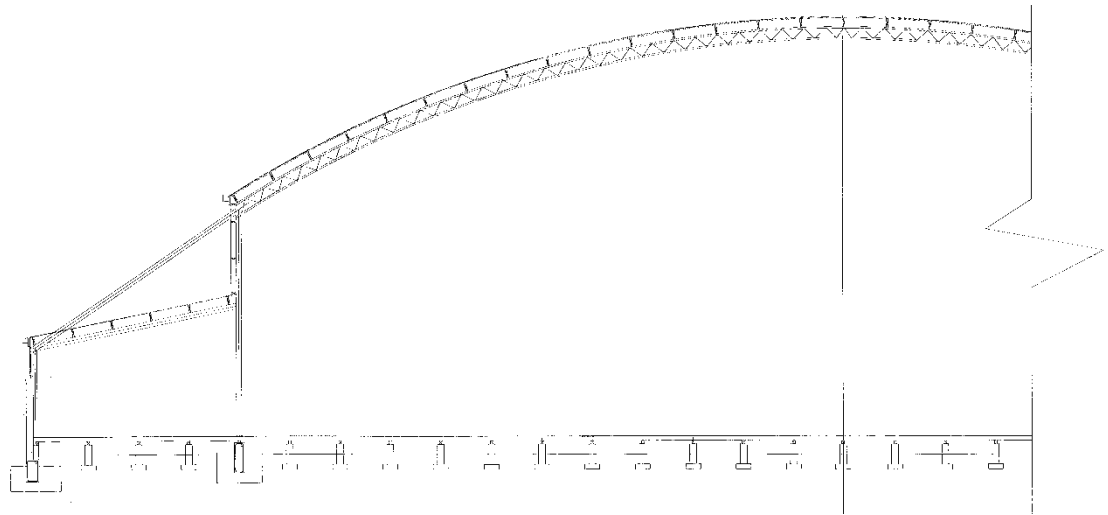
Figure 1 Typical cross section

The hall roof is supported by seven shallow trussed arches spaced at 5.71m (Figure 1) plus the two end-walls. By “trussed arches” we mean that they are fabricated like trusses and look like trusses but their structural actions are, primarily, that of an arch hence working primarily in compression under gravity loads. However under seismic actions bending in the roof arches will occur and this is resisted partially in truss action. The trussed arches support simple timber purlins and sarking with aluminium cladding above.

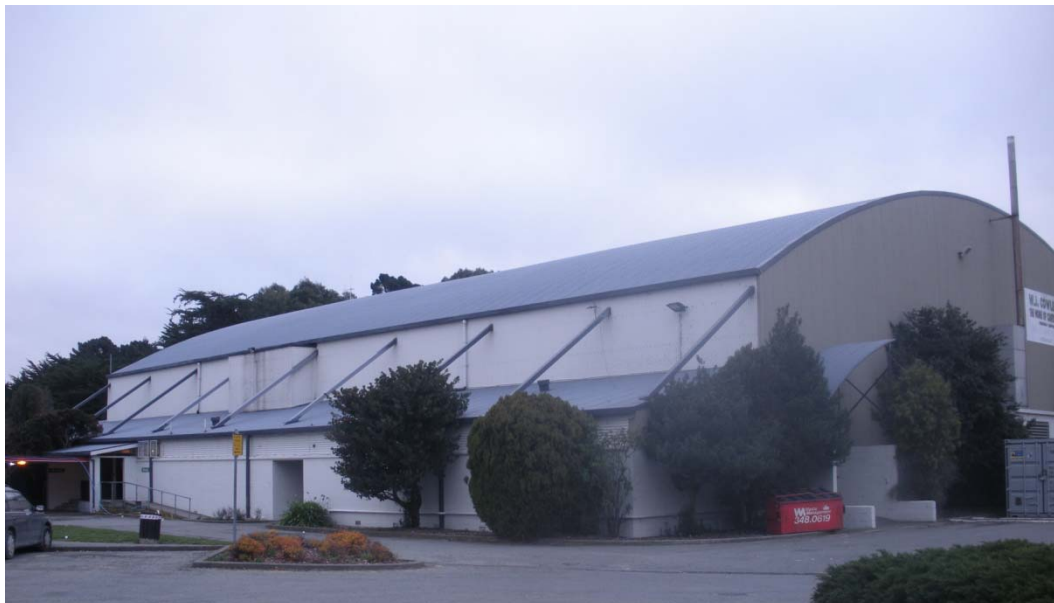
Cowles Stadium (Photo 1) is primarily a single hall containing two basketball courts (Photo 2) plus tiered seating at one end equal in area to about a further half court. There is a lean-to area down each of the long sides of the hall which provide storage, changing/toilet facilities, kitchen and the like. The hall is orientated on a North-East axis with overall dimensions of the hall at 45.7m x 36.6m and the lean-tos at 6.1m wide. The South-East lean-to extends beyond the end of the hall by about 20m (Umpires Room) but this appears to be subsequent construction.

Photo 1 – External view.

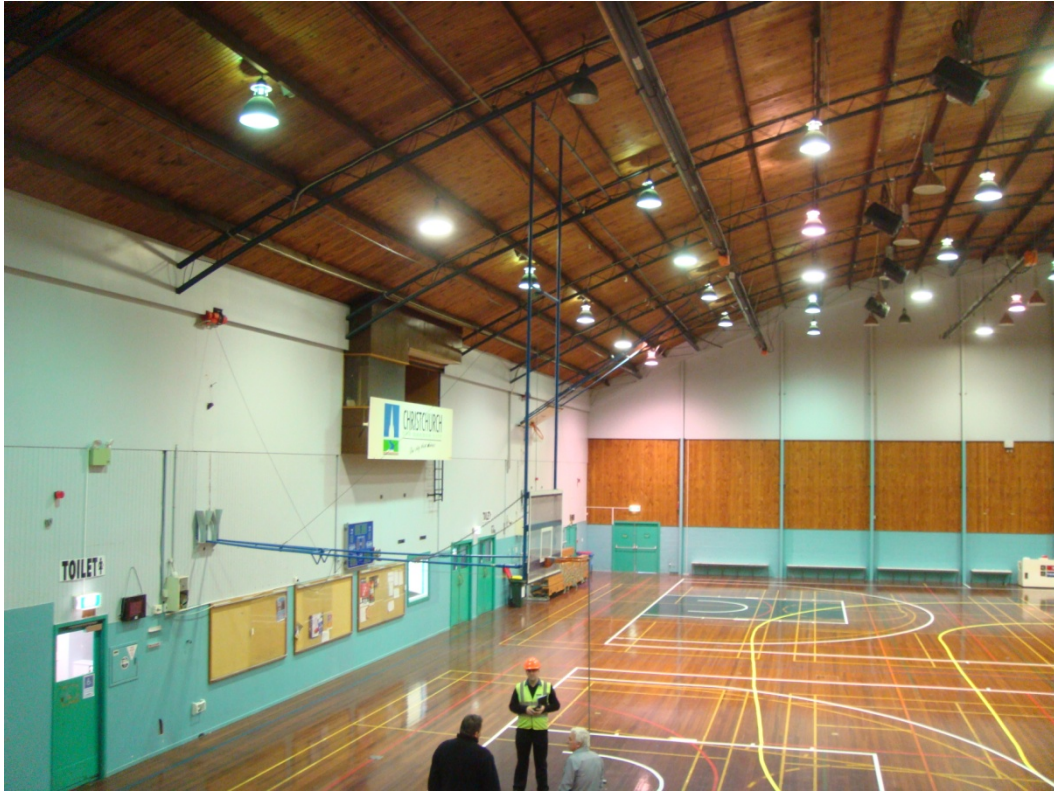
Photo 2 – Internal view
