CHRISTCHURCH CITY COUNCIL
PRK_3616_BLDG_005 EQ2
Duvauchelle Reserve – Toilet Block 1 &
Changing Rooms
Seafield Rd, Duvauchelle

QUALITATIVE ASSESSMENT REPORT
FINAL

- Rev C
- 23 May 2013

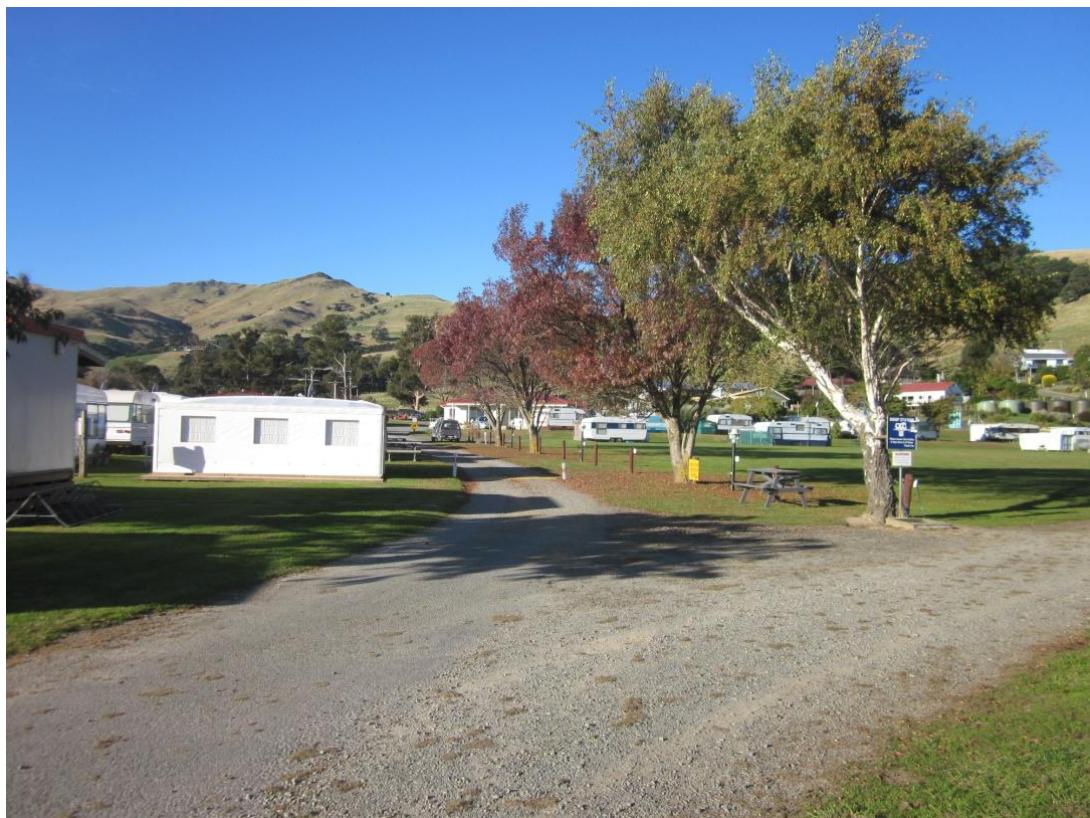
The only evidence of earthquake damage to the onsite structures was shear cracking to the masonry clad toilet. There is no evidence of any land damage.

▪ **Figure 4 Overview of the site looking north east.**
