Fendalton Library & Service Centre BU 0450-001 EQ2

**Detailed Engineering Evaluation
Quantitative Assessment Report**

Date: November 2012
Reference: 6-QUCCC.27
Status: Final

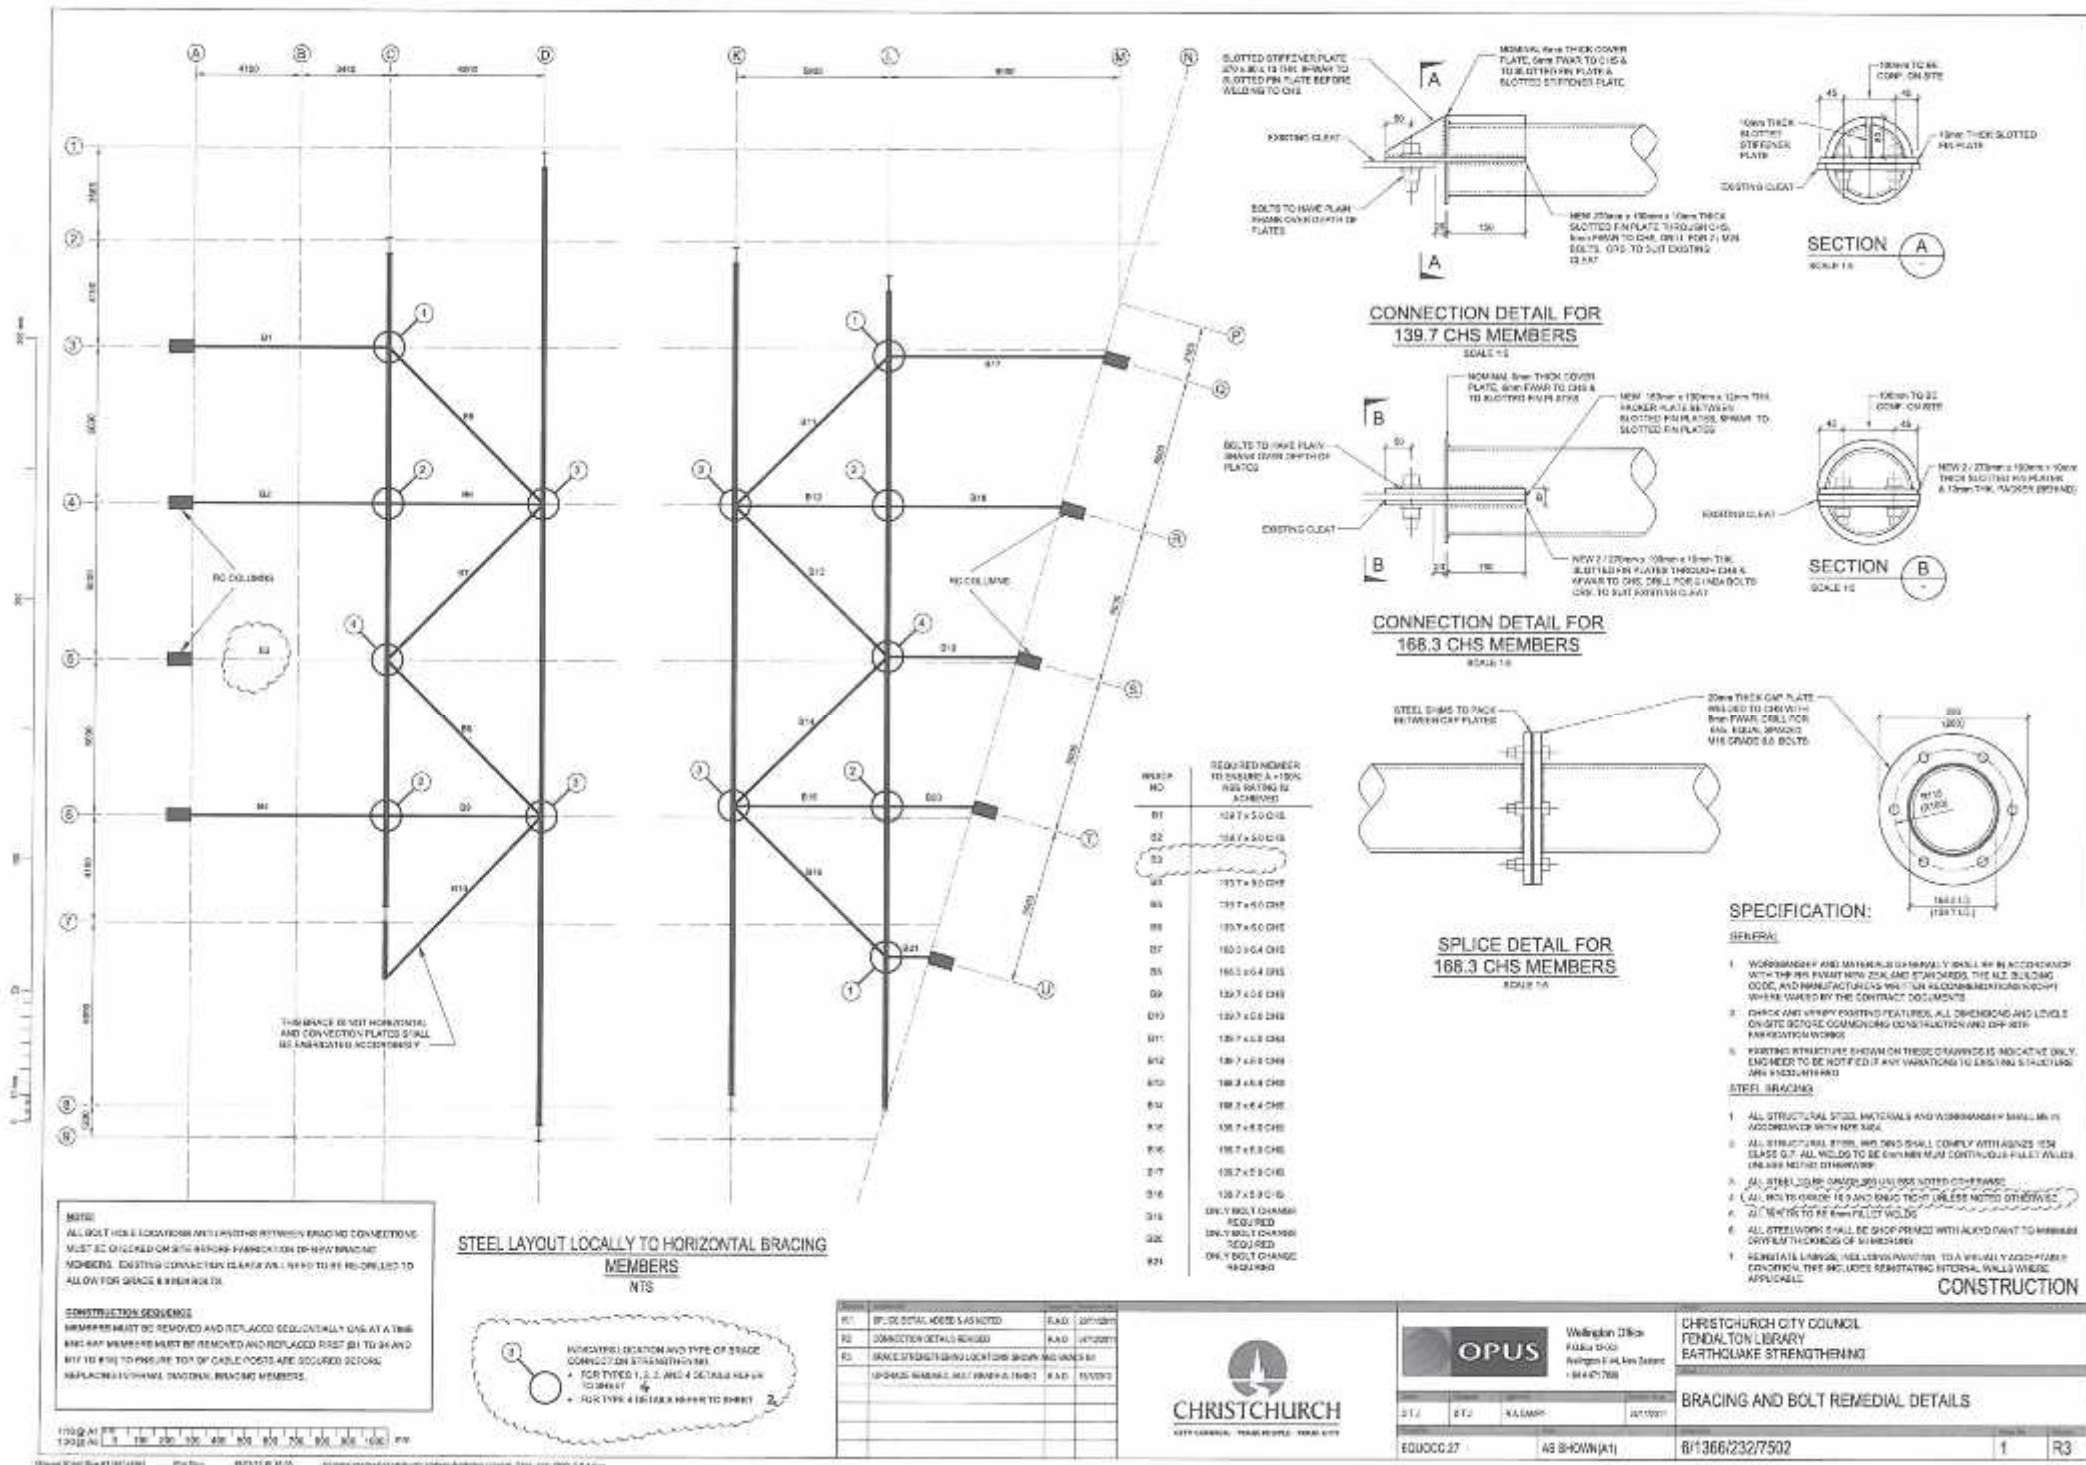
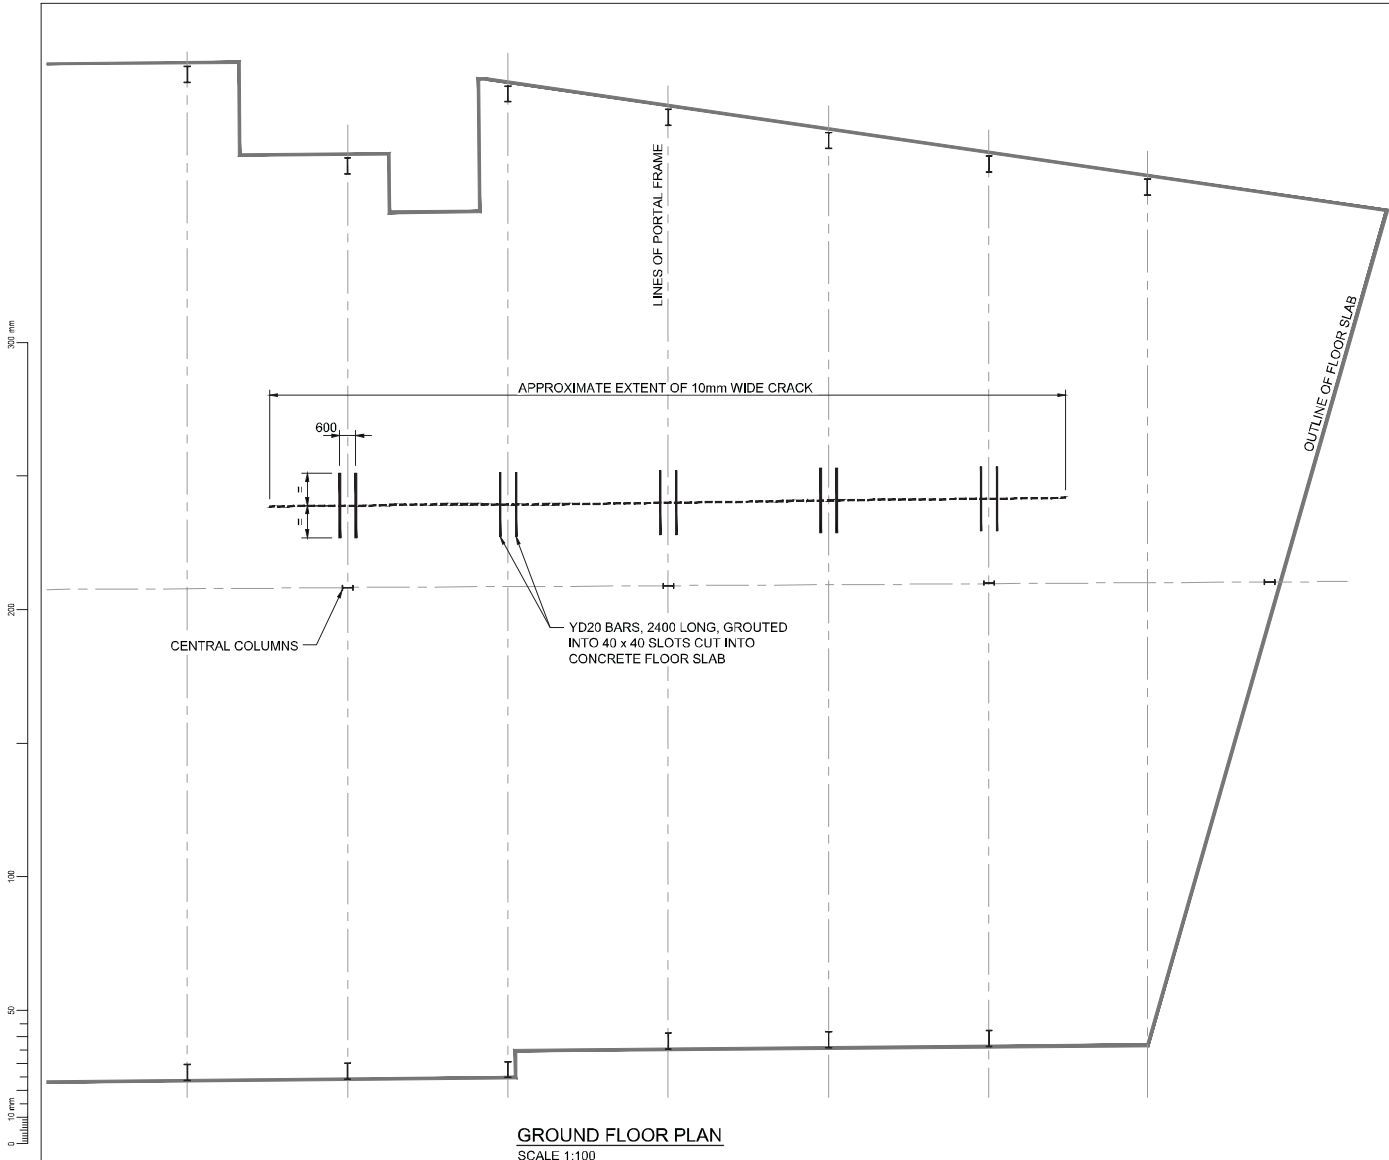
Sheet:
REMEDIAL WORK TO FLOOR SLAB CRACKS

Structural damage in the Canterbury earthquake sequence was limited to cracking in the ground floor concrete slab. These have now been repaired.
