CHRISTCHURCH CITY COUNCIL
PRK_0348_BLDG_005 EQ2
The Groynes – Dwelling No.1
182 Johns Road

**QUANTITATIVE ASSESSMENT REPORT
FINAL**

- Rev B
- 26 March 2013

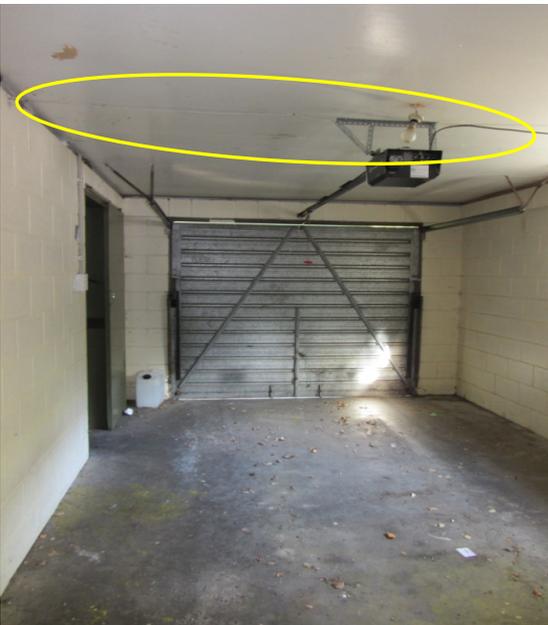
Photo 21: North-West Garage / Storage Room

- 11) Hairline cracking present along ceiling lining joints in the north-west garage/ storage room (PHOTO 21 & 22).

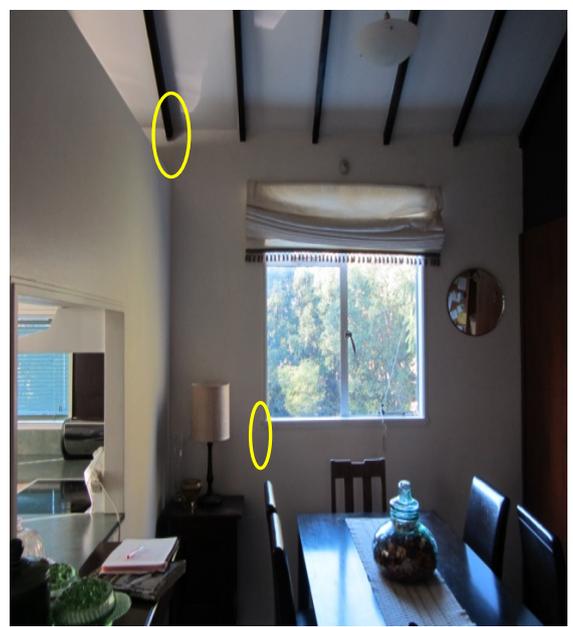
Photo 34: Dining Area

16) Vertical hairline crack present at wall lining joint under the eastern corner of the south wall window (PHOTO 34 & 35).

17) Hairline crack present at wall lining joint on the south wall. Crack located above the kitchen partition wall (PHOTO 34, 36 & 37).

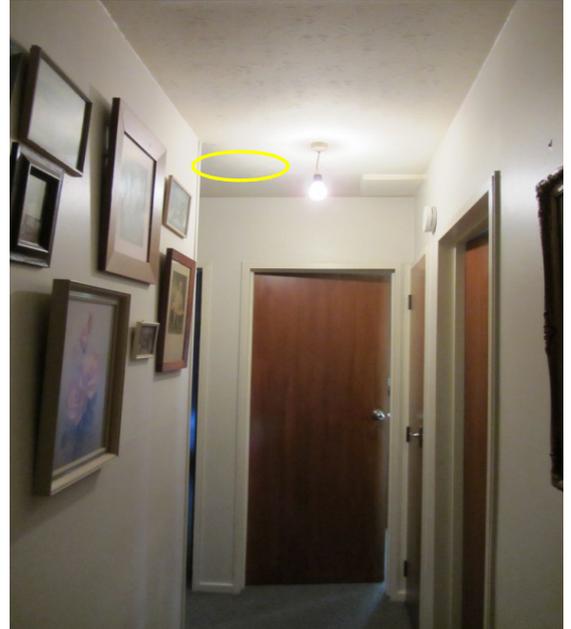
Photo 40: Hallway – Looking West

19) Hairline crack present in the ceiling lining joint in the south-west corner (PHOTO 40, 41 & 42).

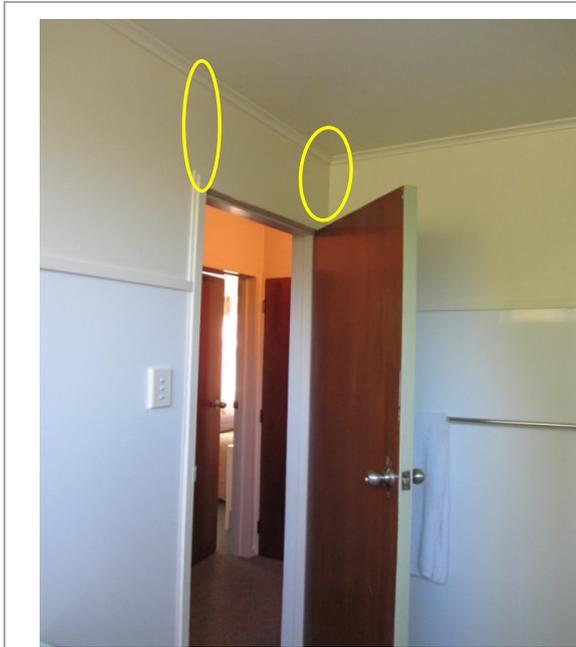
Photo 43: Bathroom

20) Hairline cracking present along wall lining joint above the southern corner of the bathroom doorway (PHOTO 43 & 44)

21) Hairline cracking along wall lining joint in the north-west corner (PHOTO 43 & 45)

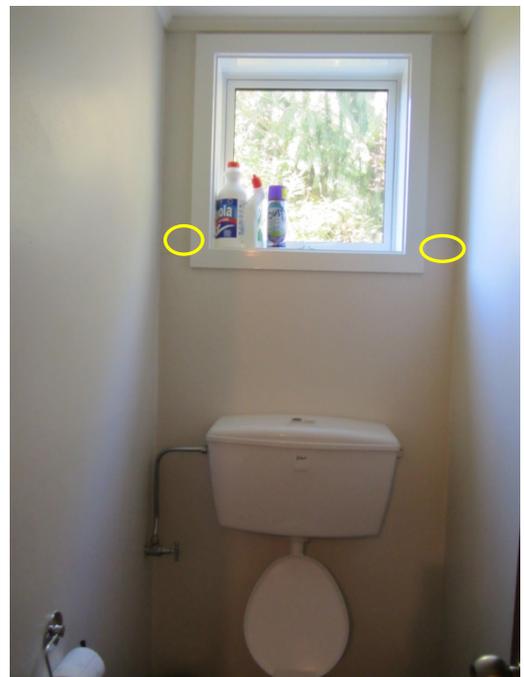
Photo 46: Toilet

23) Hairline cracking present along the wall lining joints each side of the window (PHOTO 46 & 47).
