Haast Courts-Block K - Garages 16 - 18
BU 0792-011 EQ2
Detailed Engineering Evaluation
Quantitative Report
Version FINAL

43 Haast Street, Linwood

Christchurch City Council

Date
20th December 2012

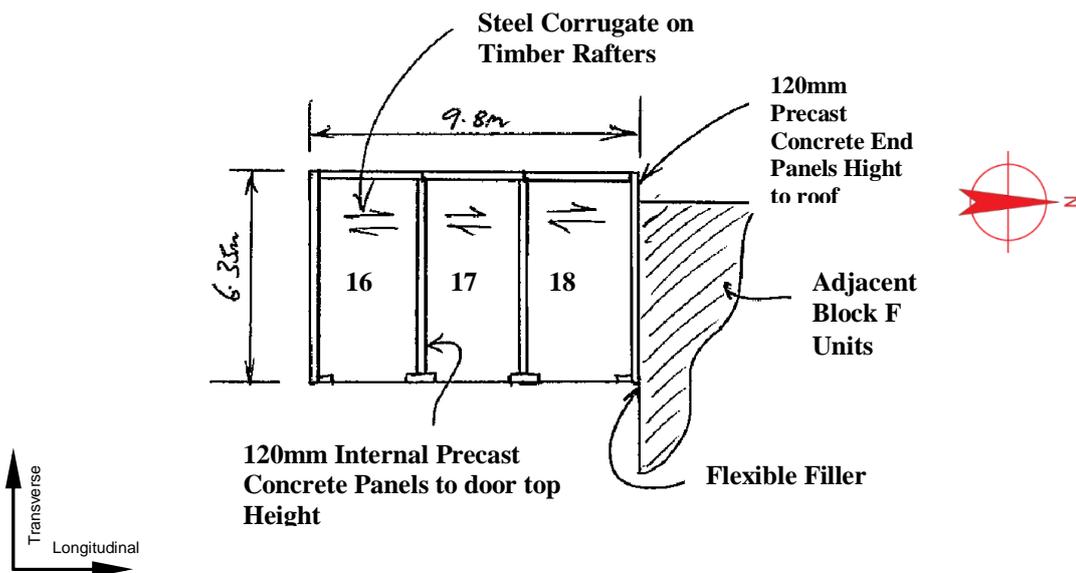
Figure 4.1 Plan of Original Structure

The main structural components are reinforced precast concrete panels. The flat roof consists of lightweight corrugated metal sheeting on timber roof joists spanning between the reinforced precast concrete partition walls. The reinforced precast concrete wall panels are supported on reinforced concrete strip footings with the floor being formed by a reinforced concrete slab on grade.

The building is approximately 6.3m wide by 9.8m long, and stands 2.25m high with plan area of approximately 62m². The nearest building to Haast Courts Block K is Haast Courts Block F, adjoining the building to the north. The nearest waterway to the flat site is the Avon River, approximately 250m to the north.

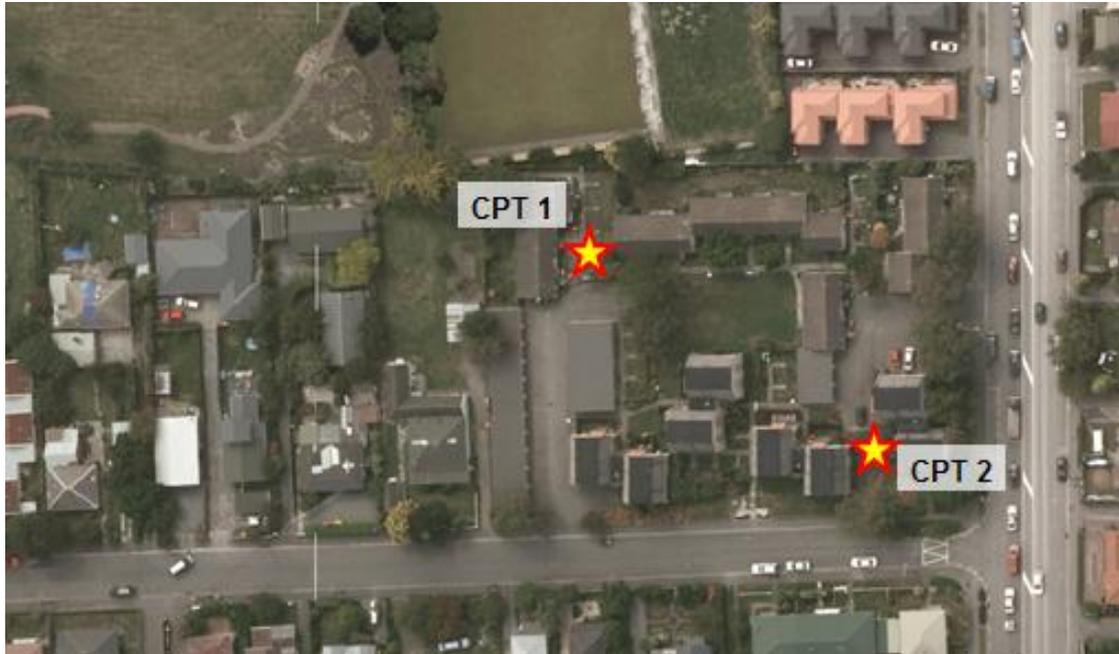
Figure 8.2 Aerial Photograph depicting CPT Investigation Locations³

In order to further understand the ground conditions at the site, intrusive testing comprising two piezocone CPT investigations were conducted at the site on 28 June 2012. The locations of the tests are indicated on Figure 8.2 below.

The CPT investigations were undertaken by McMillans Drilling Ltd on 28 June 2012, typically to a target depth of 20m below ground level. However, testing was continued to depths of 23m bgl and 27.9m bgl due to the presence of soft silts and loose sands at 20m. Please refer to Appendix C for CPT logs.

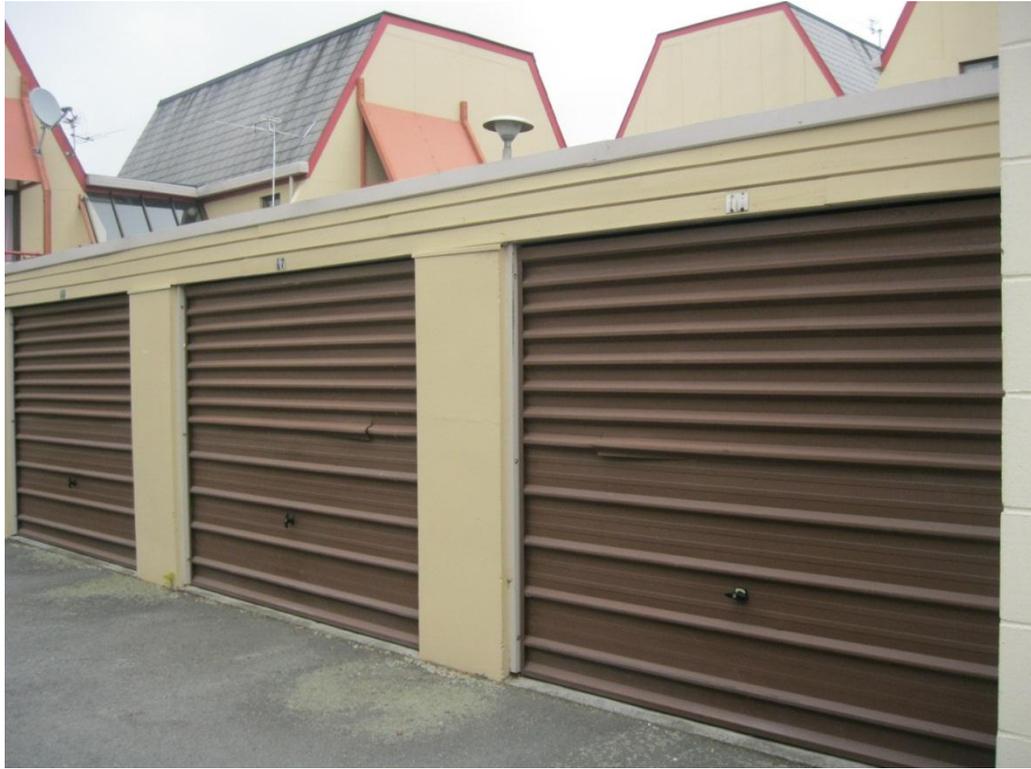
Photo 1. Eastern elevation with garage door openings.

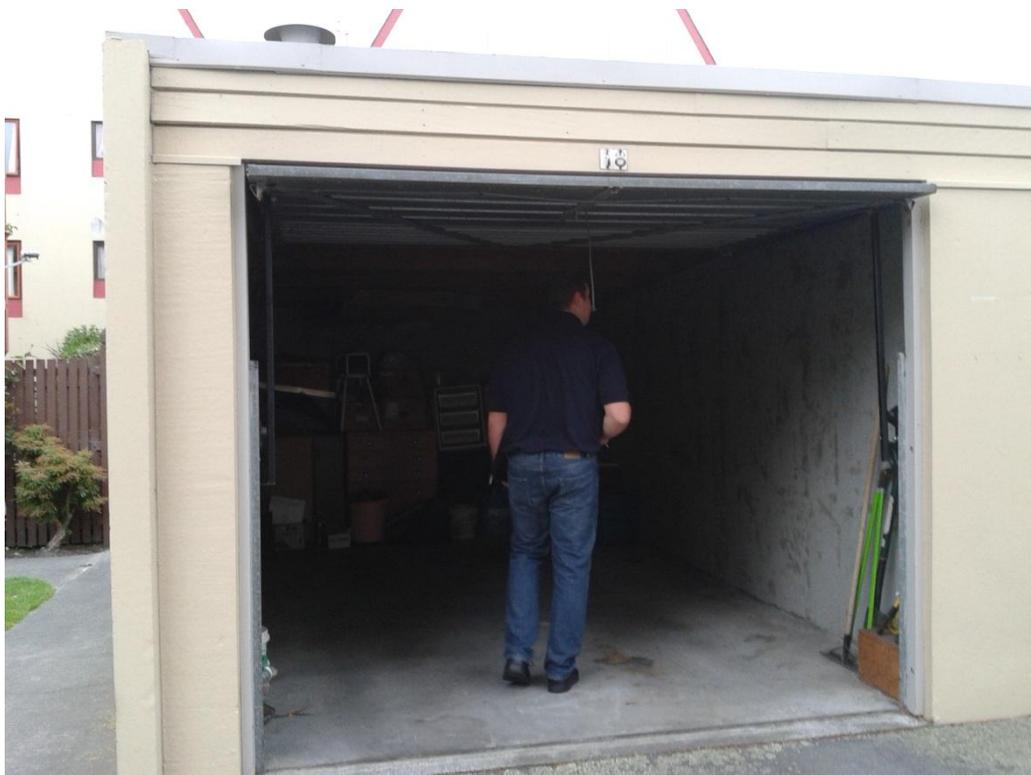
There were no residual displacements identified in the structure. Minor cracking was identified in the reinforced concrete floor slab and precast concrete wall panels, however it is unclear whether this damage is earthquake related. The cracking will not affect structural performance of the elements.

Photo 2. Interior of Garage.

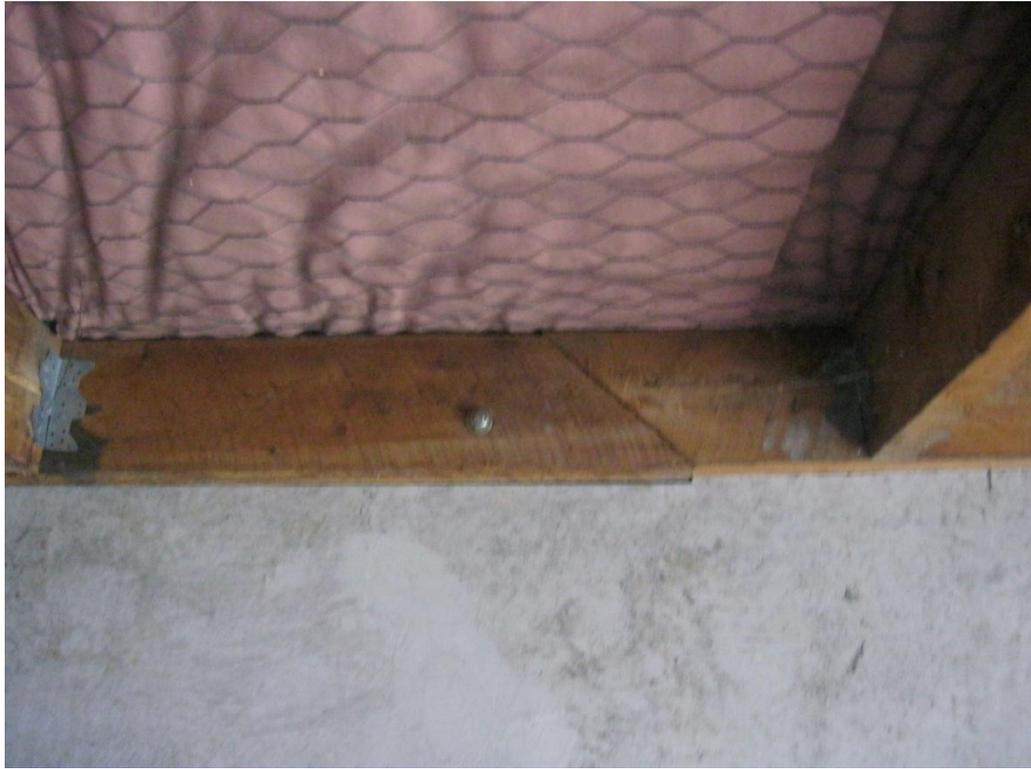
Photo 3. Timber roof construction.

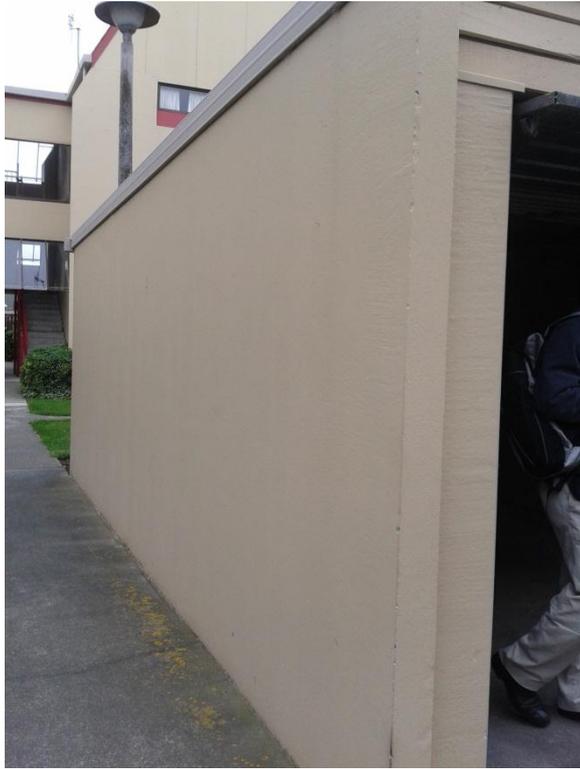
Photo 7. Southern gable wall of structure.

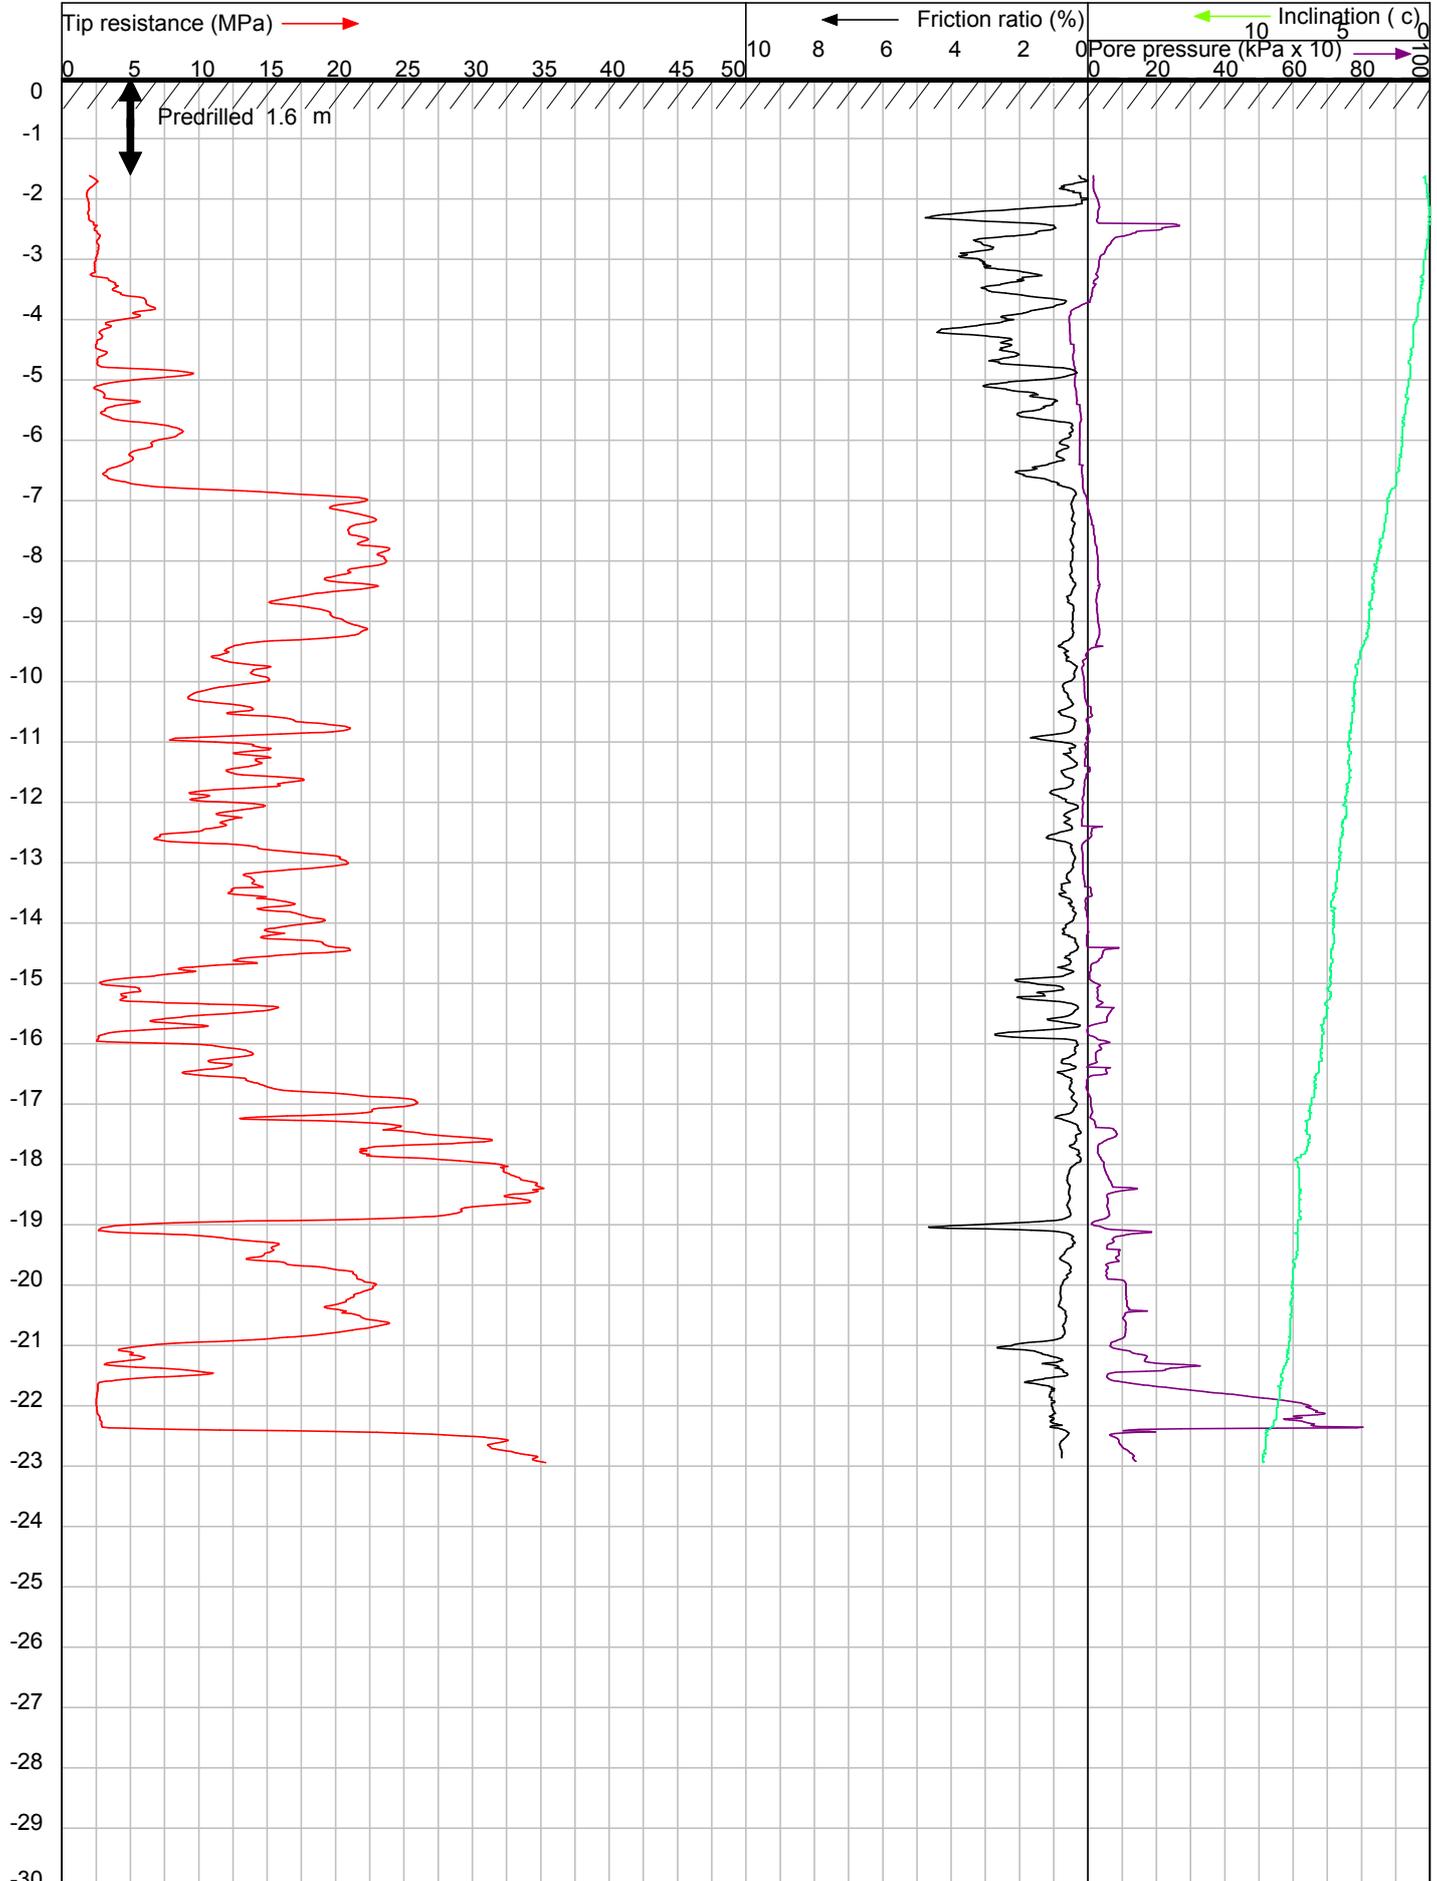
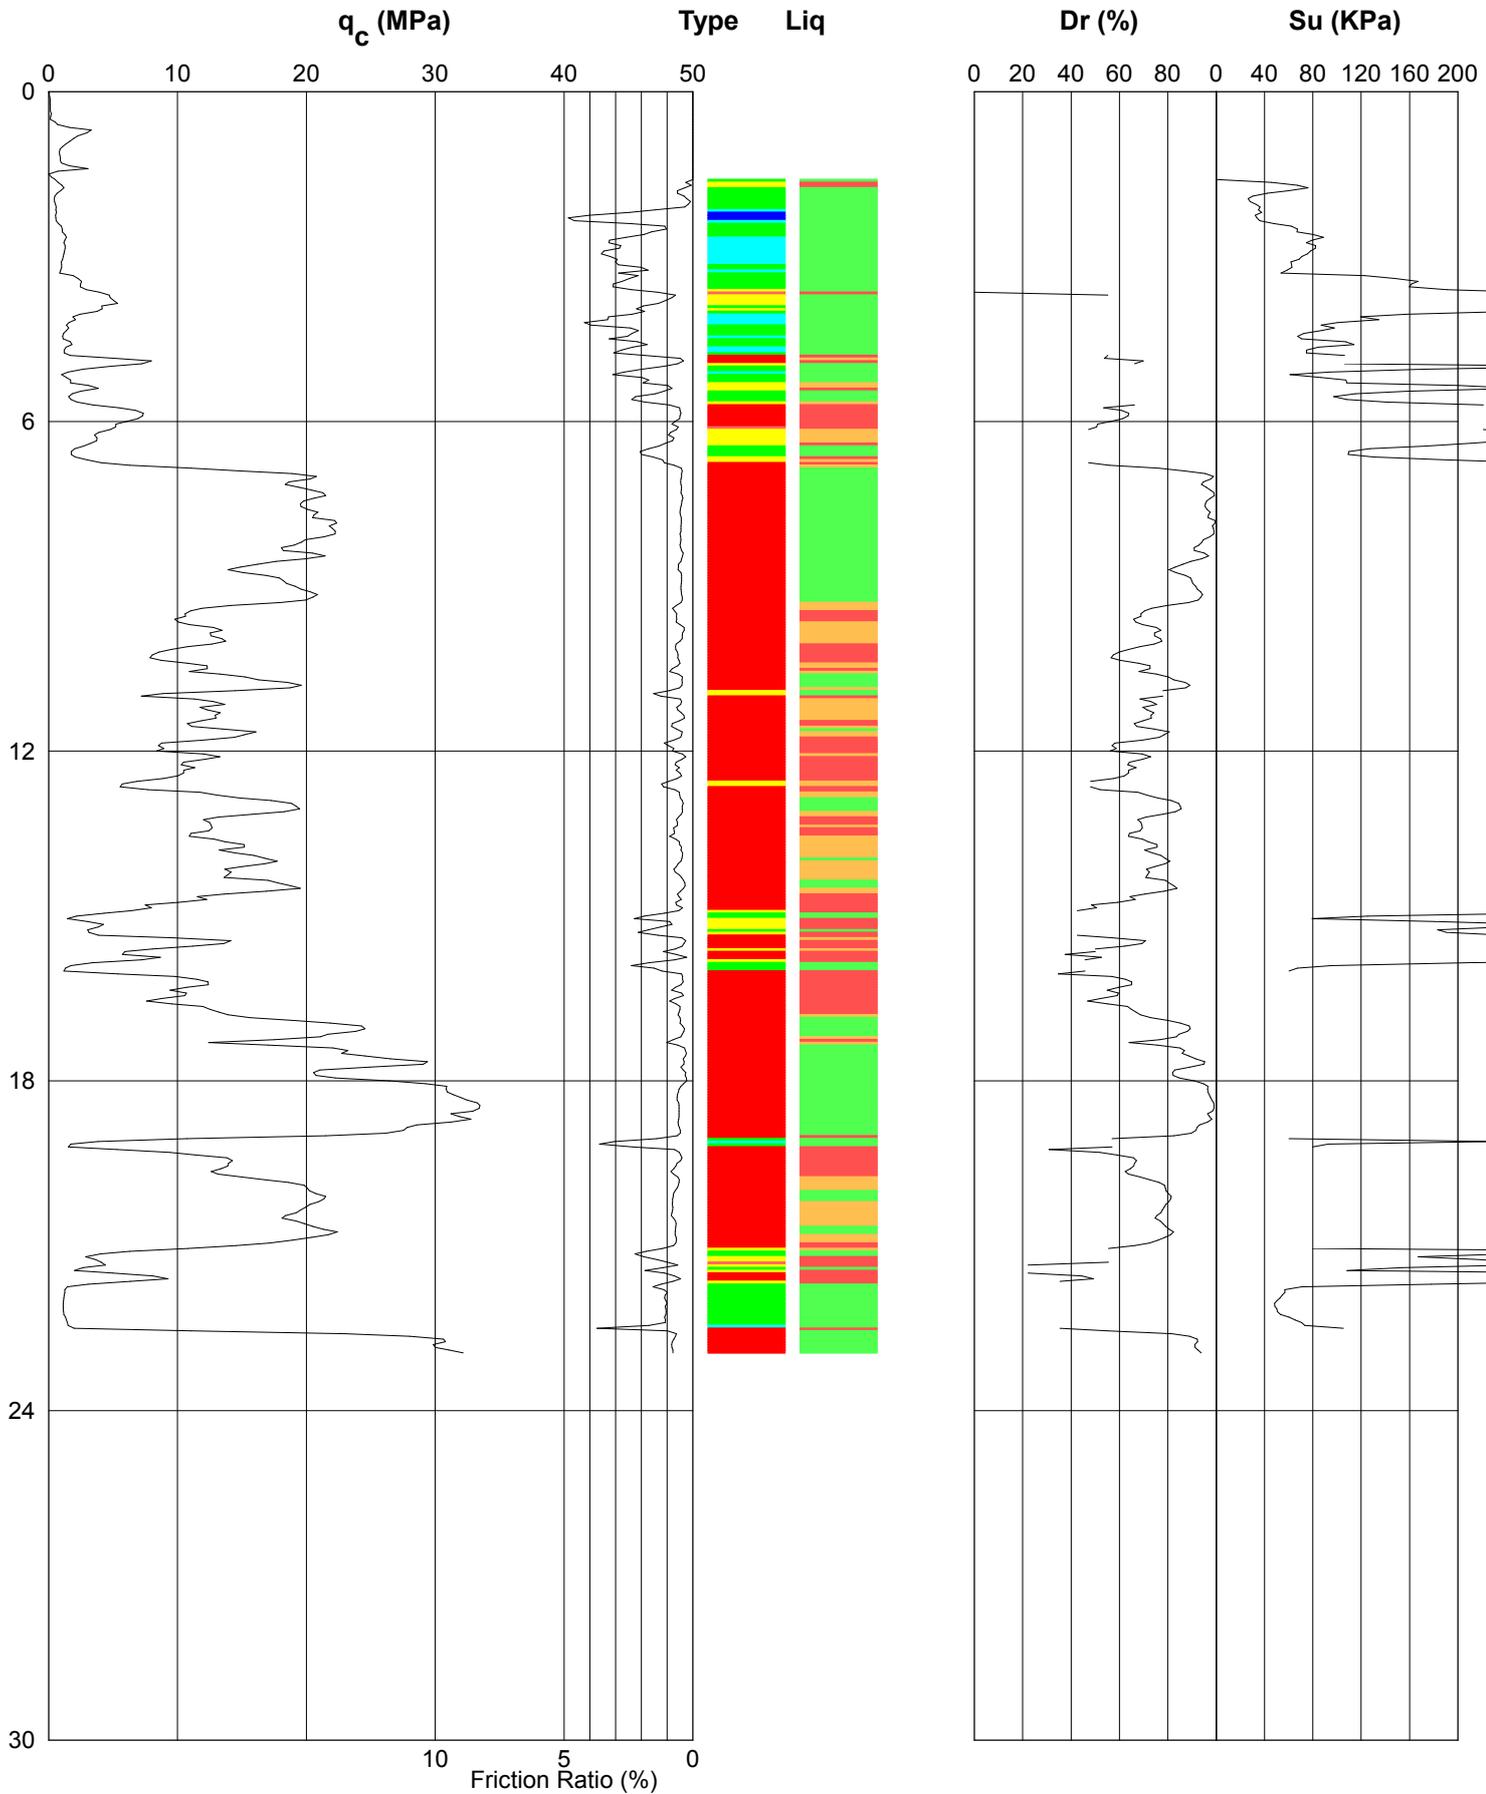
CPT No: CPTu001

CLIENT : GHD NZ Ltd
LOCATION : 149 Stanmore Road, Christchurch
DATE : 26-6-2012
OPERATOR : S.Cardona
REMARK 1 : CPTu001
REMARK 2 : Effective Refusal

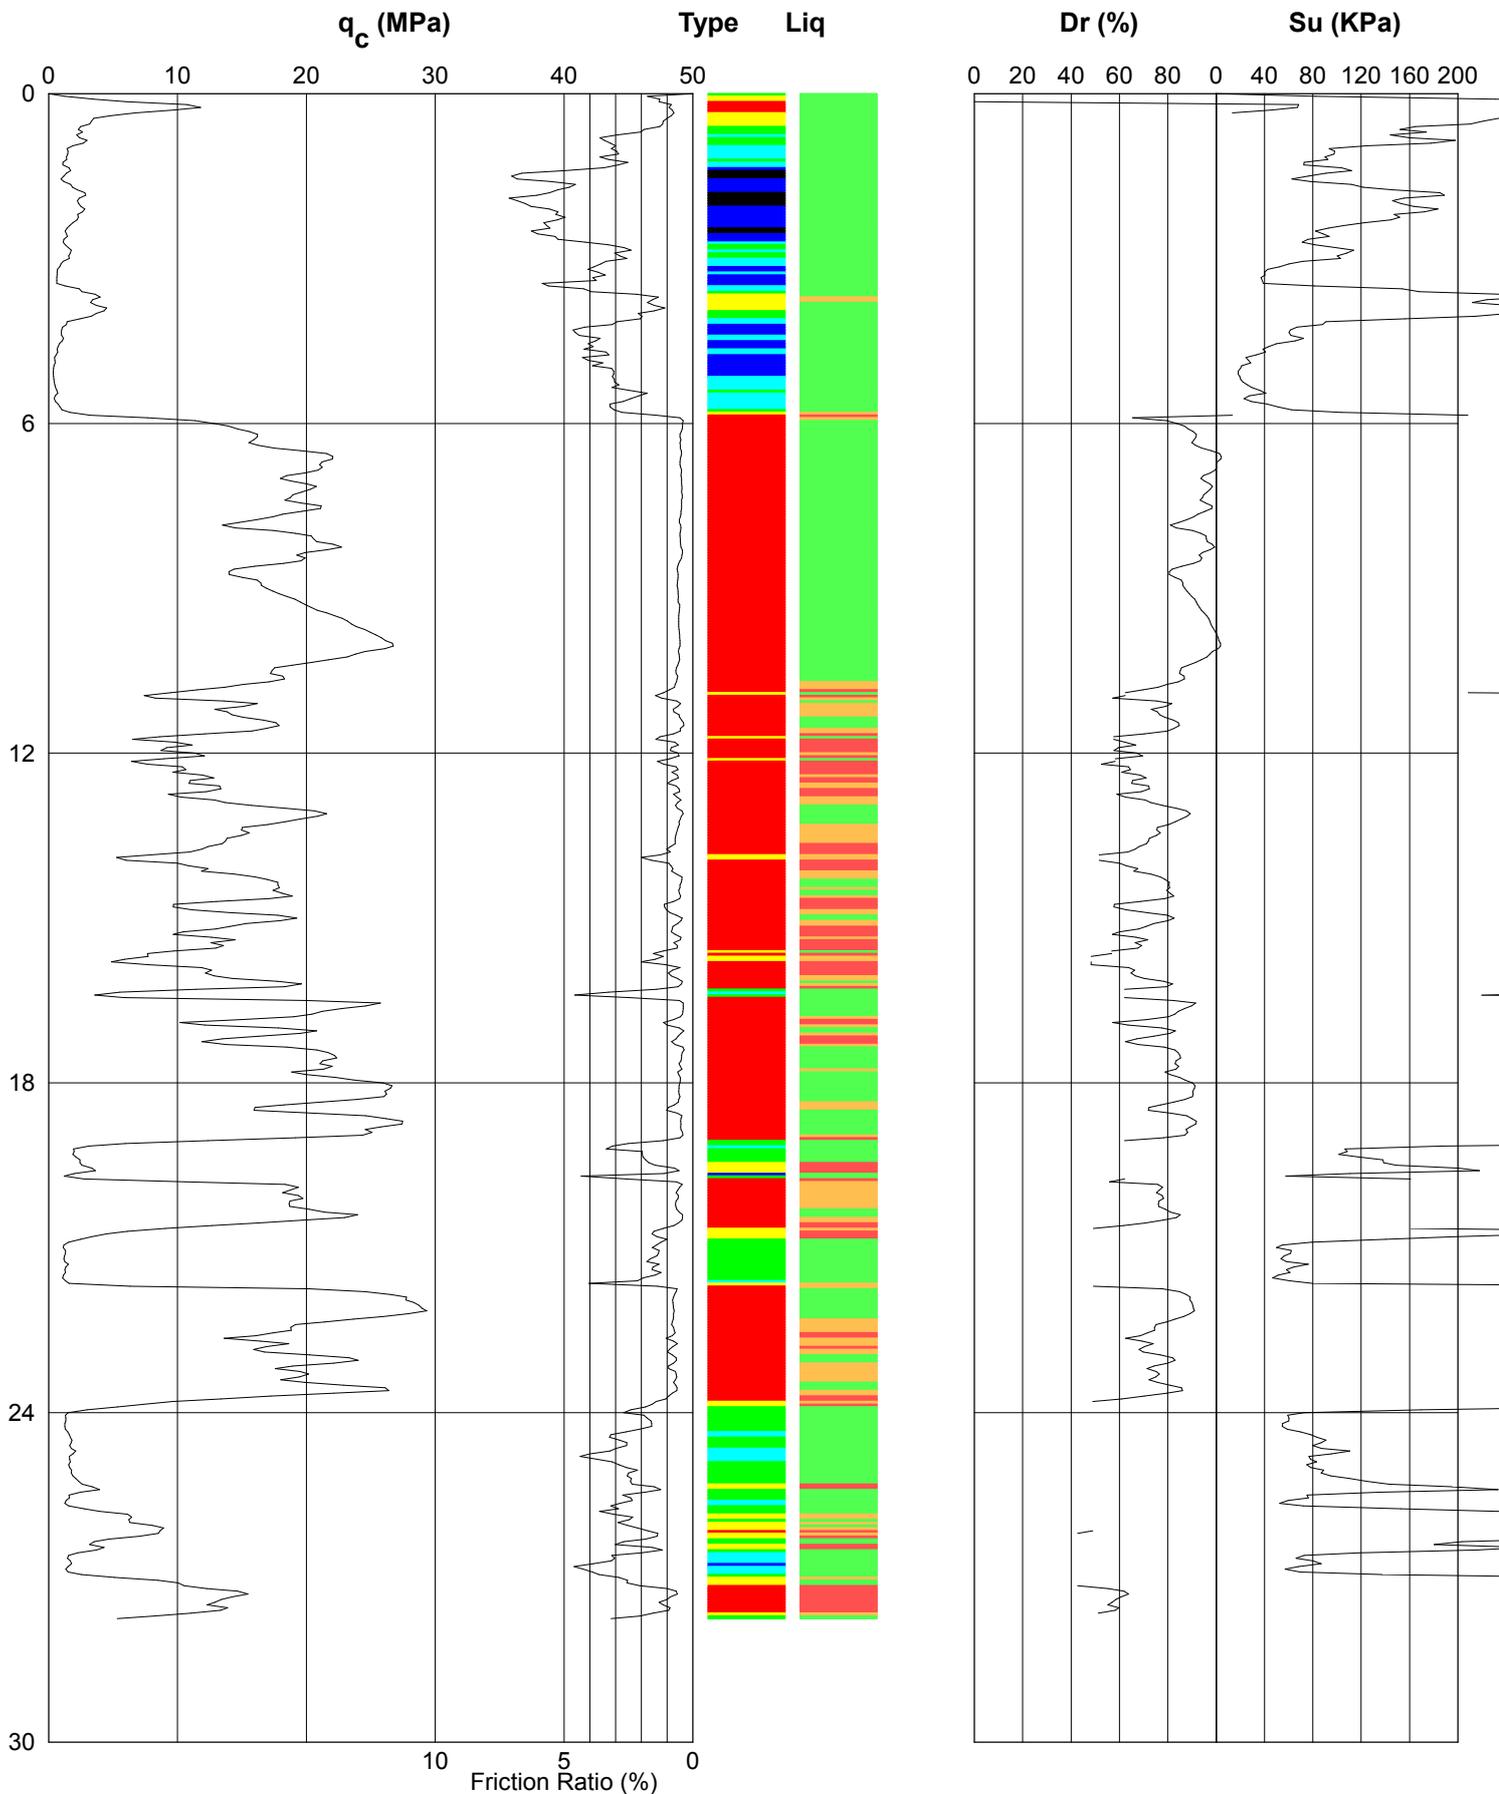
CPT No: CPTu002

CLIENT : GHD NZ Ltd
LOCATION : 149 Stanmore Road, Christchurch
DATE : 26-6-2012
OPERATOR : S.Cardona
REMARK 1 : CPTu002
REMARK 2 : Effective Refusal
