CHRISTCHURCH CITY COUNCIL
PRK_0339_BLDG_004 EQ2
Harewood Nursery – Pumphouse (x2)
239 Gardiners Road, Harewood

QUALITATIVE ASSESSMENT REPORT

- Rev B
- 23 November 2012

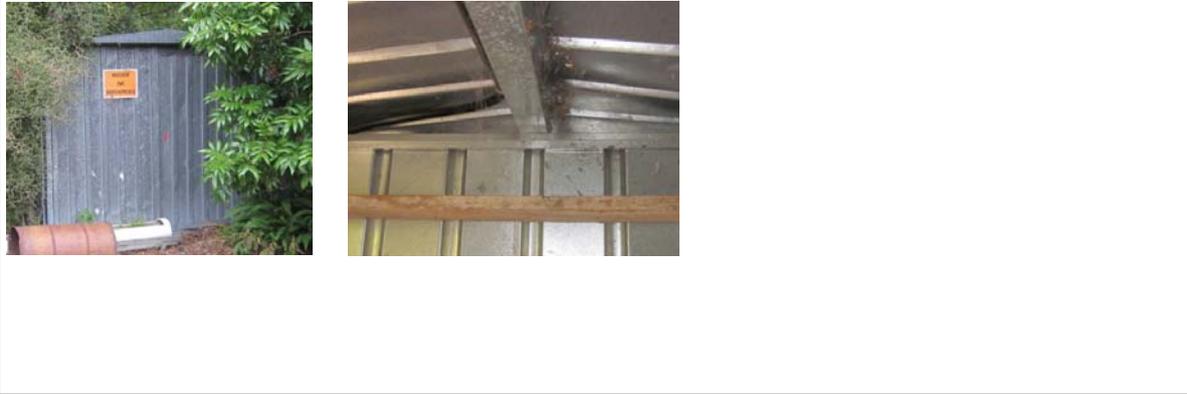
1.1 Photos (attach sufficient to describe building)

The Pumphouse structures, CCC-PRK-0339-001, are both single storey structures that are used as storage sheds at Harewood Nursery. Both structures are proprietary garden sheds that can be purchased from local hardware stores. They are constructed from light weight steel cladding and apart from some minimal light weight framing present at the roof apex and the top of the walls the structure is predominately formed from the cladding. Both sheds are supported on a concrete floor slab. The footprint of these structures is approximately 2.0m x 2.0m and 2.0m high. No structural drawings were available for these structures. Due to this we are unable to confirm their age. However based on the condition of this structure we believe that they were erected sometime in the 1990's and as a result have taken a construction period of 1992-2004 for our assessment. Lateral loads acting across and along the building will be resisted by the roof and wall cladding. Due to the lack of structural drawings available the quality of the hold-downs for both sheds is unknown. However due to the geometry and the light-weight nature of these structures if they were subjected to major shaking the end result could be that they would potentially slide away from their original location or end up out of plumb. This is unlikely to be life threatening.

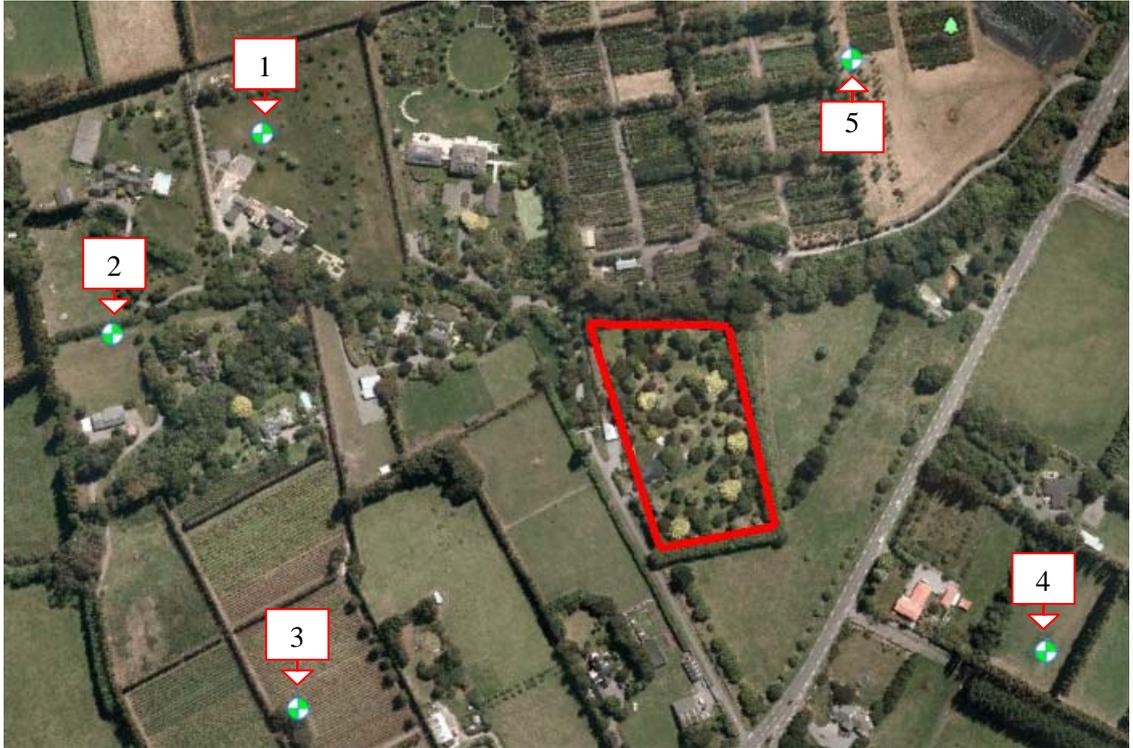
- **Figure 5 – Local boreholes from Project Orbit and SKM files (<https://canterburyrecovery.projectorbit.com/>)**

Where available logs from these investigation locations are attached to this report (Appendix B), and the results are summarised in Appendix C.

Borehole 5 identified in figure 5 was not accessible and therefore has not be included in this desk study.

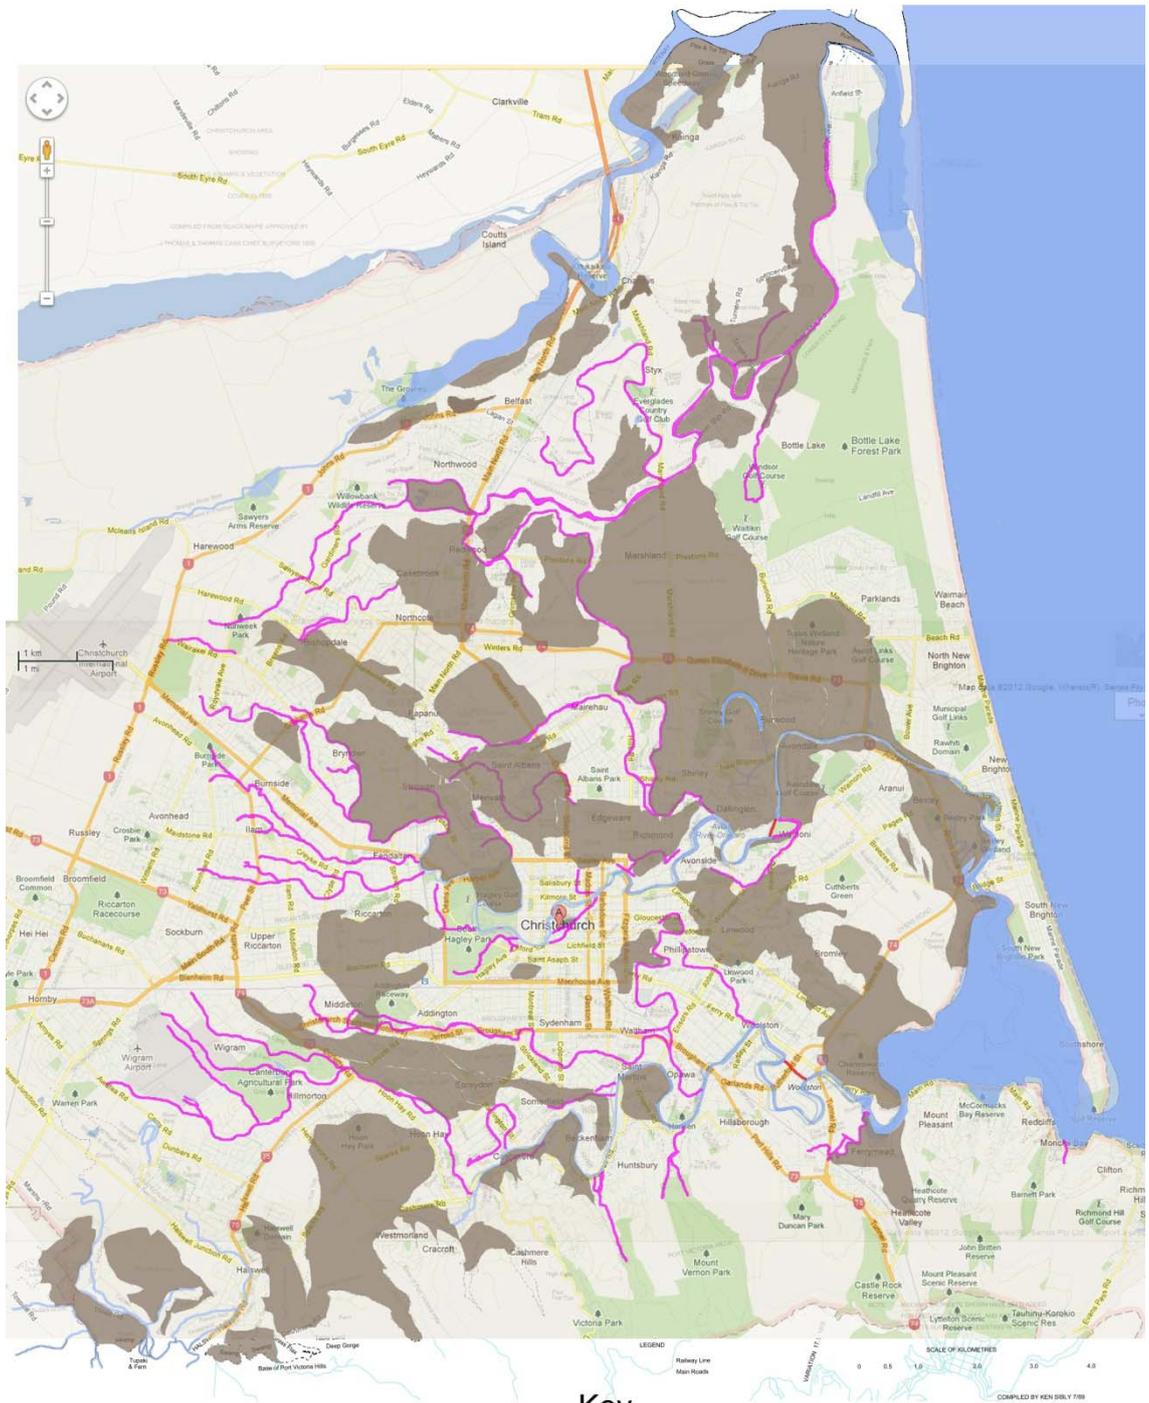
Appendix A – Christchurch 1856 land use

Reference to historical documents (eg Appendix A) shows that the site was recorded as grassland in 1856. Historical records also show a previous creek or river running through the site indicating the possibility of soft river alluvium being present underneath the site.

The swamps and previous creeks/riders from 1856 have been overlaid onto a map of Christchurch in 2012
