Christchurch City Council
PRK_0339_BLDG_006 EQ2
Harewood Nursery Vehicle Shed
239 Gardiners Road, Harewood

QUANTITATIVE ASSESSMENT REPORT

- Rev B
- 12 March 2013

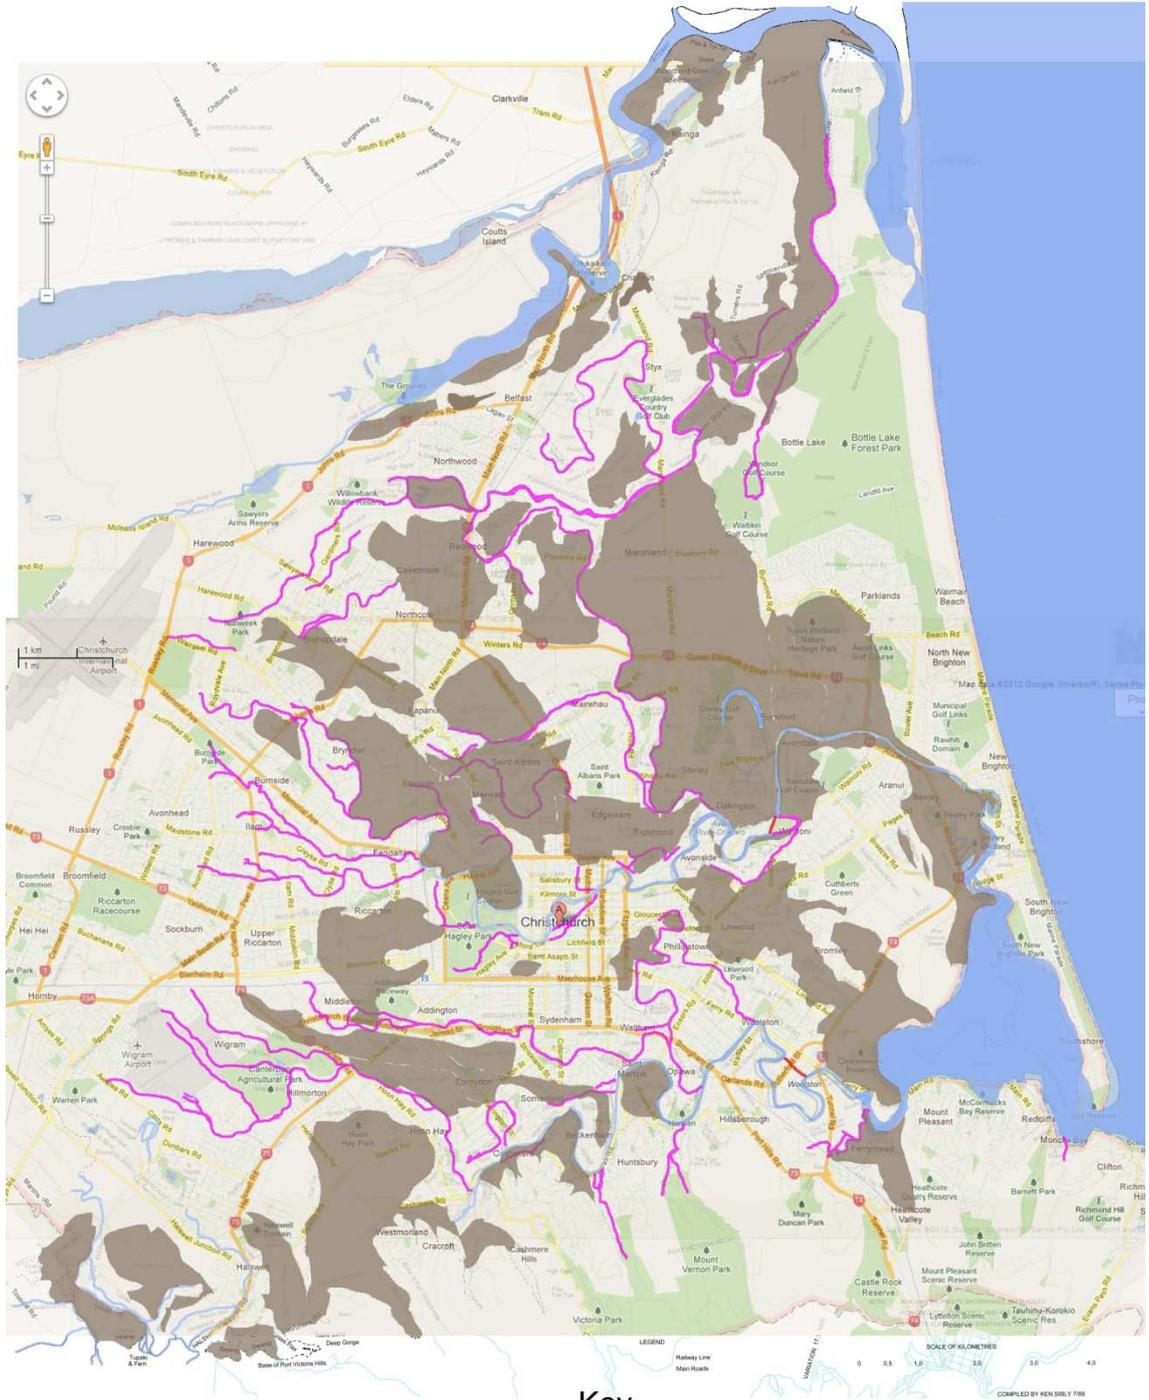
Reference to historical documents (eg Appendix A) shows that the site was recorded as grassland in 1856. Historical records also show a previous creek or river running through the site indicating the possibility of soft river alluvium being present underneath the site.

The swamps and previous creeks/riders from 1856 have been overlaid onto a map of Christchurch in 2012
