**Ka Wahine Trust  
Halfway House  
PRO 2538**

**Detailed Engineering Evaluation  
Quantitative Assessment Report**

**18 McGregors Road, Bromley,**

Date: March 2014  
Reference: 6-QC366.00  
Status: Final

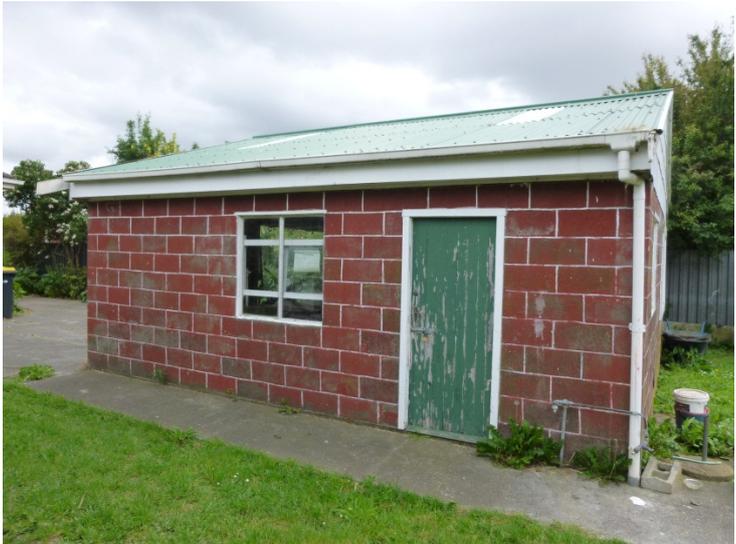
<p>14.</p>	<p>Garage exterior elevation (south-west end)</p>

The garage suffered severe damage to structural elements including significant cracking of the concrete block wall. This damage is expected as the concrete block walls are believed to be unreinforced.

- Cosmetic repairs be undertaken as required.
- The concrete block garage be strengthened or replaced.
