CHRISTCHURCH CITY COUNCIL
PRK_0227_BLDG_002
Linwood Nursery – Garage
320 Linwood Ave, Linwood

QUALITATIVE ASSESSMENT REPORT
FINAL

- Rev E
- 06 December 2013

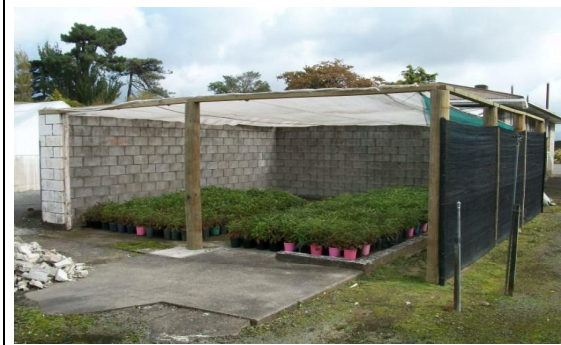
1.1 Photos (attach sufficient to describe building)

PRK_0227_BLDG_002 is a former garage now used as a shade house. Masonry walls are located on the west and south elevations of the structure and timber poles have been installed on the north and east elevations. The structure has a shade cloth covering which is fixed to the top of the masonry walls and timber poles using timber battens. The structure has a concrete floor slab with a concrete strip footing for the masonry walls.

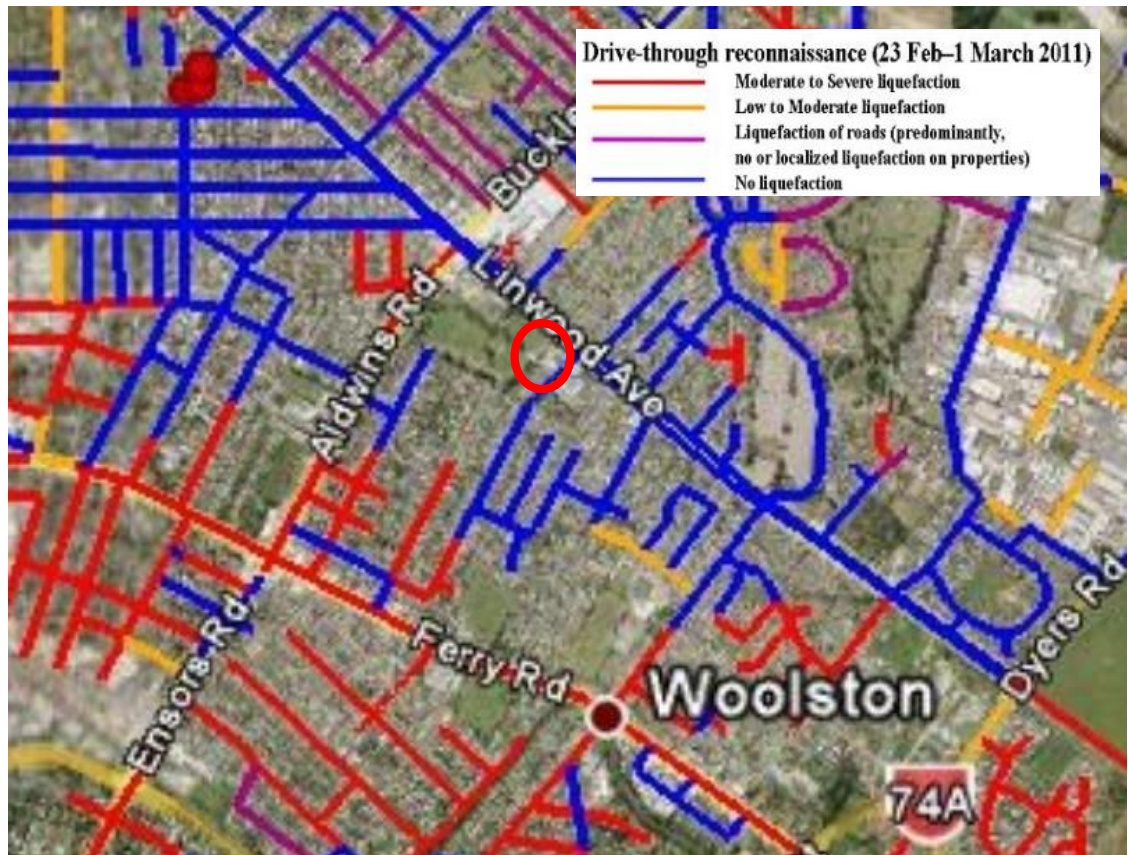
■ **Figure 4 – Liquefaction map (Cubrinovski & Taylor, 2011). Site marked in red.**

Following the 22 February 2011 event drive through reconnaissance was undertaken from 23 February until 1 March by M Cubrinovski and M Taylor of Canterbury University. Their findings show no liquefaction at this site.

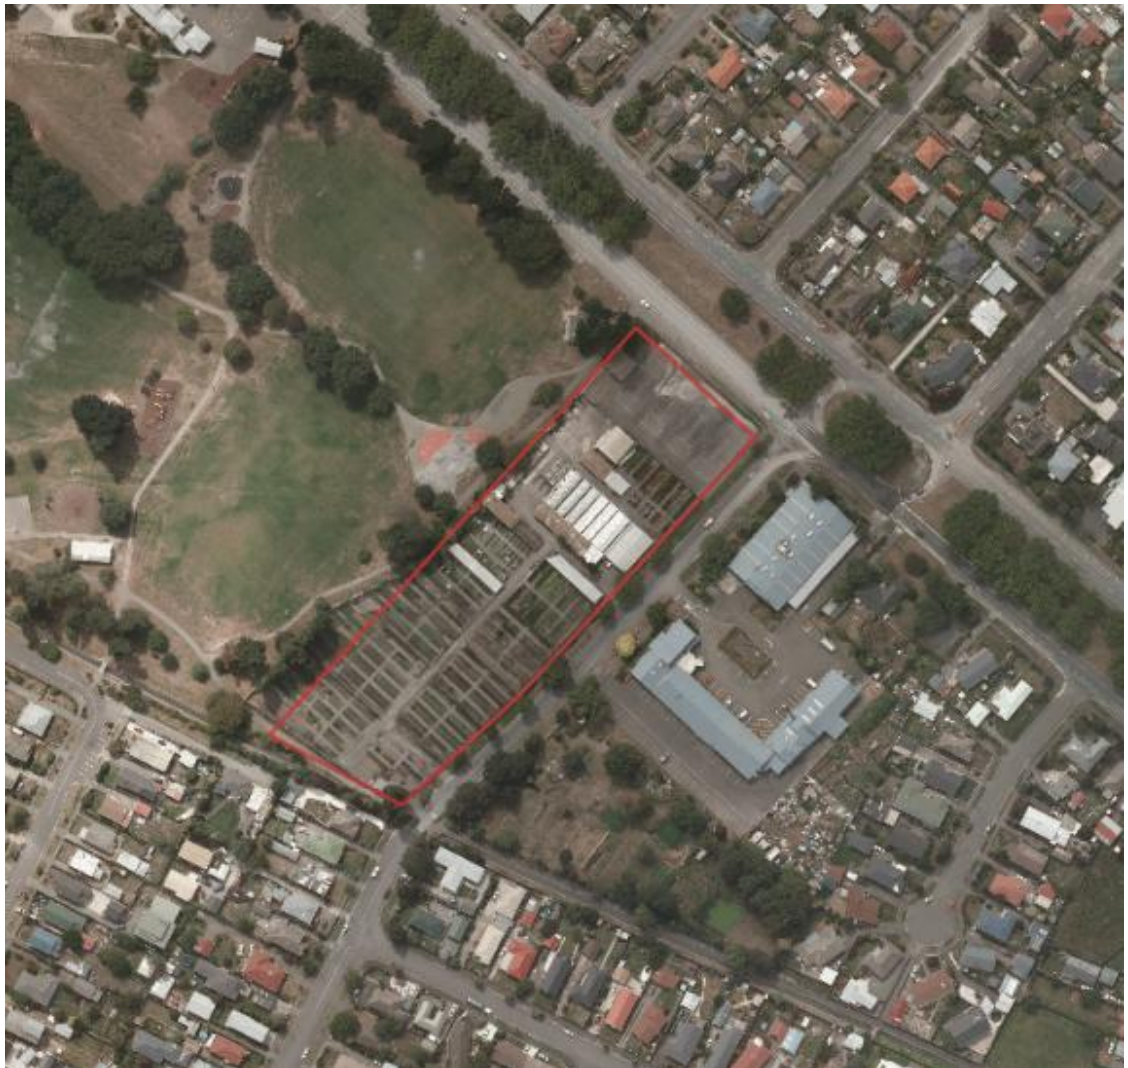
■ **Figure 5 – Aerial photography from 24 Feb 2011 (<http://viewers.geospatial.govt.nz/>)**

There appears to be liquefied material present at the northern end of the tennis courts. This relates well with the inferred underlying geology of the site, where the northern end of the site was shown to be underlain by sand of fixed and semi-fixed dunes. No liquefied material can be seen in the southern end of the site from the aerial photographs.

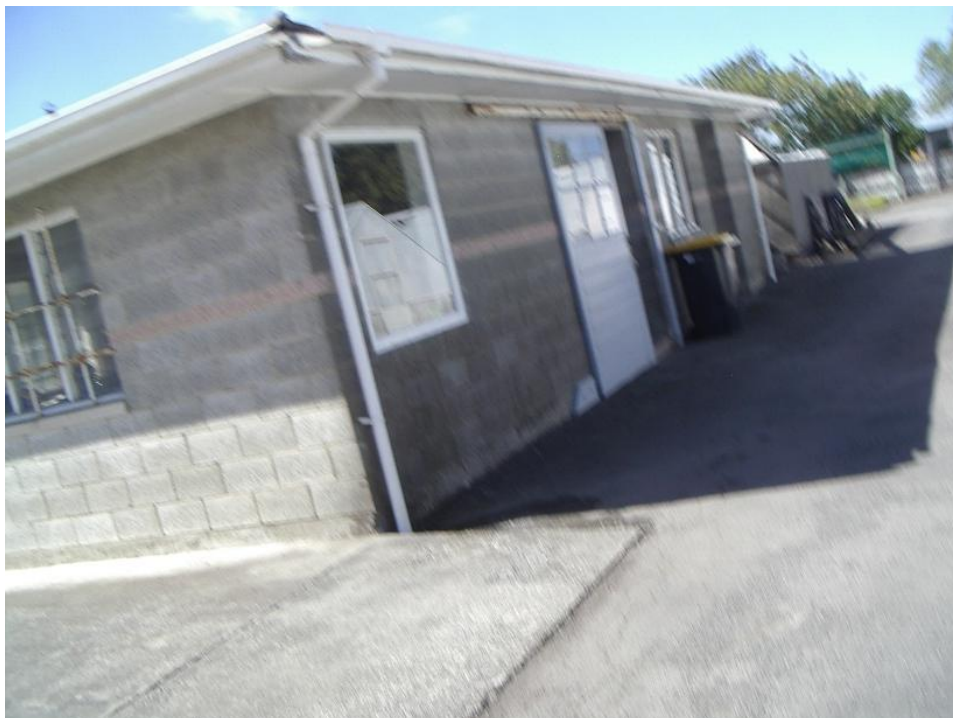
The main buildings were constructed using masonry blocks and metal clad roofs. A number of glasshouses and open frames were also present on site. No damage to any of the buildings was observed during the external site visit. Residents at the property mentioned that they saw no sign of liquefaction. Most of the site was asphalted, with no signs indicating that land damage occurred.

■ **Figure 7 Overview of Linwood nursery building**
