CHRISTCHURCH CITY COUNCIL BU 0822-014 EQ2 Linwood Resource Centre 322 Linwood Avenue, Linwood

QUANTITATIVE ASSESSMENT REPORT FINAL

- Rev C
- 01 July 2013

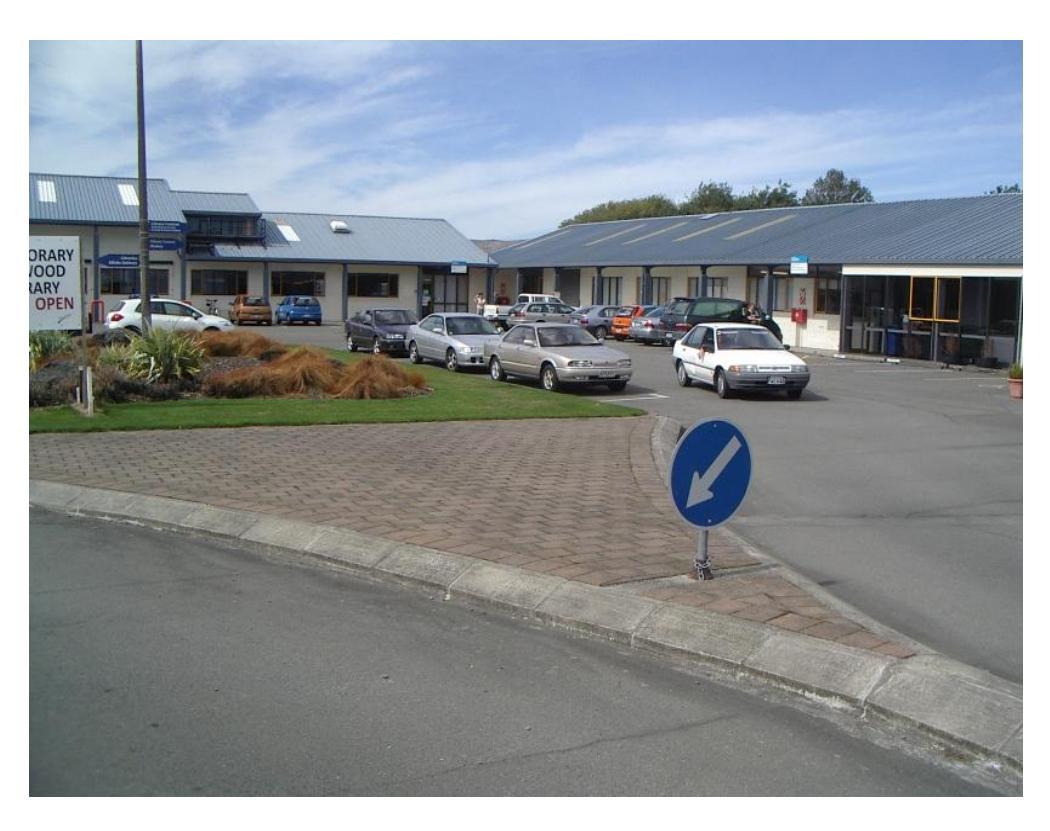
Figure 7 Overview of Linwood Services Centre and Library

The Linwood Resource Centre and Library were mostly constructed using masonry block with an iron roof, Figure 7 shows the overview of the site. The buildings were both in good condition, with no external evidence of structural damage. The majority of the land on the site was asphalt, which showed no signs of land damage. There was no evidence that liquefaction occurred on the site.
