Louisson Courts BE 1026 EQ2

**Detailed Engineering Evaluation
Quantitative Assessment Report**

Louisson Courts

Date: December 2012
Reference: 6-QUCC1.74
Status: Final

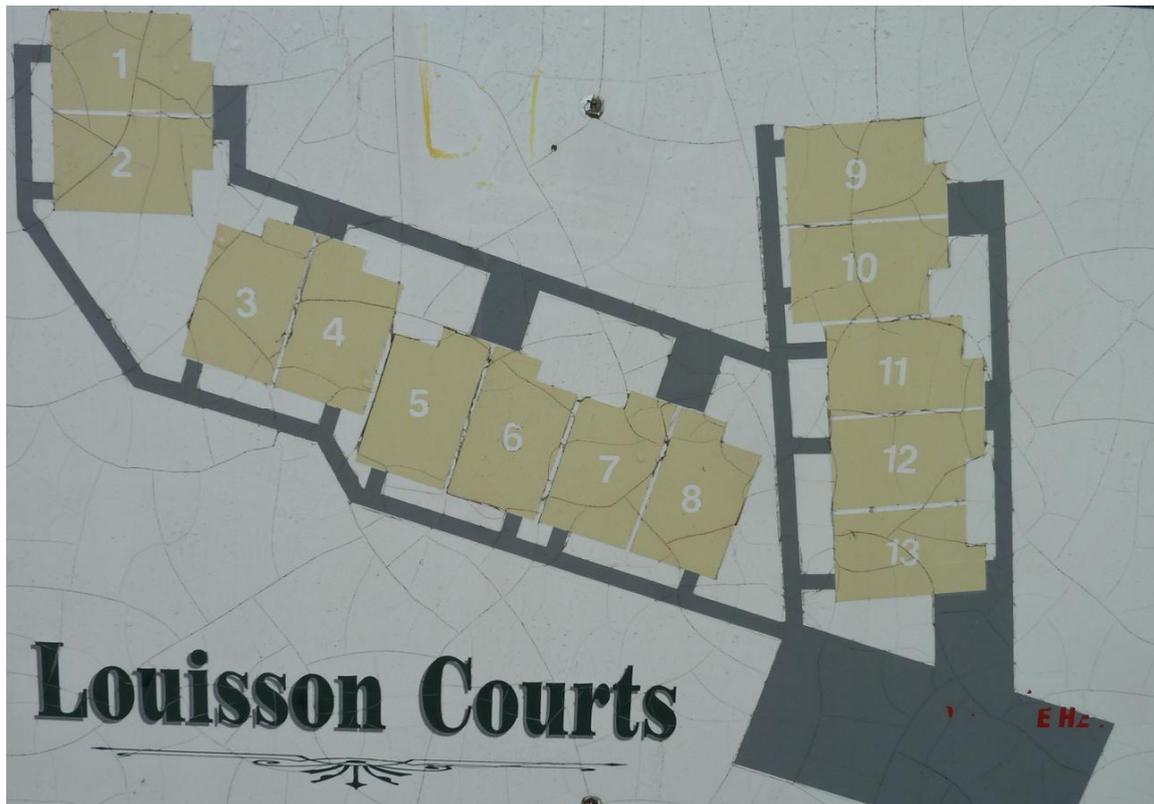
Figure 2: Louisson Courts Layout

The Louisson Courts development consists of 13 units and is situated in very close proximity to the Heathcote River. As Figure 2 below depicts, Units 1 and 2 are semi-detached buildings. Units 3 to 8 and 9 to 13 are arranged in terraces.

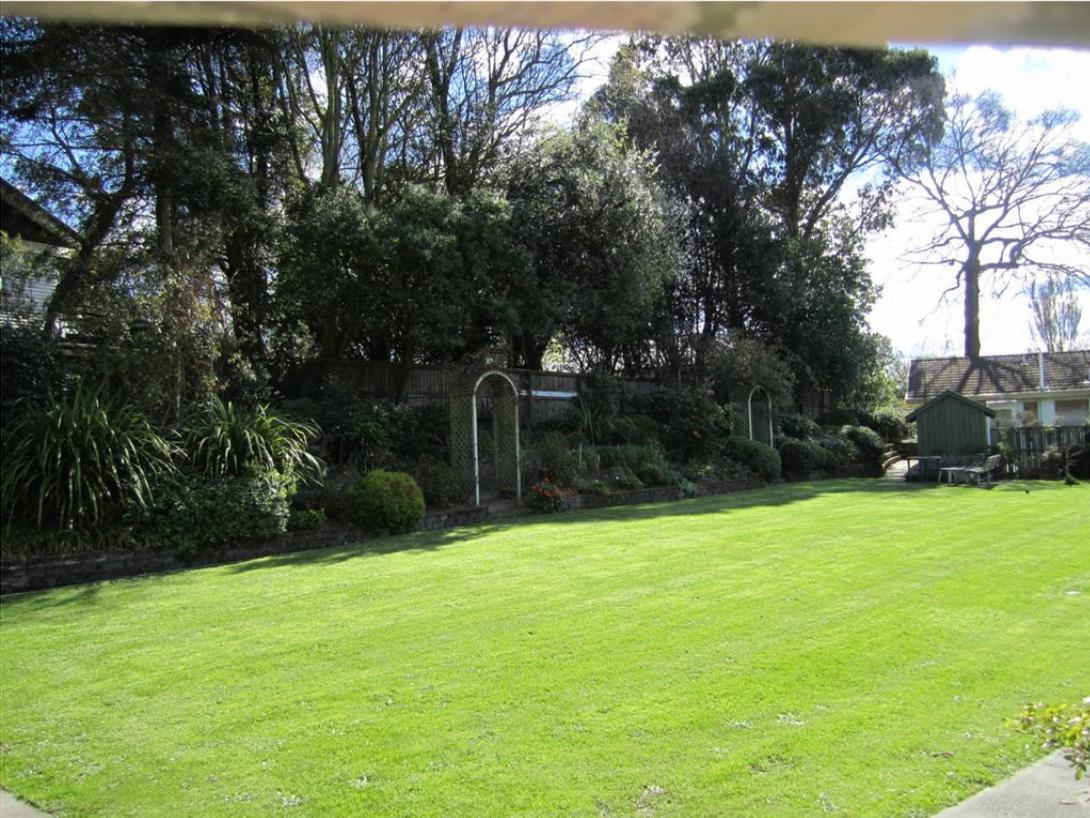
There is a 20° to 25° steep, 2.5m to 3.5m high slope on the western side of the site, leading up to the fence boundary (photo 25). The ground beyond the fence is generally flat and level. The slope is likely to be a historic river terrace of the Heathcote. There are paths on this slope and small retaining walls (typically height 0.25m or less) on the bank. The retaining walls are generally vertical to 5° off vertical, with a slight lean towards the downhill side.

Photo 25: Landscaped bank on western side of site. Units 9-13 in right corner of photo.

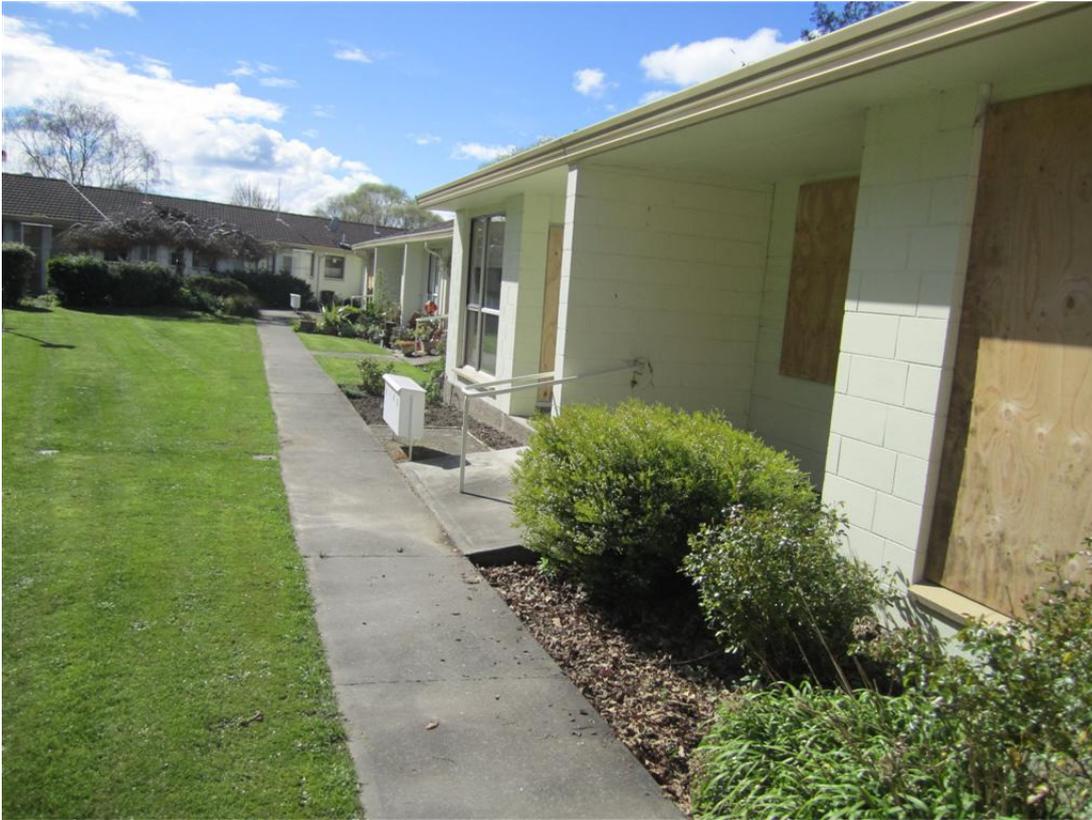
- The crack parallel with the North side of units 1-2 is indicated in the garden areas to the side of the path and was not observed on site. However, cracks and gaps in the paving were observed in the North West end.
- The crack indicated in the lawn area to the west of units 3 to 8 was not identifiable on site (photo 27).
- Cracks were noted in the building foundation of units 9-13, as was some distortion of the path. There are 10mm to 20mm wide horizontal gaps between each of the units 9 to 13 (separations in the roof guttering observed). This horizontal movement is likely to be associated with lateral spreading towards the Heathcote.

Photo 27: Lawn area on west of units 3-8, view to north. Units 3-8 on right of photo.
