Lyttelton Information Centre

Detailed Engineering Evaluation

Quantitative Assessment Report

Date: October 2012
Reference: 6-QUCC1.02
Status: Final

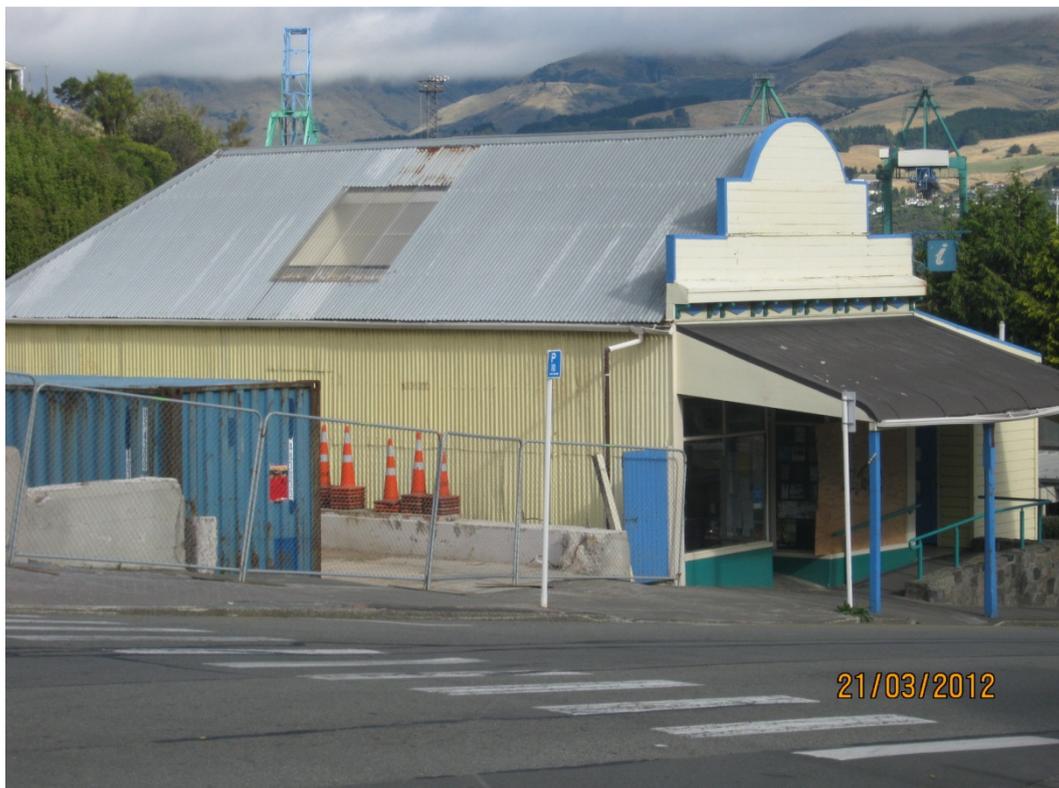
Photo 2: View of the building from the street

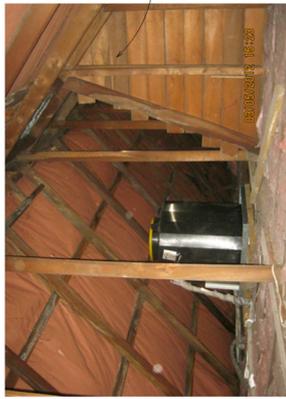
View onto skylight - shows new timber.

Notes:
 - Beams partially replaced on roof at base of skylight in order to allow for 400mm wall to the pavement level.
