DETAILED ENGINEERING EVALUATION – QUALITATIVE AND QUANTITATIVE REPORT

NEW BRIGHTON CLOCK TOWER

September 2012

NEW BRIGHTON CLOCK TOWER (213 Marine Parade, New Brighton)

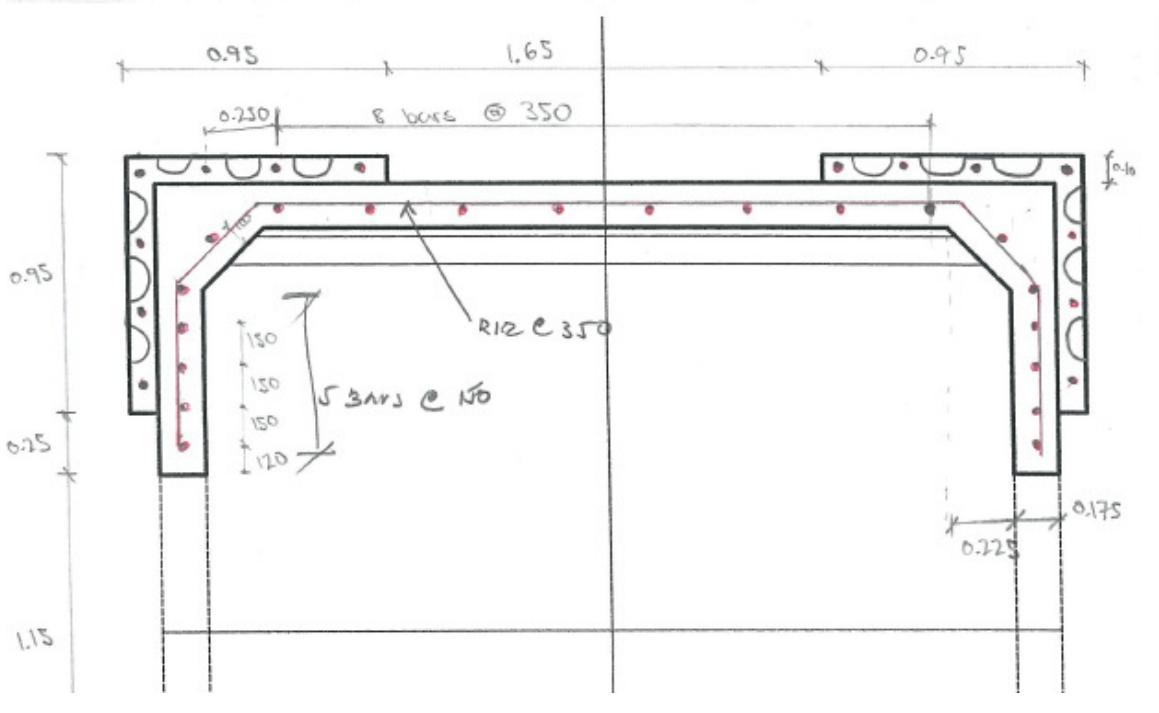
Non intrusive location and depth testing was undertaken for the steel reinforcement using a HILTI –bar scanner. This determined that one layer of longitudinal reinforcing at 350mm spacing and 350mm for the vertical reinforcing bars was within the concrete walls. The scan indicated the depth of the bars but did not provide the bar diameters. It was assumed round R12 were used. The NZTA manual section 5.1 suggests that for this age of structure a tensile strength of 210 MPa can be used for the steel reinforcing. Figure 12.1 shows a plan cross section and the steel bar layout assumed within the walls, based on the site measurements.
