New Brighton Library

BU 1330-004 EQ2

**Detailed Engineering Evaluation
Quantitative Assessment Report**

Date: September 2012
Reference: 6-QUCCC.67
Status: Final

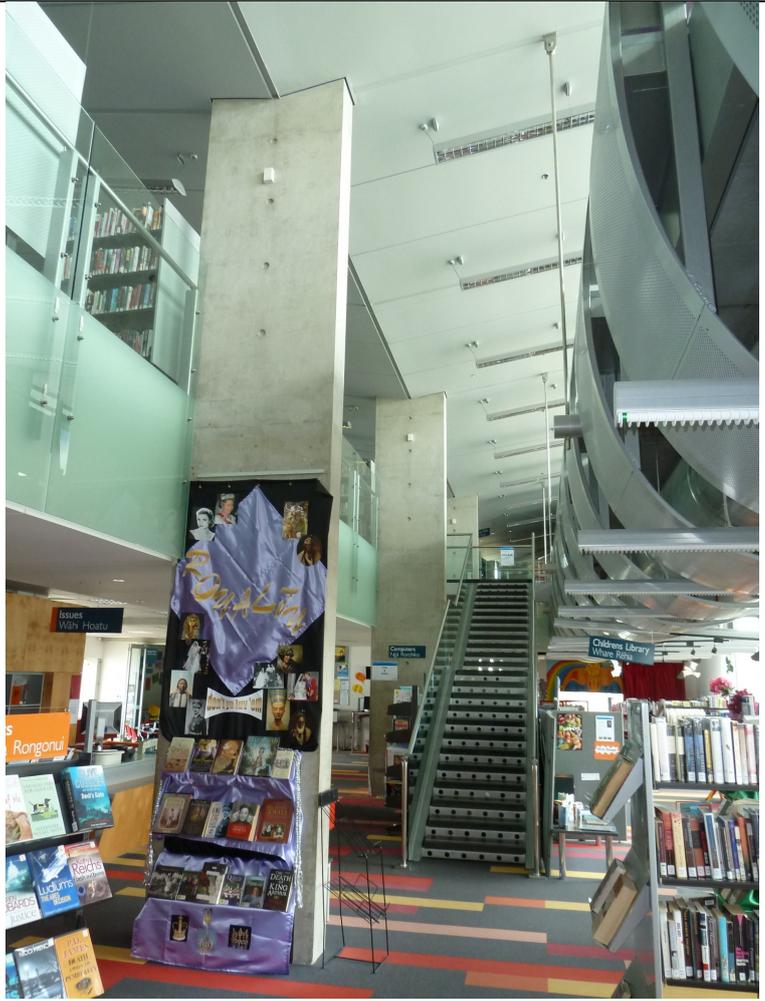
<p>5.</p>	<p>Internal view of library showing cantilevered columns and internal staircase</p>

The internal steel staircase is fixed at both first and ground floor level. This will cause it to take some load when the building moves during an earthquake. This will result in a concentrated eccentric load at all attachment points. This would also result in an eccentric load being applied part way up the column off which the mid-way landing is supported, and may result in hinging of the stringers. Being of steel construction, collapse of the staircase is not considered to be likely; however, levels of damage at and around the connection of the staircase may be increased.

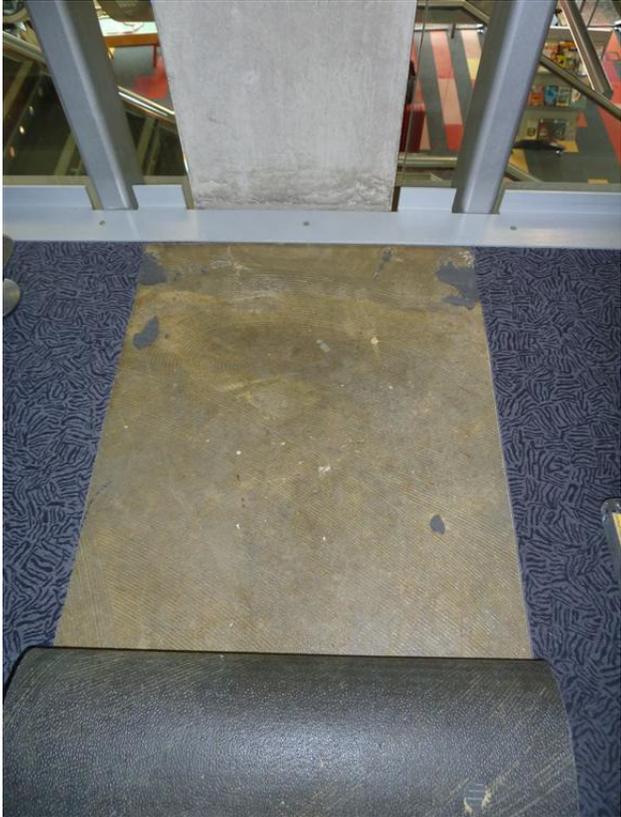
<p>10.</p>	<p>First floor diaphragm above precast concrete beam</p>

The visible portion of the precast beams running east-west across the building in the library show signs of flexural cracking on the vertical face of the beams due to weak-axis bending. These cracks are typically up to approximately 0.5mm wide, decreasing to nothing part-way across the underside of the beam. This may indicate that some softening of the floor diaphragm may have occurred. It will be necessary to remove the floor linings above to confirm whether the topping slab has been damaged.

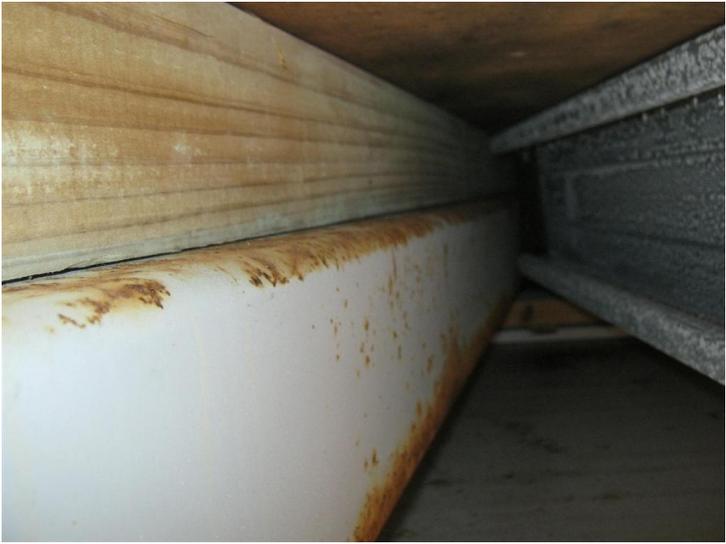
<p>20.</p>	<p>Plywood diaphragm with timber collector element to horizontal steel brace</p>

This connection differed to the consent issue structural drawings. The steel brace was fixed to the underside of the rafter via a fully welded connection rather than a bolted connection. There was no damage observed to any part of this connection or the horizontal collector elements.
