Ouruhia Hall
BU 0391-03 EQ2
Detailed Engineering Evaluation
Quantitative Report
Version FINAL

225 Guthries Road, Belfast

Christchurch City Council

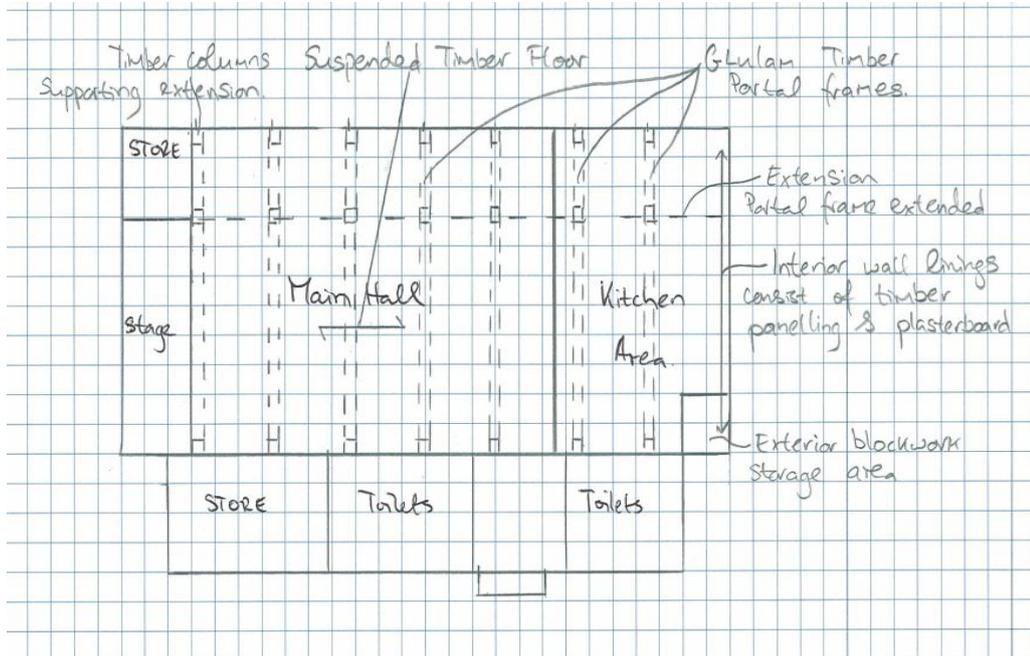
Figure 2 Plan Sketch Showing Key Structural Elements

Key structural details of the building are shown in Figure 2 to 4.

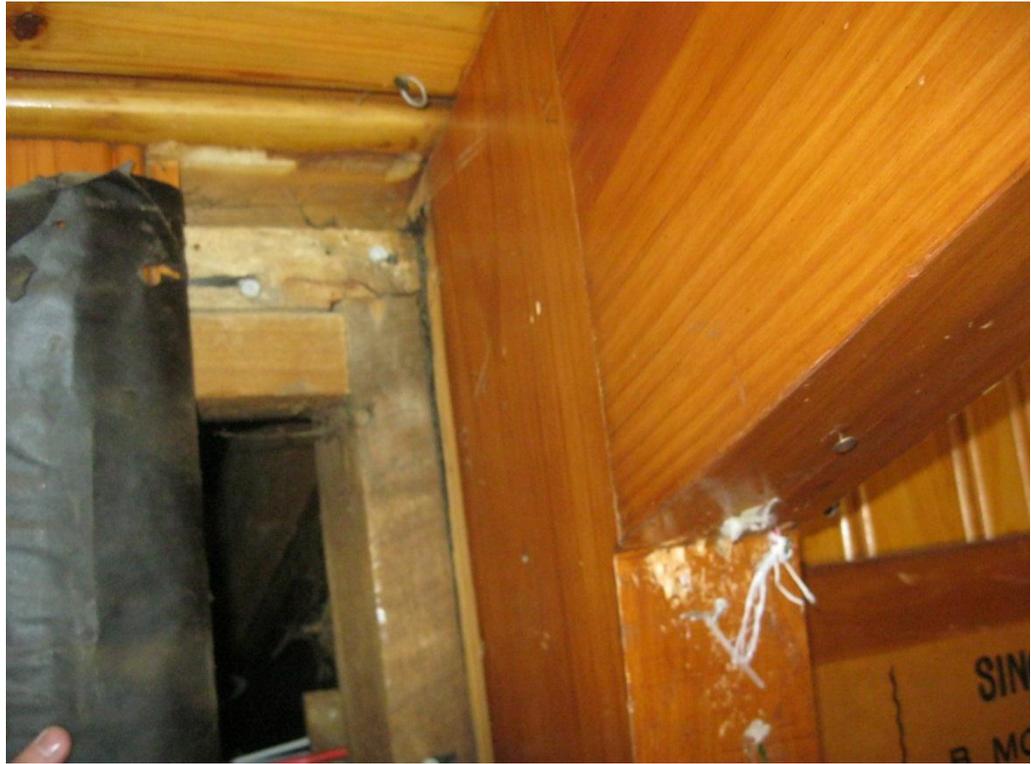
Photograph 11 **Beam Connection between the Timber Portals**

Further inspections were carried out on the 29th August 2012 to confirm the beam connection between the timber portals (Photograph 11). Furthermore, the inspections undertook the verification of the roof and wall member dimensions of the toilet/store rooms. Also, the steel reinforcing and the connection to the building of the masonry outhouse were identified.
