**Phillipstown Courts
Housing Complex
PRO 0818**

**Detailed Engineering Evaluation
Quantitative Assessment Report**

**263 Ferry Road, Waltham
Christchurch 8011**

Date: September 2013
Reference: 6-QC388.00
Status: Final

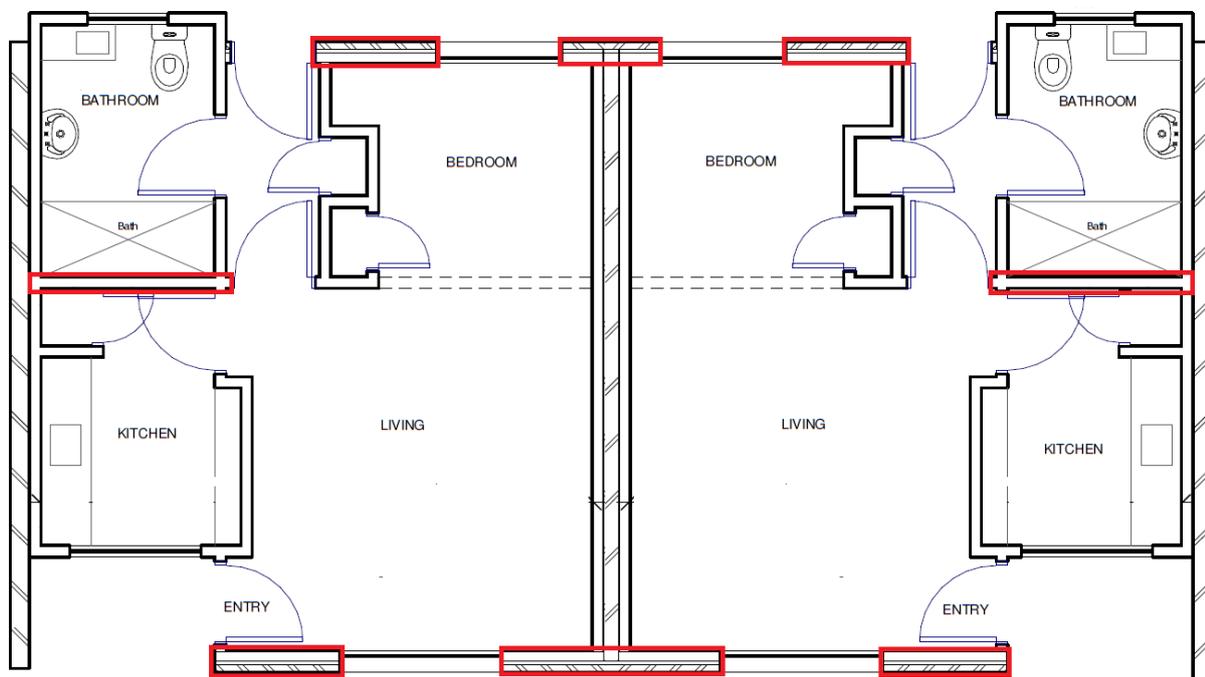
Figure 6: Walls used for bracing in the longitudinal direction.

Hand calculations were performed to determine seismic forces from the current building codes. These forces were applied globally to the structure and the capacities of the walls were calculated and used to estimate the %NBS. The walls, highlighted in Figure 6 and Figure 7, were used for bracing in their respective directions.
