# Pickering Courts

## Detailed Engineering Evaluation Report

BU 0611-001 EQ2 Block A Qualitative  
BU 0611-002 EQ2 Block B Quantitative  
BU 0611-003 EQ3 Block C Quantitative

17 April 2013

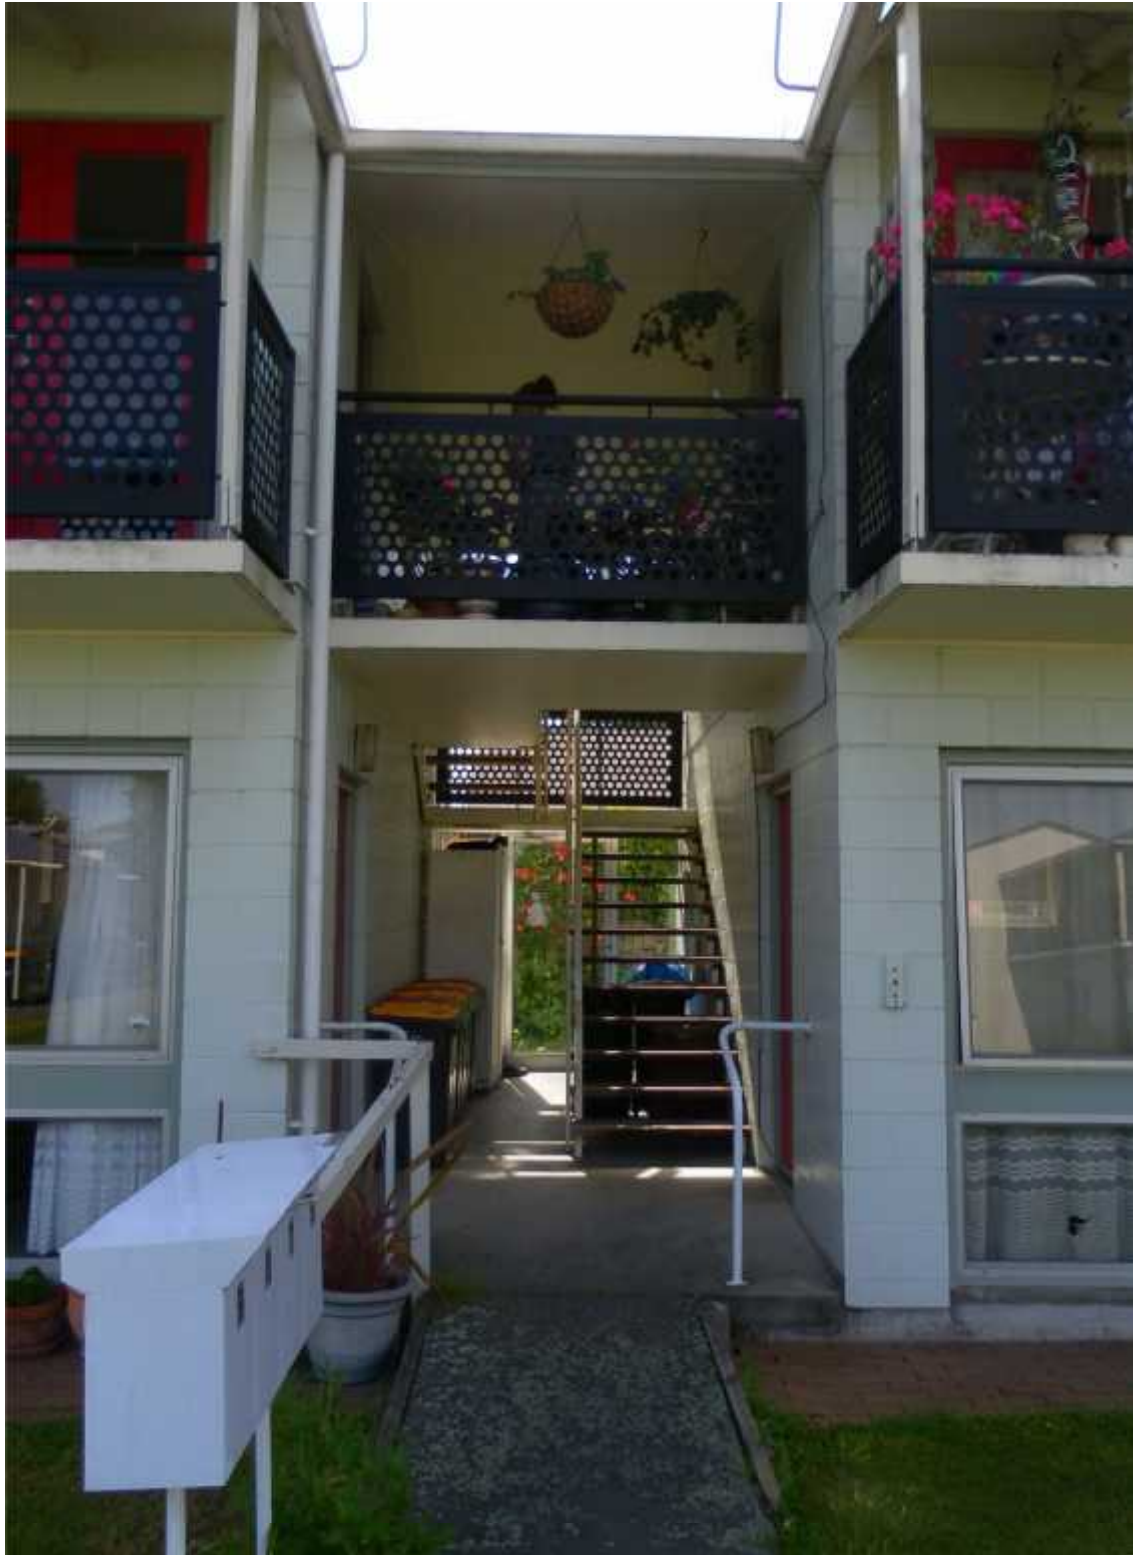
The building has suffered cracking to the first floor stair landings and temporary propping has been installed. Details of the temporary propping solution were provided by email dated 21 December 2012.

For analysis purposes, the first floor stair landings were deemed to have large enough diaphragm discontinuities that seismic loads could not be transferred across the landing and throughout the structure. This was exemplified by the moderate level of cracking from pounding between the blocks. As a result, Block B was divided into two “blocks” and Block C was divided into five “blocks”; two end blocks and three middle blocks with the stair landings serving as the seismic break, refer Figure 1 in Appendix A.

**Photo 5:** Intra-block stairs. Detail is typical for the three sets of stairs in Block C, as well as the set of stairs in Block B. The stair landings are the dividing feature/seismic separation between each block (refer to Section 11.1).
