Porritt Park Garage
BU 0706-003 EQ2
Detailed Engineering Evaluation
Qualitative Report
Version FINAL

845 Avonside Drive, Wainoni

Christchurch City Council

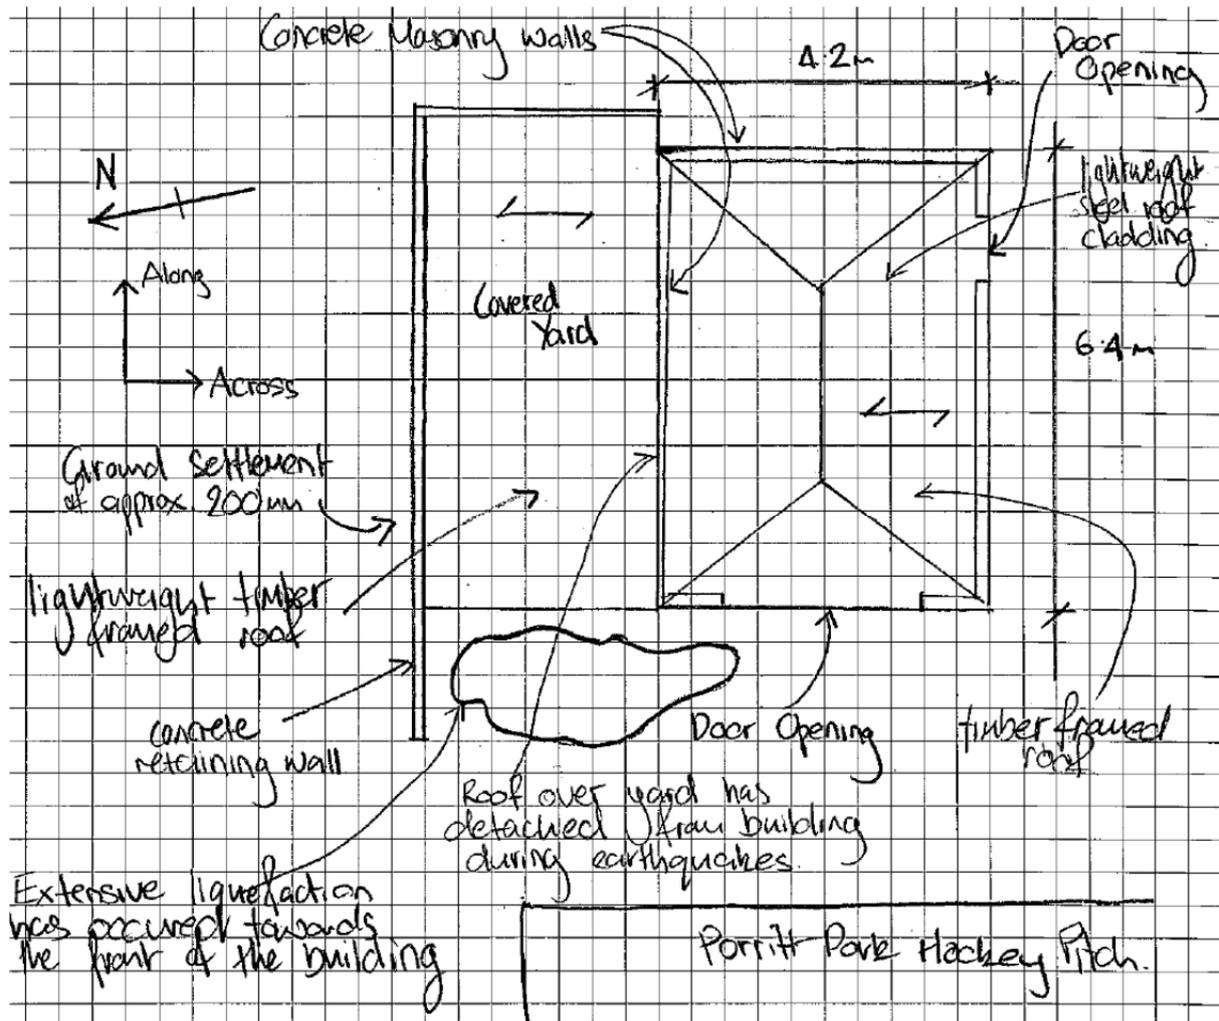
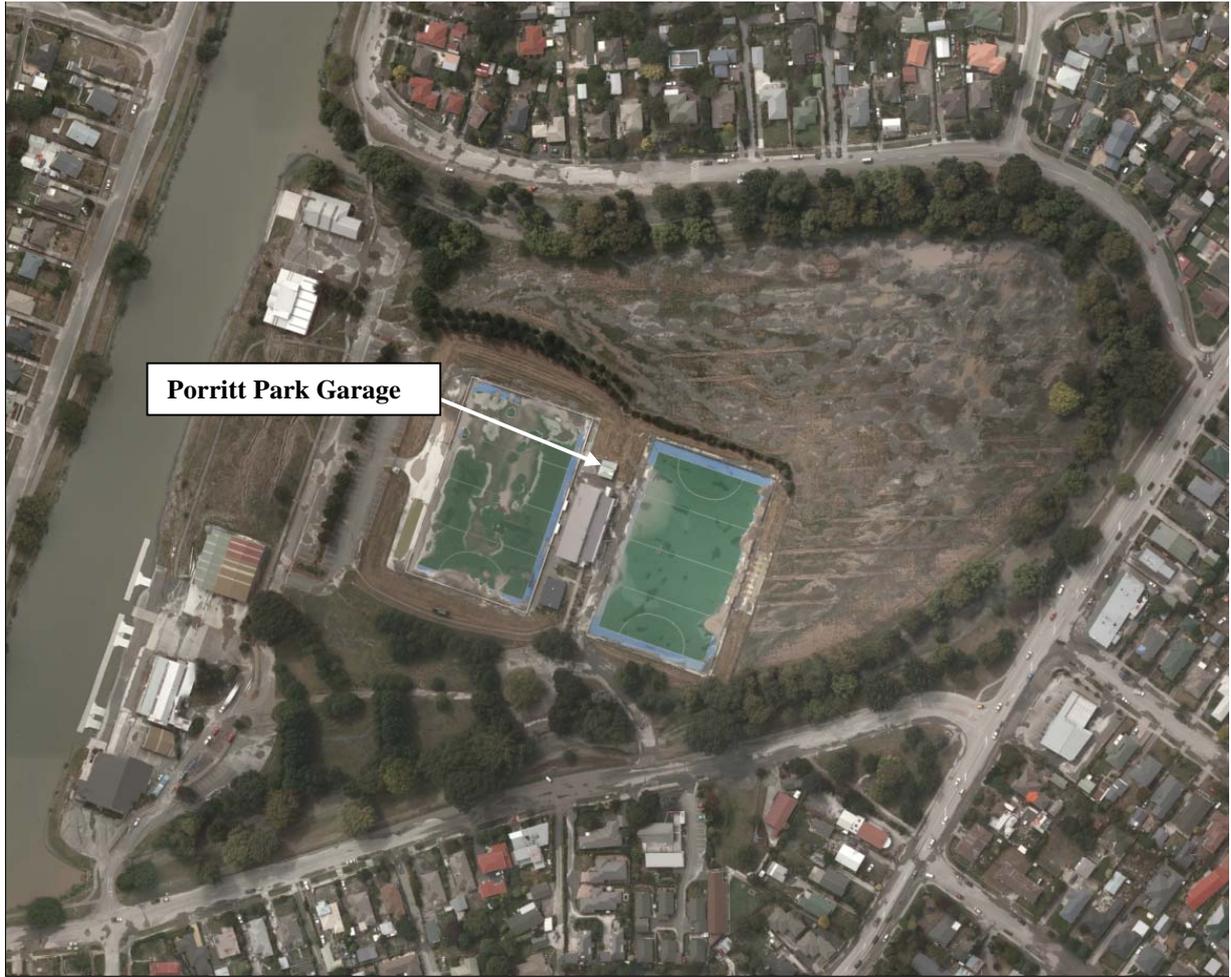
Existing Drawings / Sketches

No structural or architectural drawings have been made available for this building. Shown below is a marked up plan of the building showing key structural elements. A site plan is also included.
